**Historical Architectural Review Board
FINAL Review Sheet**

HDC-2024-00024

Address: 1525 W Chew Street

Proposal: Legalize porch repair work

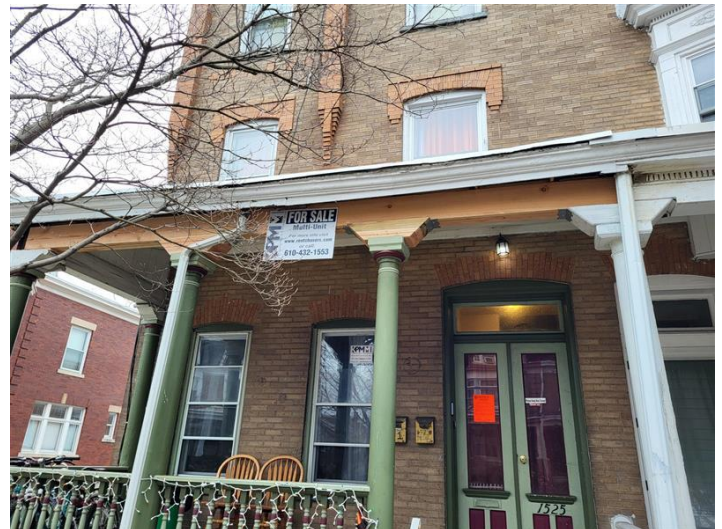
Repaired Porch (Applicant)

This application proposes to legalize the replacement of the porch roof header due to rotting. The work will include removing the existing 2" x 10" x 8' header. A new 5" header will be installed and recovered with 1"x material that is 3/4" solid wood. The installation will be caulked and painted to look exactly the same as it was prior to the work being completed.

Observations & Comments: This is a relatively straightforward in-kind repair and appears to match the existing configuration well. Although no existing photographs were provided and it is not clear if there was any additional detailing at the header (similar to what is present at the adjacent porch header).
