CITY OF ALLENTOWN

Denial of a Certificate of Appropriateness – 1410 W. Linden Street

**Historical Architectural Review Board
COA Final Review Sheet**

HDC-2022-00058

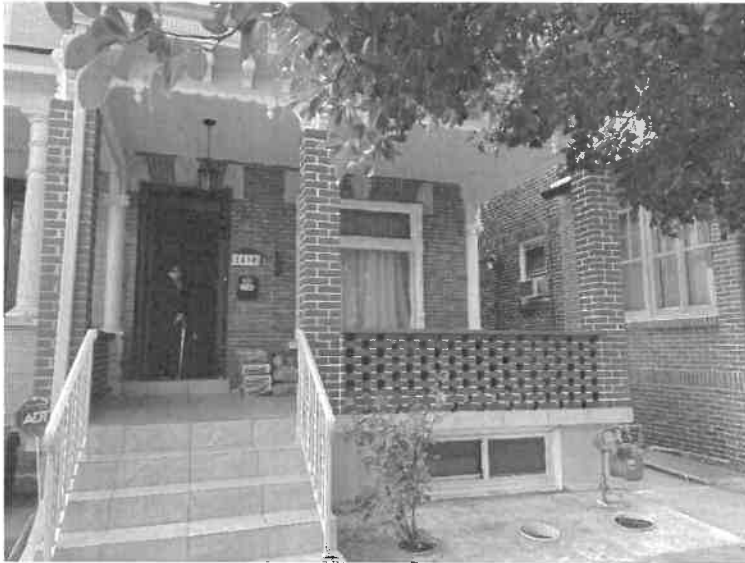
**1410 W. Linden Street after replacement.
(Applicant)**

The brick piers and railings do not replicate the historic in material composition, size, shape, profile, dimension, appearance, or finish and do not comply with Guidelines 3.7.4 or 3.7.5. Staff recommends removing the brick and replicating the historic columns, capitals, balusters, and railings. In the revised scope, the contractor proposes to install 8-inch wood columns and states that they match the dimension of the original. Staff finds the round wood columns to be an acceptable match.

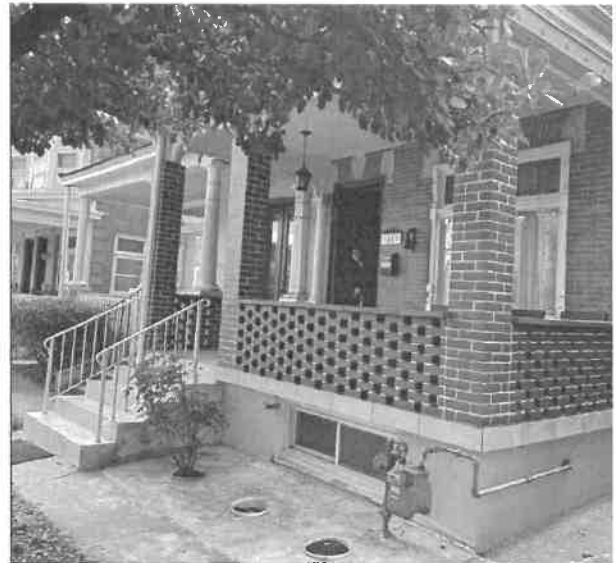
**1410 W. Linden Street porch after replacement.
(Applicant)**

While the original porch decking and steps had been removed at some point in the past and replaced with concrete, the installation of ceramic tile on the steps and floor do not comply with Guideline 3.7.8. Staff recommended removing the tile and re-exposing the painted concrete steps and floor. The contractor has agreed to reverse the installation of the tile.

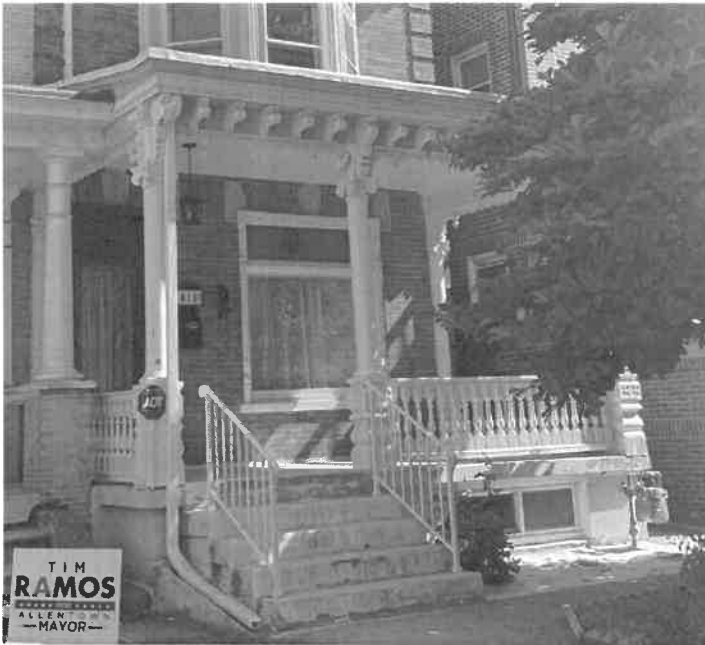
**1410 W. Linden Street porch prior to replacement, 2021.
(Easton Architects)**

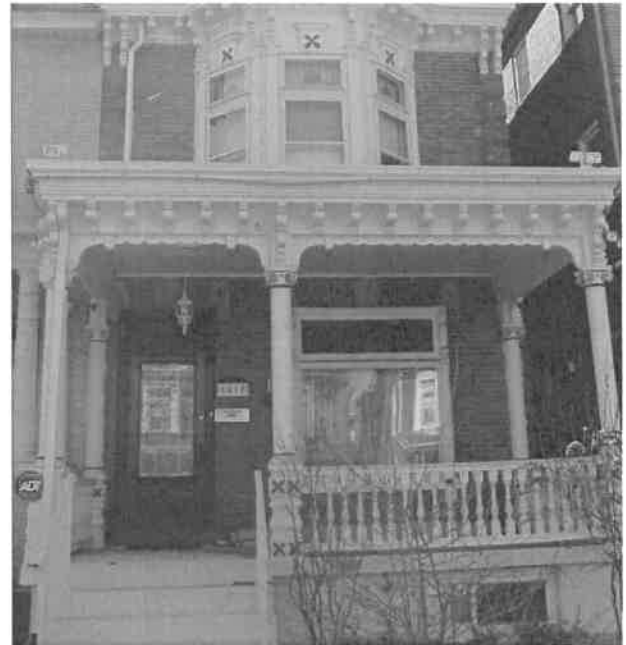
**Original decorative wood porch balusters, railings, columns,
and capitals, c. 2004. (HARB files)**

The property at 1410 W. Linden Street has a richly detailed façade and is exemplar for its metal cresting and decorative carved wood elements. The columns, capitals, and balusters contributed greatly to the character-defining elements of the building's façade. The loss of those features has negatively impacted the building's architectural significance. The removal of the wood features and installation of brick piers and railings, as well as the addition of ceramic tile flooring, do not comply with the historic district's design guidelines. The guidelines advocate for repair and restoration and, when not possible, replacement in-kind. The staff notes that prior to replacement, no outstanding violations existed on the property, and there was no indication that the porch presented a dangerous or unsafe condition. Staff contends that the porch was in repairable condition.

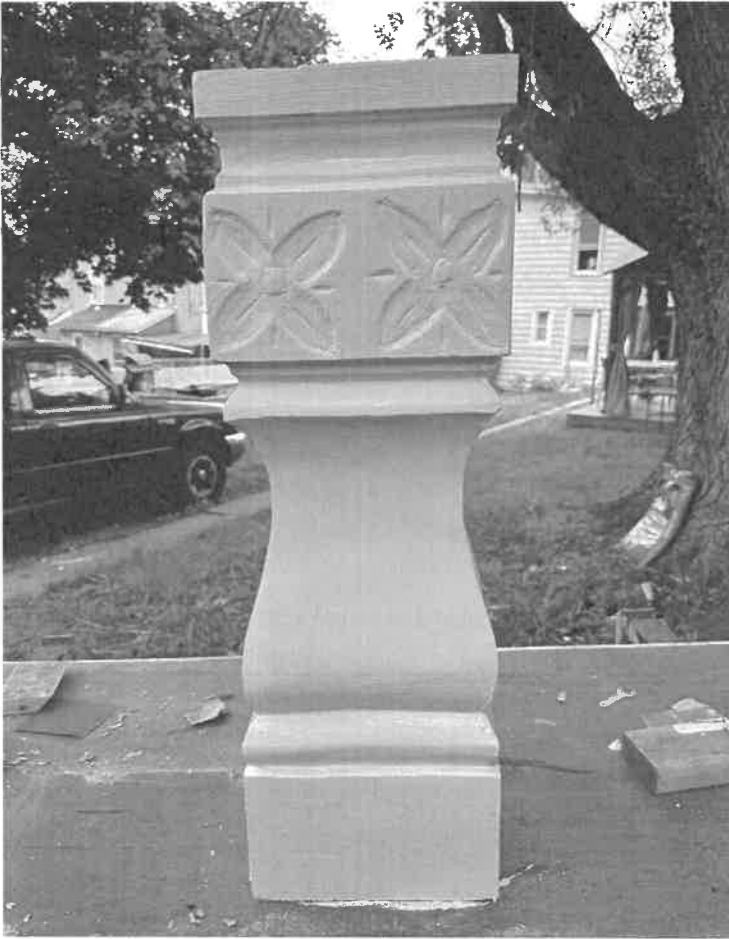
**Detail of new column base.
(Applicant)**

The applicant submitted a revised column base for review. The photograph of the sample base more accurately replicates the historic base in design and appearance. Staff recommends approval of the proposed base, provided the incised design is also included at the plinth. Staff notes that the HARB has requested that the applicant provide further details on the Ionic scroll at the capital, as well as balusters and railings that more closely replicate the original.
