Historical Architectural Review Board

COA Preliminary Review Sheet

HDC-2025-00020

Address: 519 Allen Street

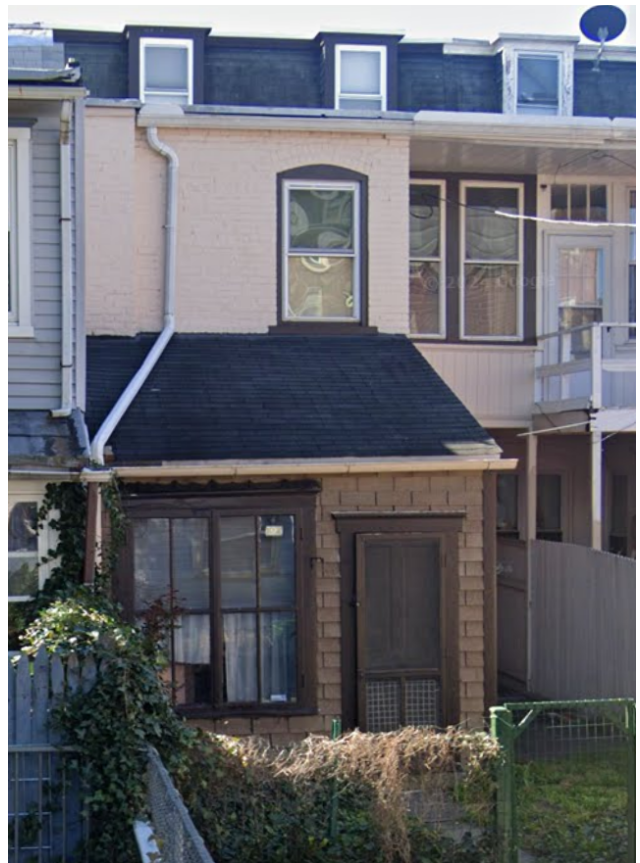
Previous Condition at Rear (Google Maps, April 2024)

From Google Maps imagery, it appears that the original door may have been a 4-panel door, but this is unclear. The proposed door options are all appropriate replacement options in configuration and material.

The original windows were a pair of out swinging 2/2 casement wood windows. The proposed window options include paired 1/1 aluminum clad wood single hung and double hung windows. Replacement windows should match the original as closely as possible in type, size, operation, profile, appearance, and configuration of lites and muntins. Aluminum clad wood is an appropriate replacement material. The proposed window options do not match the original in operation and muntin configuration; it would be appropriate for the replacement windows to be out swinging casement with 2/2 lites.

Staff Recommendation: More information is required to review the proposed siding. Staff recommend approval of any of the proposed door options, and recommend approval of the proposed windows with the conditions that the muntin pattern matches the original windows, and that the windows operate as casement windows.

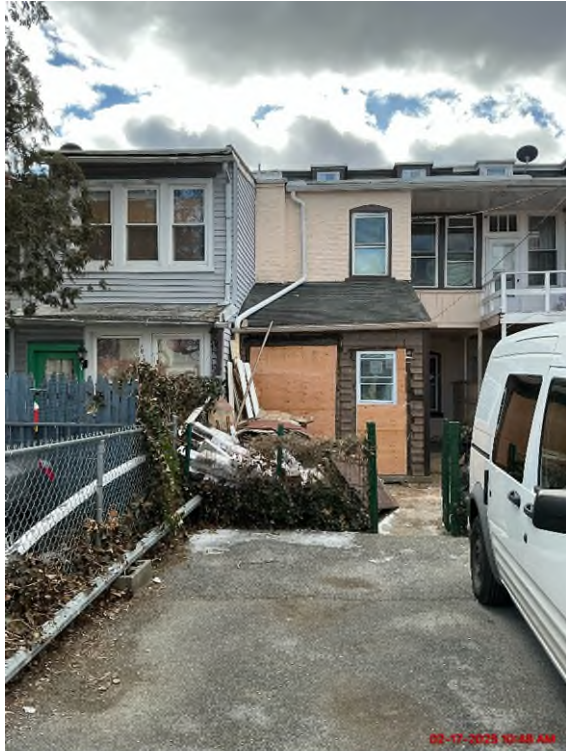
Current Condition at Rear (City of Allentown)

Discussion: The applicant purchased the house in January 2025, not realizing the requirements for historic districts. The applicant seeks to correct the violation and perform the renovation work appropriately. Mr. Santos stated that the rear was in disrepair. Mr. Huber noted that the fiber cement siding is appropriate but should not be textured; it should have a smooth finish. Mr. Huber indicated the trim around the windows and door on the photo of the previous installation as elements to be replicated, and Mr. Santos agreed. Mr. Huber explained the configuration of the windows, casement versus double hung, and the 2/2 configuration versus 1/1. Mr. Santos agreed to install replacement windows to match the original configuration and operation. The HARB and Mr. Santos discussed each of the elements for replacement, and Mr. Santos was amenable to replacing the door to match as closely as possible to the original and may consider a full-lite storm door.

- Windows to be out swinging 2-over-2 casement windows, wood or aluminum clad wood
- Paneled wood door to be in a configuration as close to the original as possible
- Window and door trims to match the original as much as possible
- Siding to be smooth fiber cement
