**Historical Architectural Review Board
COA Final Review Sheet**

HDC-2023-00013

Address: 328 N. 8th Street

Proposal: Replace slate and asphalt roof with asphalt shingles

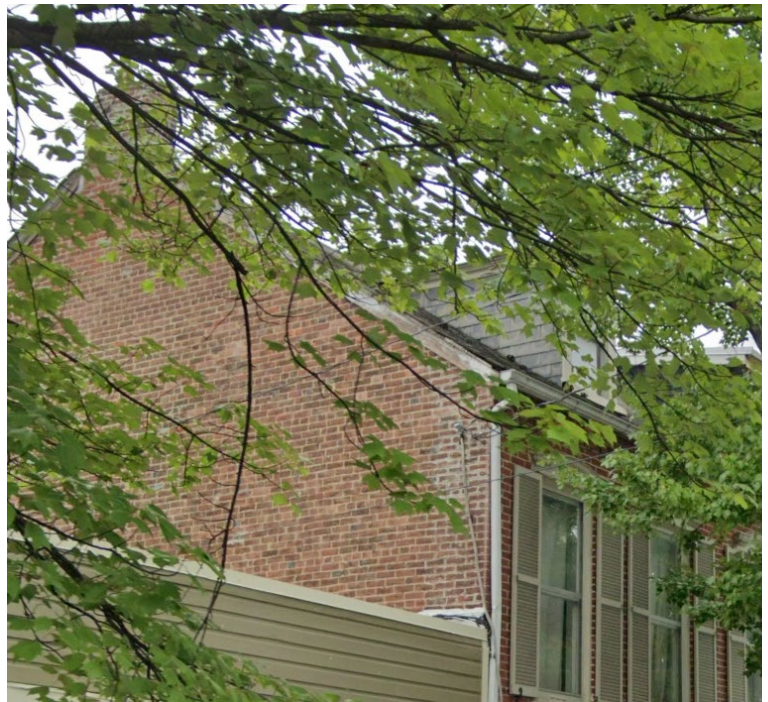
Detail of slate at dormer, 2019.
(Google StreetView)

Staff requests clarification on whether the front dormer cheek walls are proposed for replacement and recommends retaining the historic slate if it remains in good condition.

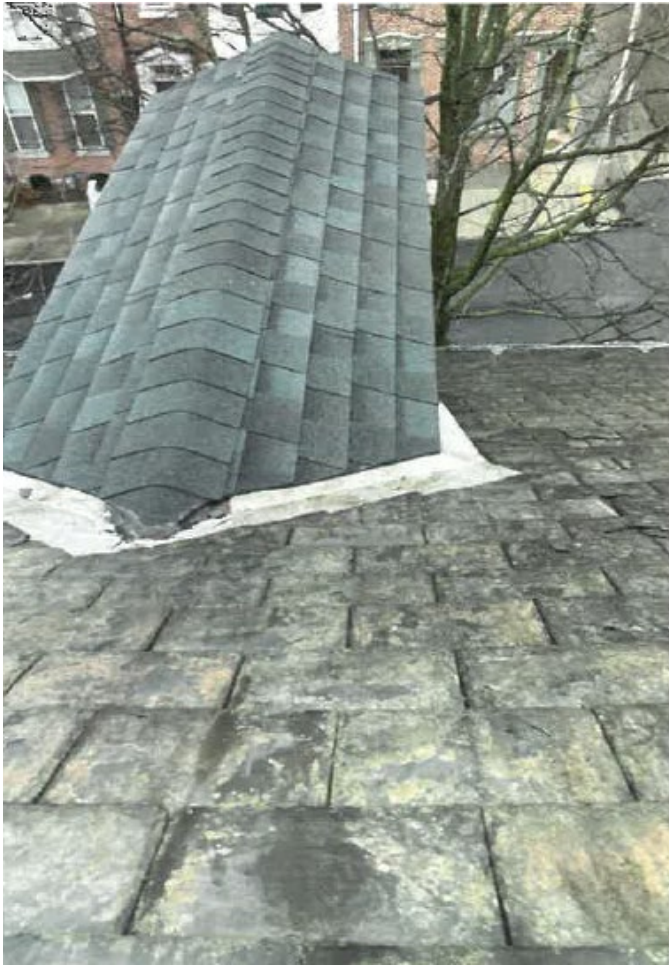
**Front slope of roof with original slate (replacement at dormer).
(Applicant)**

The applicant contends that the existing slate requires replacement because the slate is highly deteriorated. Staff notes that the condition photos show that the slate is delaminating, with some fractured slate shingles, and is in generally poor condition at the front roof slope. The rear roof slope has been replaced with asphalt shingles, and no historic material remains.

Approval, pursuant to Chapter 3, Section 3.1 Roofs, with the staff to review details, provided the new roofing material matches the historic slate on the front roof slope in dimension, shape, profile, color, exposure, and overall appearance.

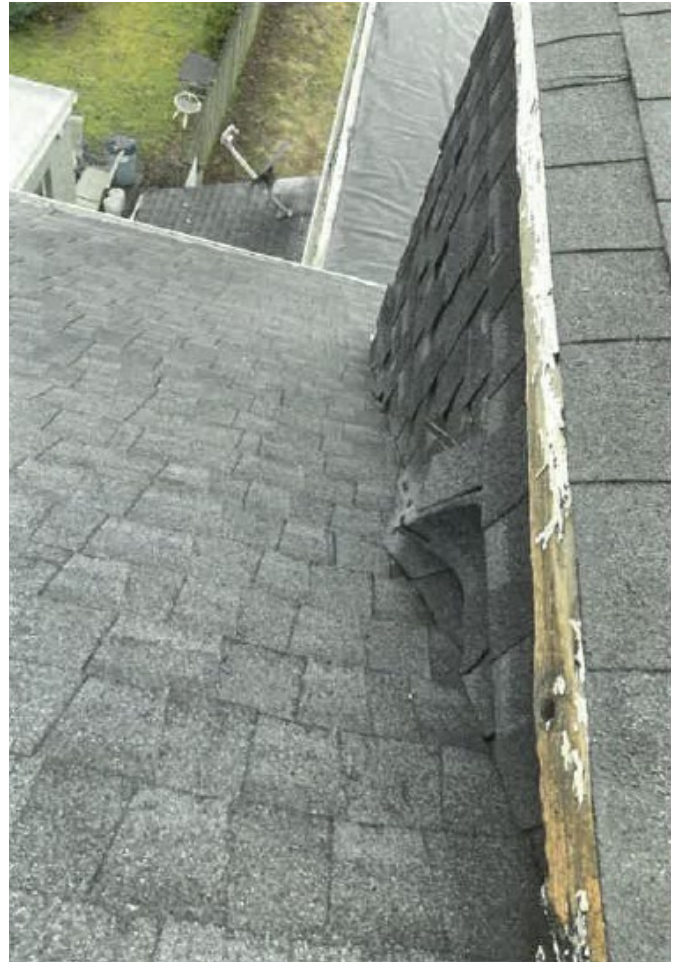
**Rear asphalt shingles.
(Applicant)**
