**Historical Architectural Review Board**  
**COA Preliminary Review Sheet**

**HDC-2026-00012**

**Address: 334 N. 9<sup>th</sup> Street**

**Proposal: Repair deteriorating brick facade**

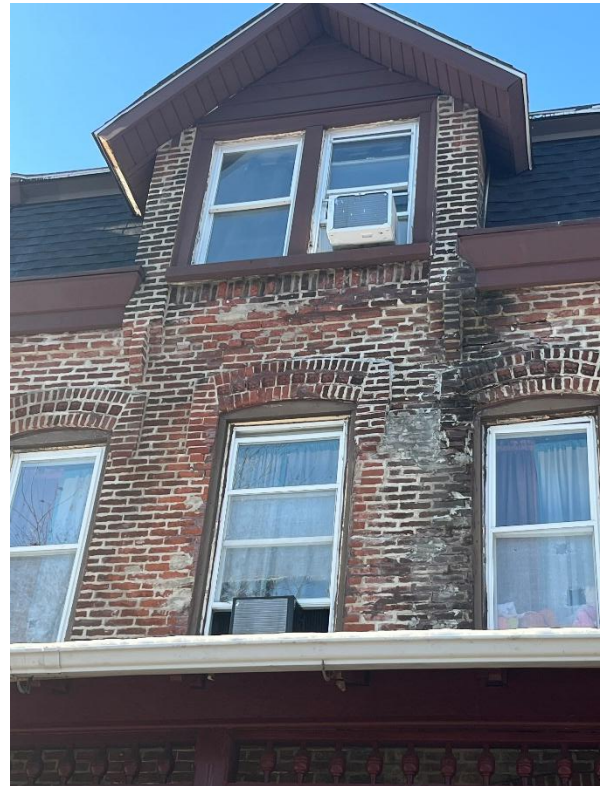
**Existing Upper Floor Condition (Applicant)**

334 North 9th Street Allentown PA, contractor upon sight visit noticed the following. Severe water and structural damage on the right side of the building above the window arch. Upon further assessment it was noted that water damage and wrong use of mortar was the main cause of damage. Damage is way too far

Due to severe structural damage, shoring will need to be installed before any of the construction process begins. Once permits are pulled and in place the first thing to be done is the installation of the helibeam system. This system is a shoring method in masonry restoration to prevent further structural damage by installing stainless steel heli beam bars all through the masonry structure to distribute the load bearing weight. Once these bars are installed they require 24-48 hours of cure time before any demo will take place. While these bars are being installed the roof underneath will be shored up to withstand the weight of bricks materials, workers, and demo process. The protection of the building's roof is also a concern and 3/4 plywood will be installed as a "protection board" during the construction process. After all shoring and safety measures are taken the main repairs will take place, demo of failed brick, relay to historical guidelines, install proper flashing and wall ties. After these repairs take place a permanent solution to the water damage will be resolved.

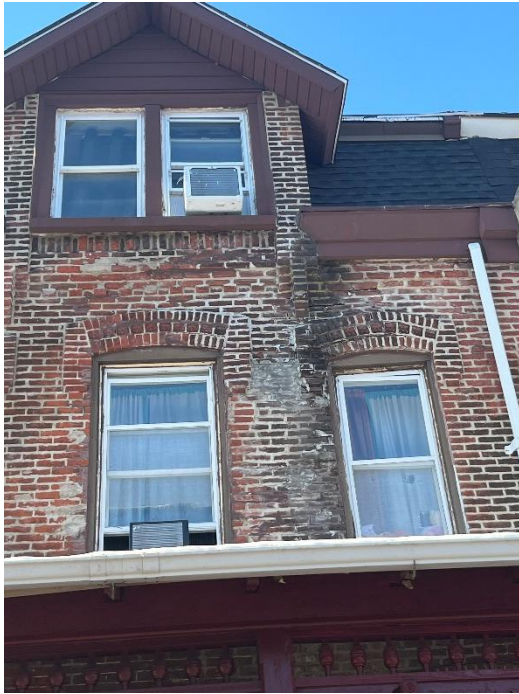
**Existing Upper Floor Condition (Applicant)**

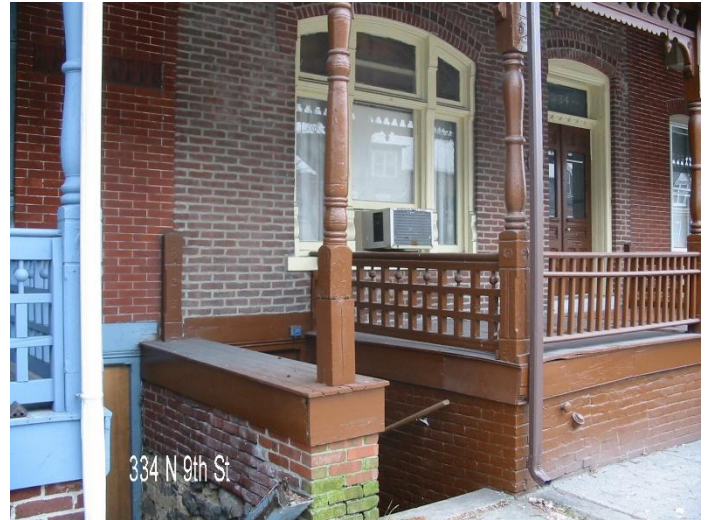
**Existing First Floor Condition (Applicant)**

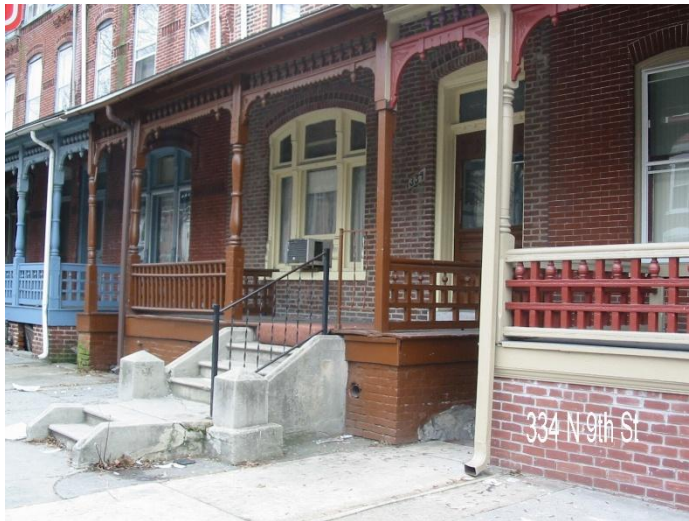
**Existing First Floor Condition (Applicant)**

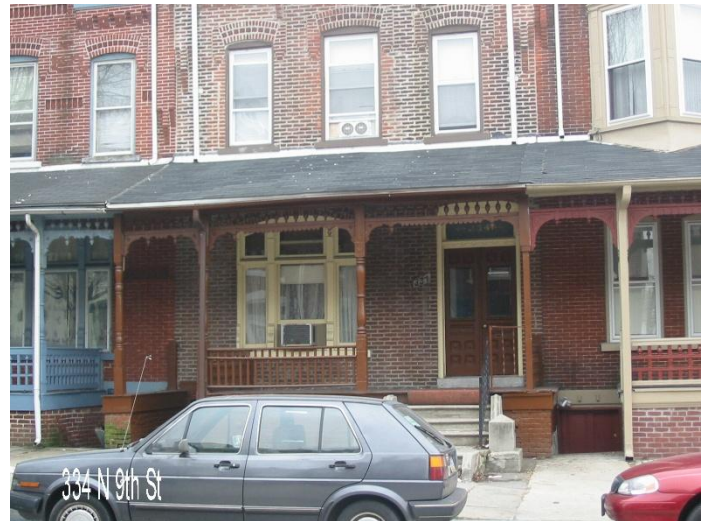
**Existing Condition (Applicant)**
