**Historical Architectural Review Board  
COA Final Review Sheet**

**HDC-2023-00020**

**Address: 631 N. Park Street**

**Proposal: Replace metal porch posts and railings; legalize tile flooring, stucco, railings, and roofing**

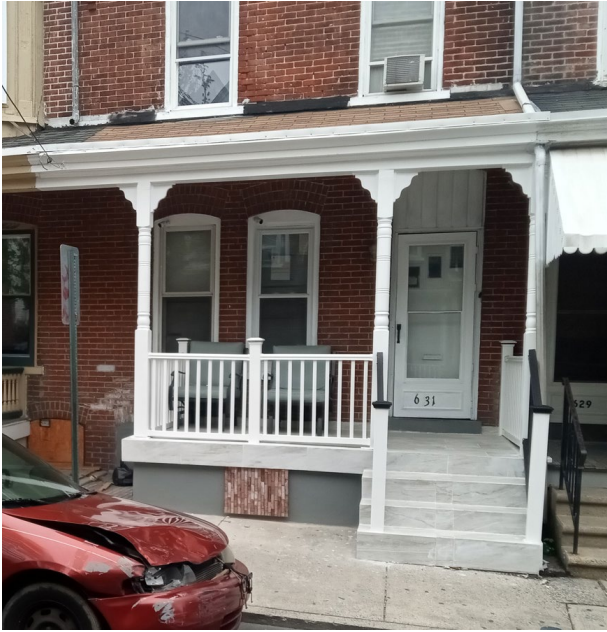
**Porch following replacement, 2023.  
(Applicant)**

The applicant contends that the metal porch posts and railings that were previously installed were in poor condition and needed replacement. The applicant installed wood porch posts with brackets, which staff considers appropriate. However, the porch railings are composed of PVC, an inappropriate material according to Guideline 3.7.8. Staff recommends replacing the railings with turned wood balusters that approximately match the historic balusters of the row, such as at 629 N. Park Street.

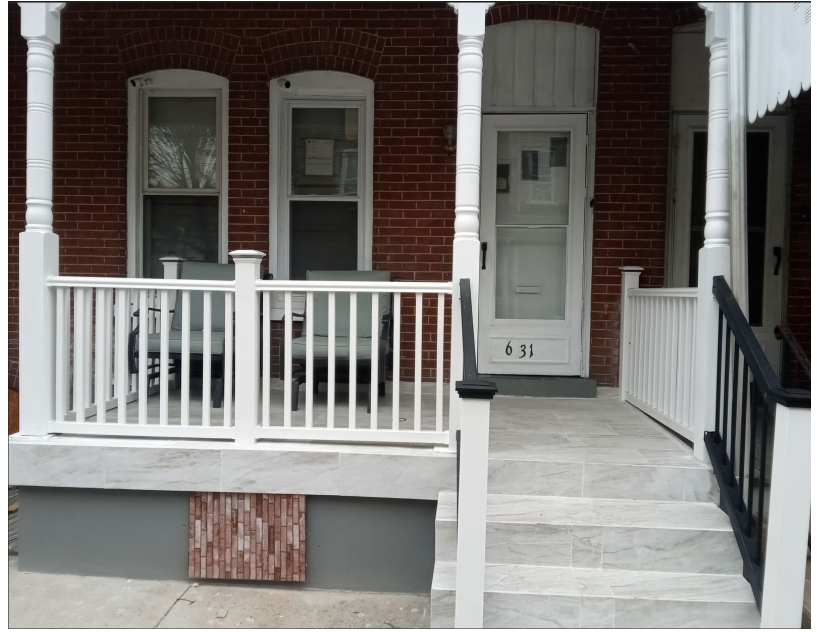
**Detail of porch following replacement, 2023.  
(Applicant)**

In addition to the posts and railings, the applicant covered or removed the wood tongue-and-groove decking and replaced it with tile. Guideline 3.7.8 notes that tile is inappropriate as a floor material and recommends wood or composite wood decking.

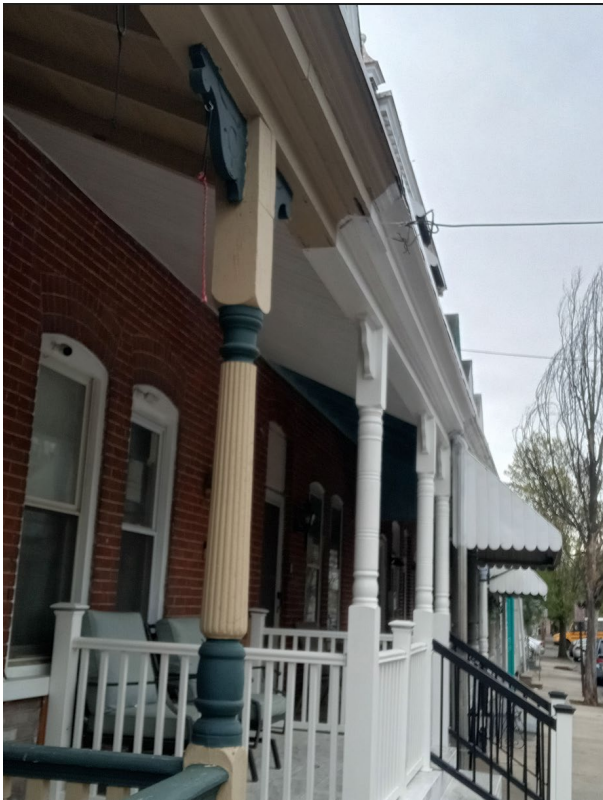
**Porch detail following replacement, 2023.  
(Applicant)**

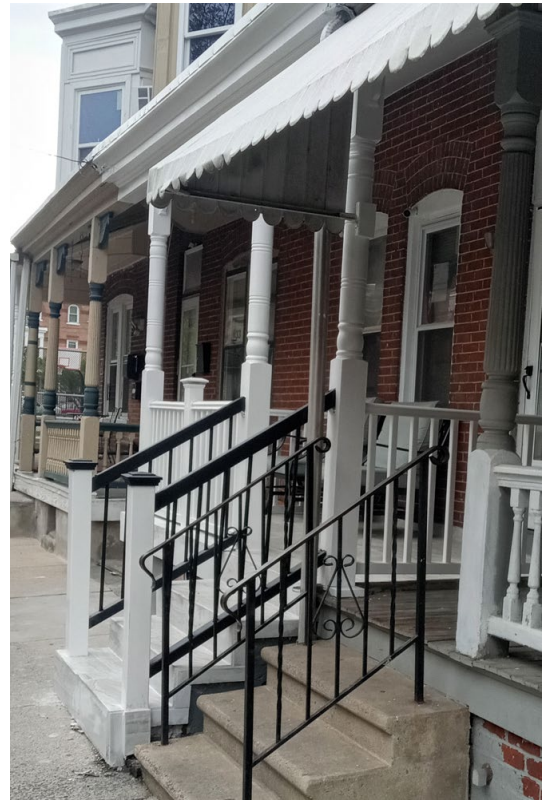
**Detail of new railing, 2023.  
(Applicant)**

New vinyl railings were installed at the steps where railings did not previously exist. Guideline 3.7.5 advises against the installation of railings where they did not historically exist, though notes that a simple, compatible railing may be acceptable. Staff suggests a black metal picket railing in place of the vinyl railing.

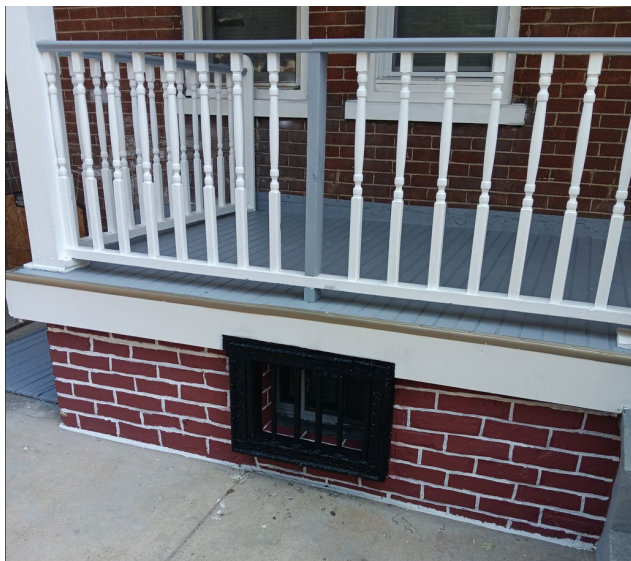
**Completed work to correct violation, 2023.  
(Applicant)**

The contractor noted that the historic metal grille was reinstalled over the basement window, and he confirmed that he painted the brick foundation wall after removing the stucco. The HARB found that the paint was inappropriate and determined that the best solution would be to paint it a solid color.

Mr. Lichtenwalner moved to approve with conditions the application presented on 9/5/2023 for replacing metal porch posts and railings and legalizing porch flooring, stucco, railings, and roofing at 631 N. Park Street, pursuant to Chapter 3, Section 3.3 Masonry and 3.7 Porches & Steps, with the condition that the brick foundation wall is painted a solid color. Mr. Hart seconded the motion, which carried with unanimous support.

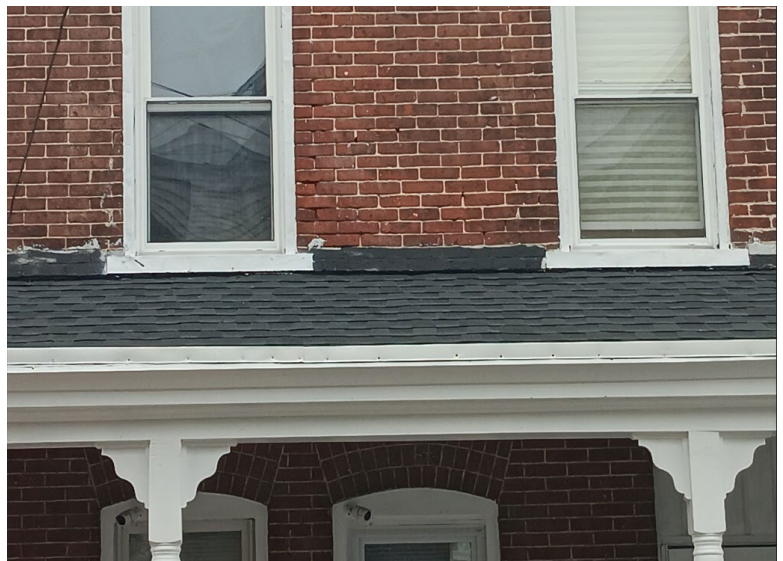
**Architectural shingles at porch roof, 2023.  
(Applicant)**

The HARB discussed the work that was completed, noting that the railings and posts had been approved by staff. The HARB discussed the roofing and concluded that a misunderstanding over the difference between 3-tab and architectural shingles resulted in the wrong shingle being installed; however, the HARB found that the dark gray architectural shingle was an improvement over the previous roofing.

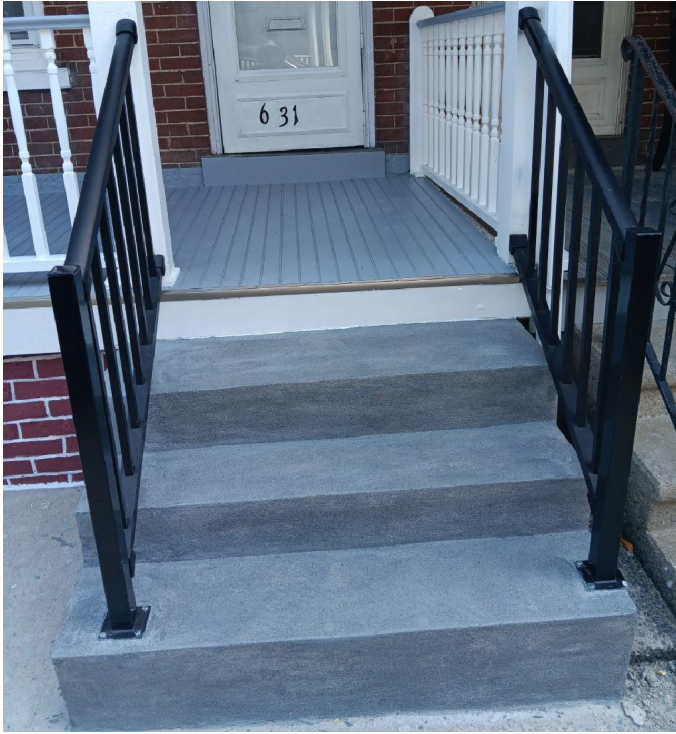
**Steps and metal railings not reviewed by staff, 2023.  
(Applicant)**

The HARB raised an issue with the steps being leveled and the bullnose detail being removed, but found that the detail could not easily be returned.

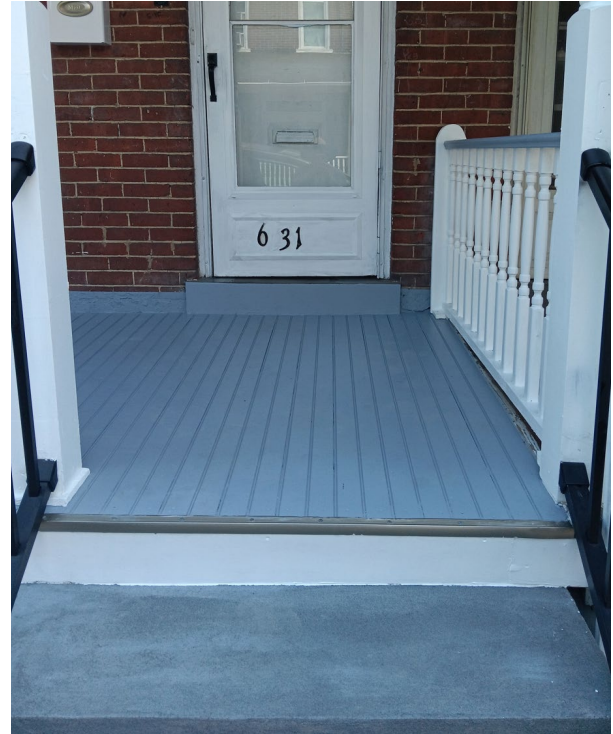
**Tongue and groove porch flooring, 2023.  
(Applicant)**
