# Historical Architectural Review Board

## COA Preliminary Review Sheet

**HDC-2025-00091**

**Proposal:** Legalize the installation of a Multi-Zone Mini split system slim duct and units along Emmett Street.

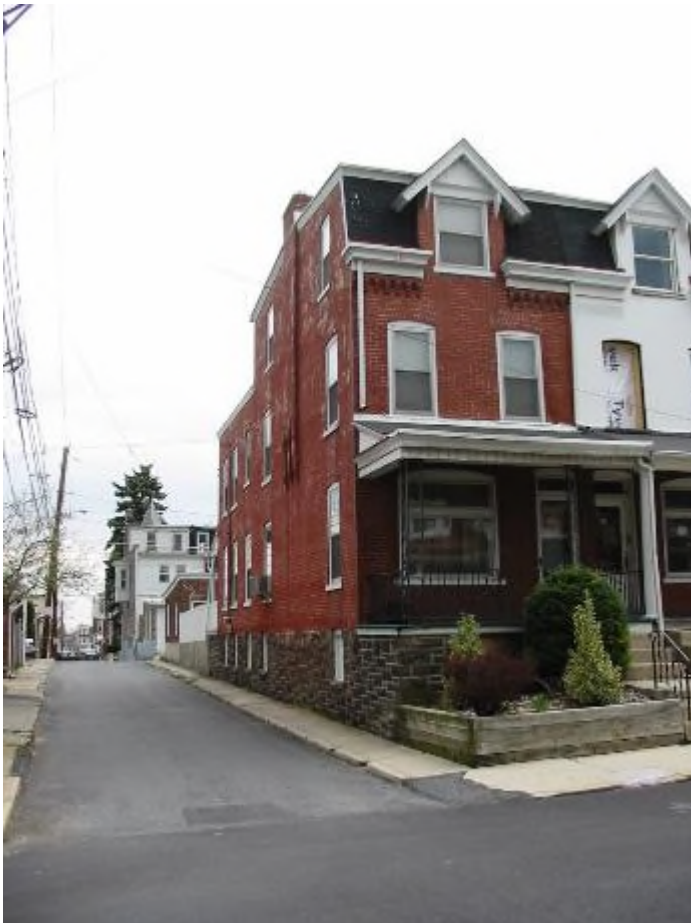
Previous Condition, before installation (Applicant)

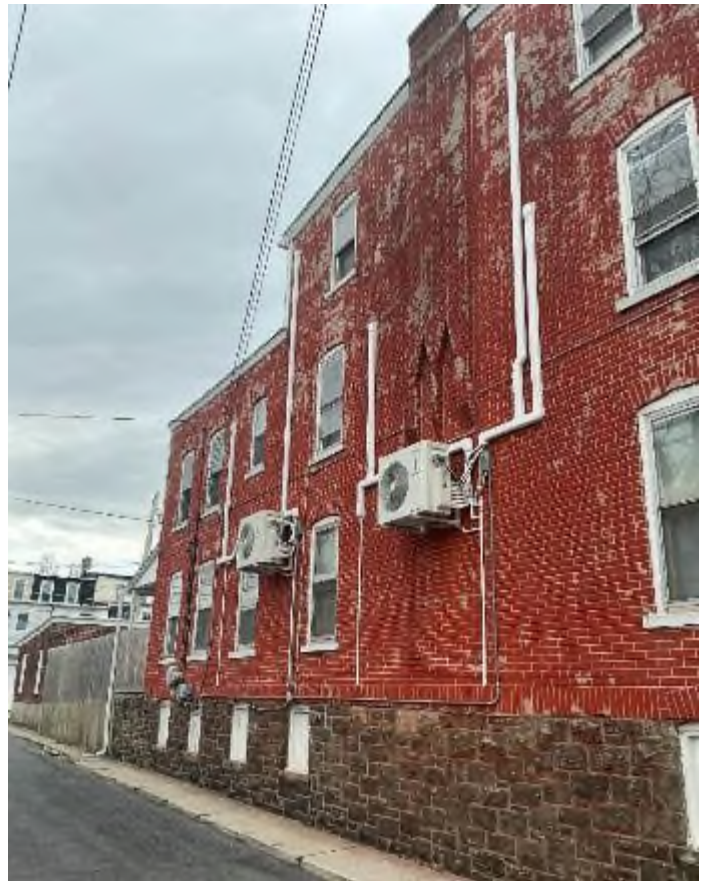
Current Condition, after installation (Applicant)

**Observations & Comments:** This application follows the denial of the legalization of the mini-split installation at the October 6, 2025, HARB meeting. The current HVAC system is installed on the exterior wall of a corner building, along Emmett Street. Two units are mounted on the wall near the top of first floor windows and various equipment lines are routed across the wall surface.

The current Slimduct lines are white and highly visible on the exterior. The applicant's proposal to paint the Slimduct to match the exterior brick is appropriate to make these elements more inconspicuous and blend in. The proposed work includes brick repair. More information would be helpful to understand the intent, location, and materials used in brick repair.

**Staff Recommendation:** More information would be helpful to understand the scope of the brick repair. Regarding the mechanical system reconfiguration, staff recommend approving the application with the following conditions:

- The roof-mounted mechanical units are set back from the roof edge so that they are not visible from a public right-of-way.
- Brick repair is performed so that any units and mortar match the existing in dimension, materiality, texture, pattern, and color.

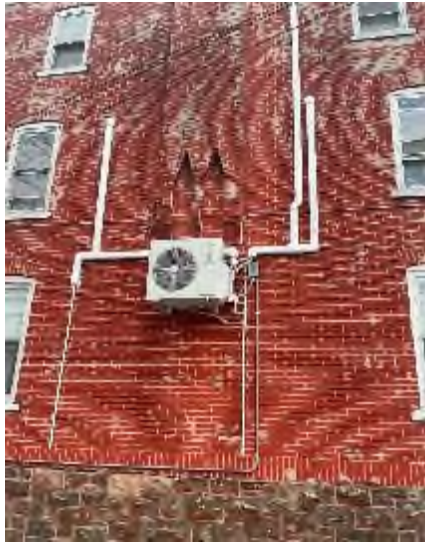
**Current condition (Applicant)**

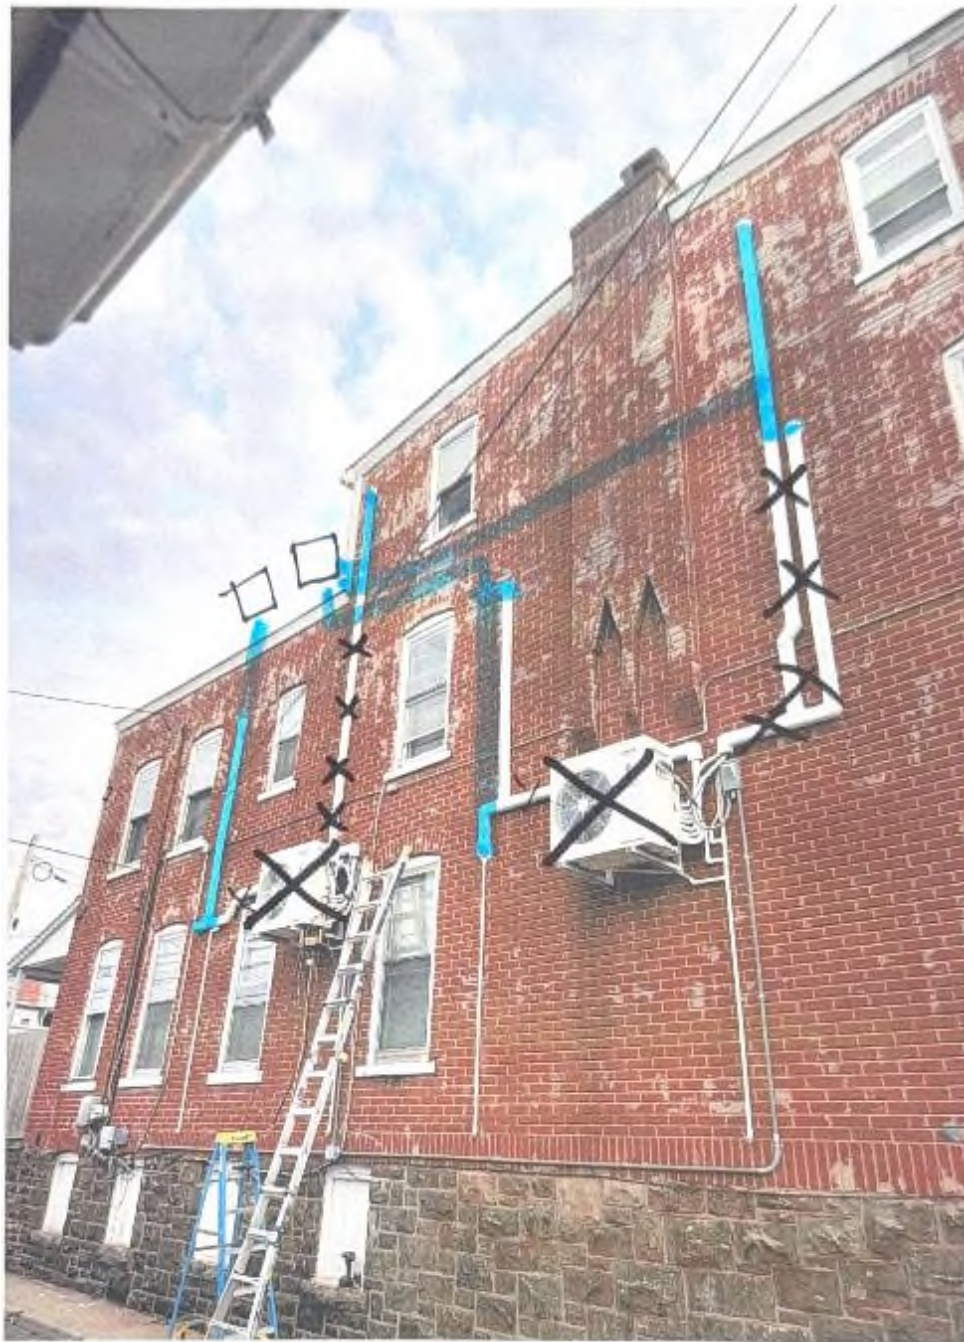
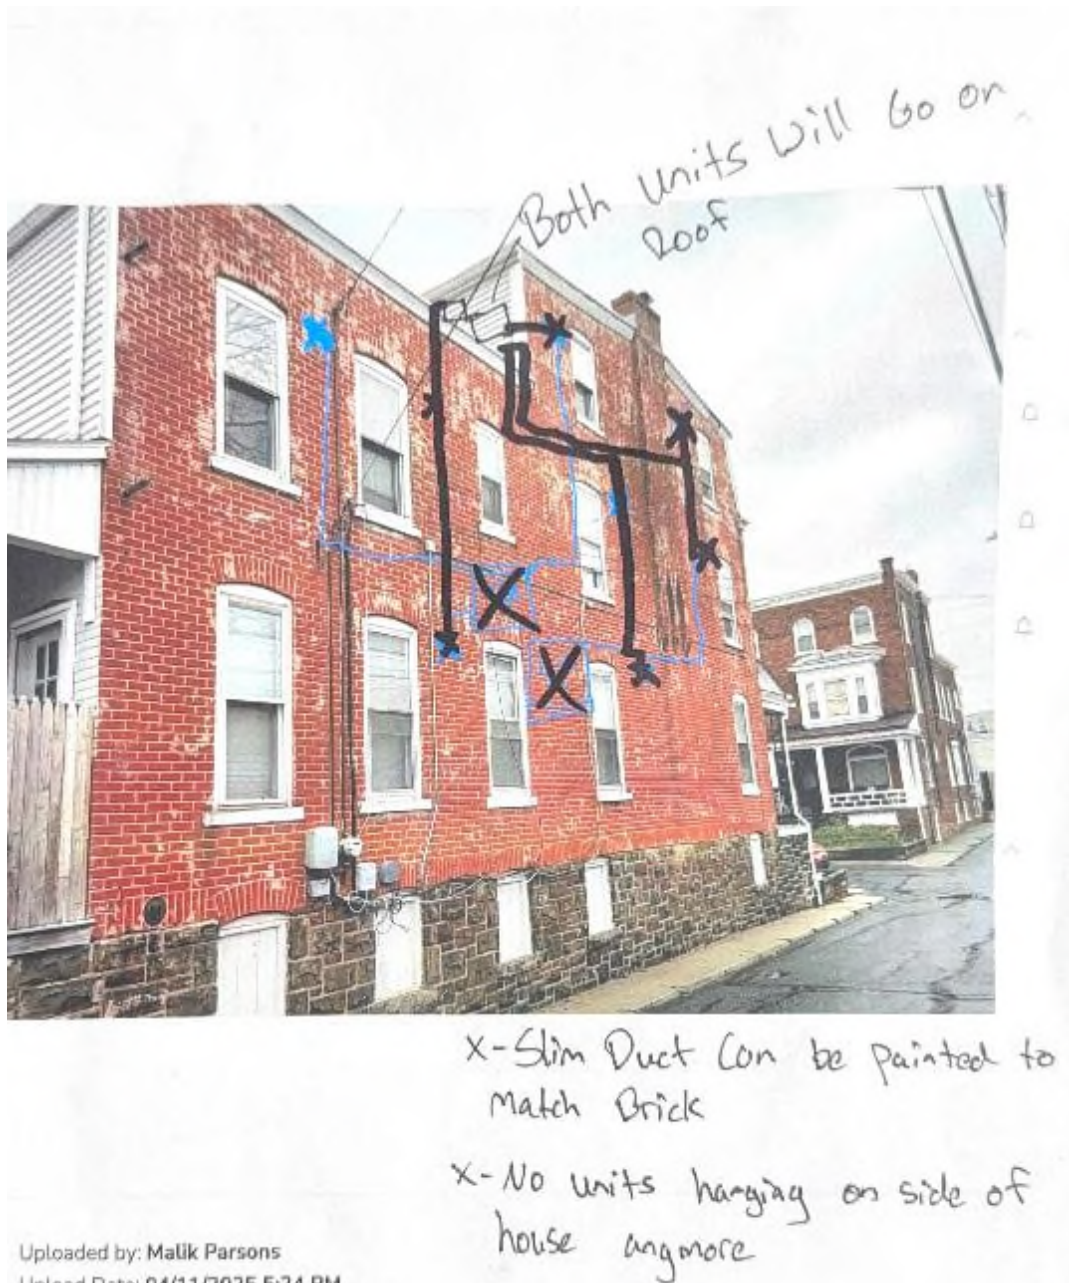
**Proposed modifications to installed system (Applicant)**

The applicant's proposed modifications indicate that the wall-mounted units would be located on the roof. This is a more appropriate approach to locating the units. Further discussion with the applicant will be helpful to determine if it is feasible for the units to be set back from the roof edge so that they are not visible from a public right-of-way.

- The roof-mounted mechanical units are set back from the roof edge so that they are not visible from a public right-of-way; minimum 5'

- Brick repair is performed so that any units and mortar match the existing in dimension, materiality, texture, pattern, and color. This would be sent to staff for approval.
- As demonstrated in submitted photos and in discussion, all Slimduct lines would be routed vertically to avoid major horizontal runs.
