CITY OF ALLENTOWN

Denial of a Certificate of Appropriateness – 141 N. 10th Street

**Historical Architectural Review Board
COA Final Review Sheet**

HDC-2023-00060

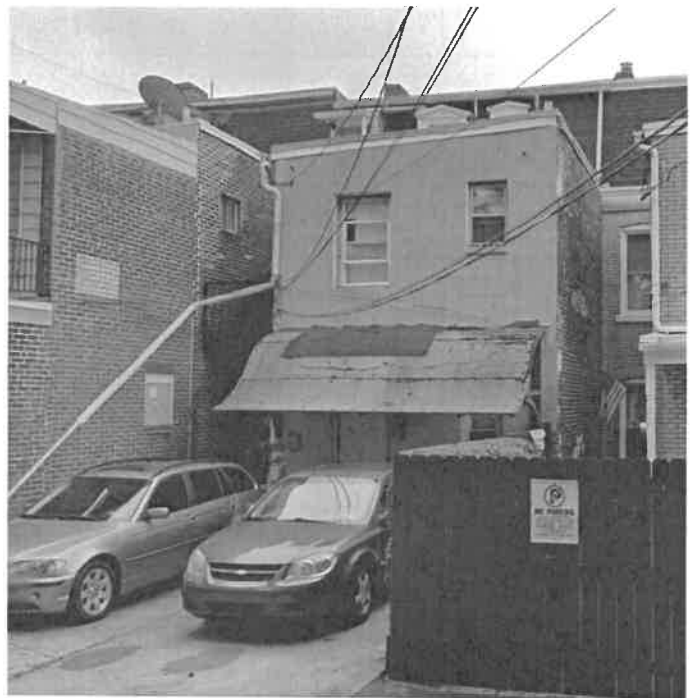
**Rear porch roof of 141 N. 10th Street prior to removal, 2019.
(Google StreetView)**

Though located at the rear of the building, the one-story porch was highly visible from the public right-of-way because of its proximity to the Allentown Cemetery, which is located immediately across Hazel Street. The porch also had the distinctive form of the Allentown porch roof, which is the curved projecting roof installed on brackets. The owner contends that the porch roof was in poor condition and beyond repair, and that it had to be removed to comply with insurance requirements.

Staff finds that, because the porch was visible from the public right-of-way and was of the distinctive Allentown porch roof design, the porch should be replicated and reinstalled to match the original. The 1932 Sanborn map shows that the porch had a “composition roof,” and staff suggests that asphalt shingles or a similar material be used, and recommends that the roof be secured on wood brackets to match the original.

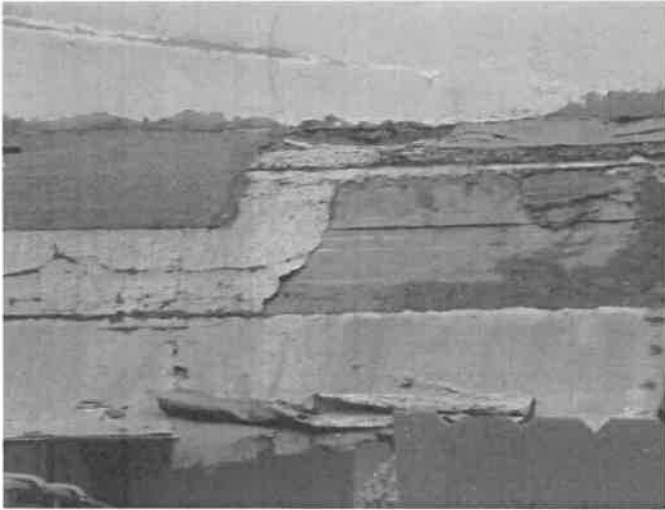
Detail of porch roof prior to removal.
(Applicant)

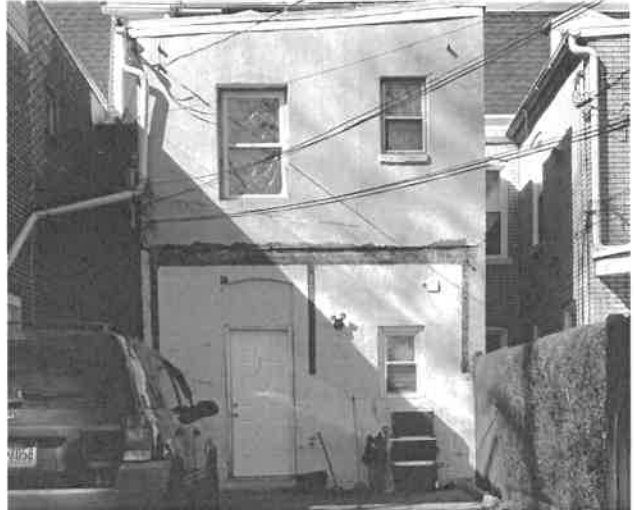
On May 12, 2023, staff issued a first notice of violation to the owner of 141 N. 10th Street for the demolition of a rear porch roof visible from Hazel Street. A second notice of violation followed in July 2023. This application proposes to legalize the demolition of the rear porch roof.

Rear of 141 N. 10th Street following removal of the porch roof, 2023.
(HARB files)

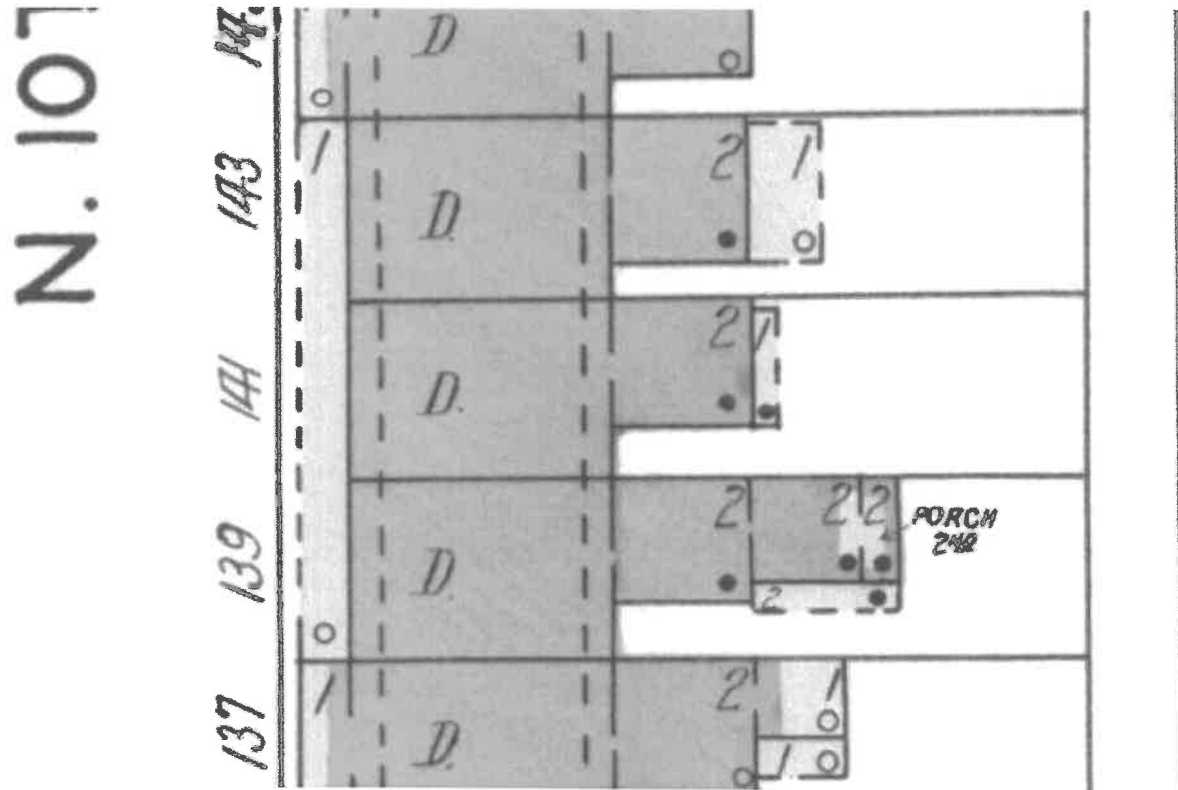
1932 Sanborn map showing rear one-story porch.
(Pennsylvania State University Library)
