**Historical Architectural Review Board  
COA Final Review Sheet**

**HDC-2023-00096**

**Address: 503 W. Allen Street**

**Proposal: Replace second-story windows and framing**

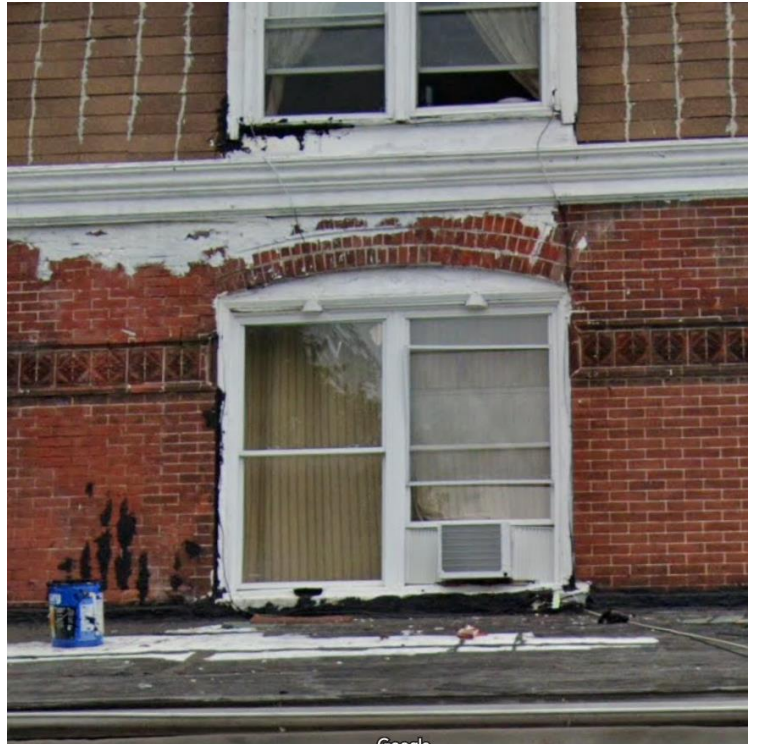
**Photo showing the windows and framing to be replaced.  
(Google StreetView)**

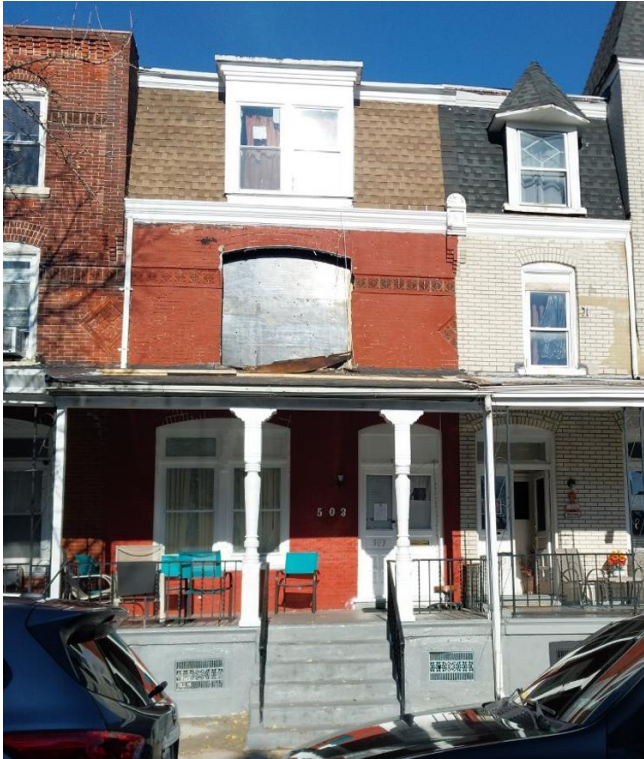
Front façade with windows removed and boarded, 2023.  
(Applicant)

At the time the applicant submitted the application, the second-story windows and framing had been removed without permits or a certificate of appropriateness. The drawing included in the application shows the interior framing and proposed window replacement. Staff initially rejected the drawing and requested an exterior drawing showing the framing and masonry opening; however, the applicant again provided the same drawing of the interior framing. Staff finds that the HARB cannot properly review the proposed scope of work without a drawing that shows the exterior framing, noting that the decorative trim below the lintel and the center mullion have been removed and should be recreated to their original dimensions and appearance to comply with Guideline 3.5.15.

Denial, owing to incompleteness, with the comment that a scaled elevation drawing of the exterior framing, trim, and masonry opening be submitted for HARB review.

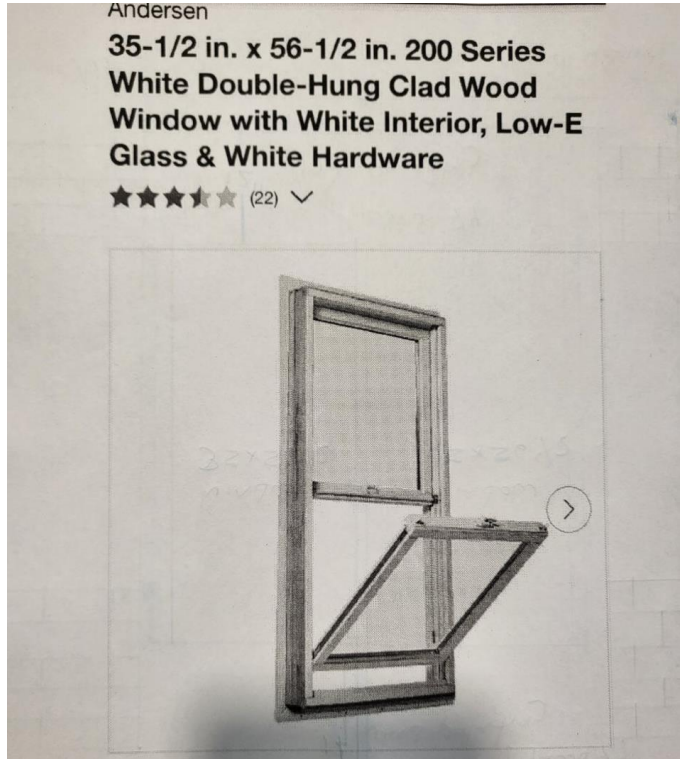
Proposed aluminum clad window.  
(Applicant)

If all exterior framing and trim is replicated to match the historic, staff finds the proposed aluminum-clad wood sash windows to be appropriate, provided they are the same dimensions as the historic windows.

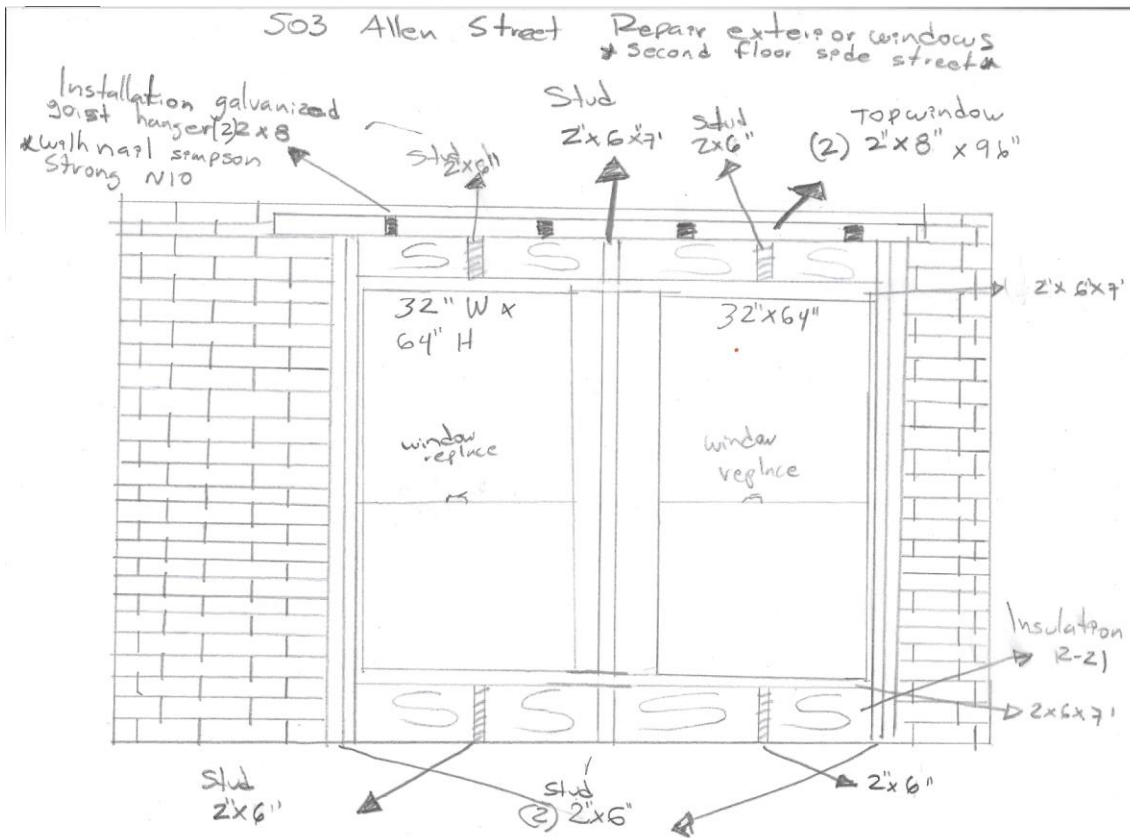
Drawing of window replacement showing interior view.  
(Applicant)
