**Certificate of Appropriateness for work in the Historic Districts: 820 Liberty St.**

**HDC-2024-00053**

**Address: 820 Liberty Street**

**Proposal: Repair work at rear of house following a fire.**

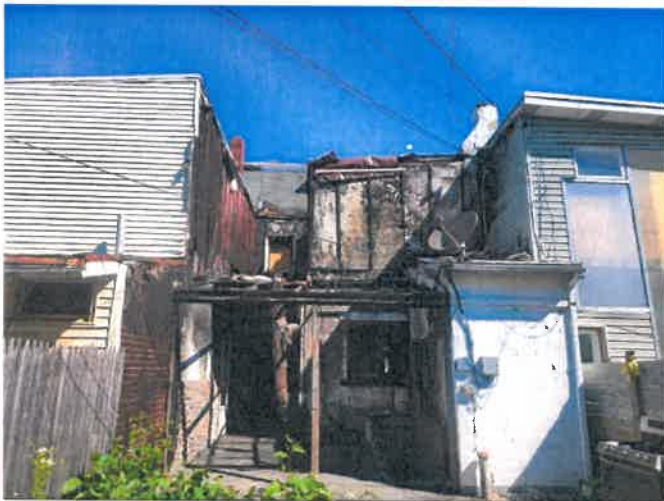
**Current Condition at Rear (Applicant)**

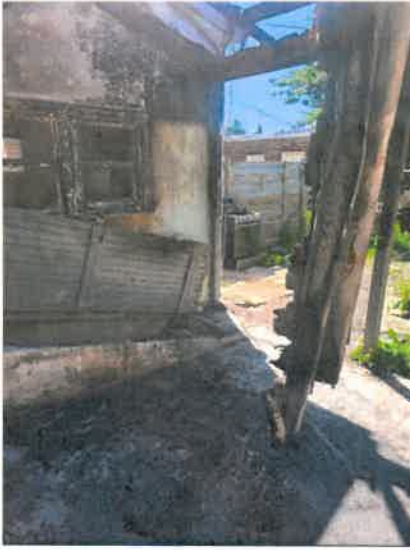
**Fire Damage at Rear (Applicant)**

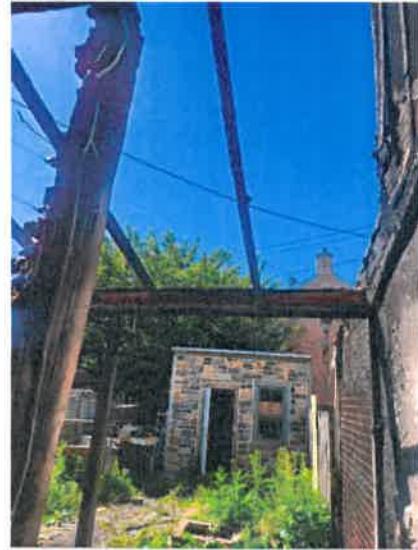
**Fire Damage at Building Rear (Applicant)**
