**CITY OF ALLENTOWN**

**R167 – 2023**

**Certificate of Appropriateness for work in the Historic Districts:**

**Historical Architectural Review Board  
COA Final Review Sheet**

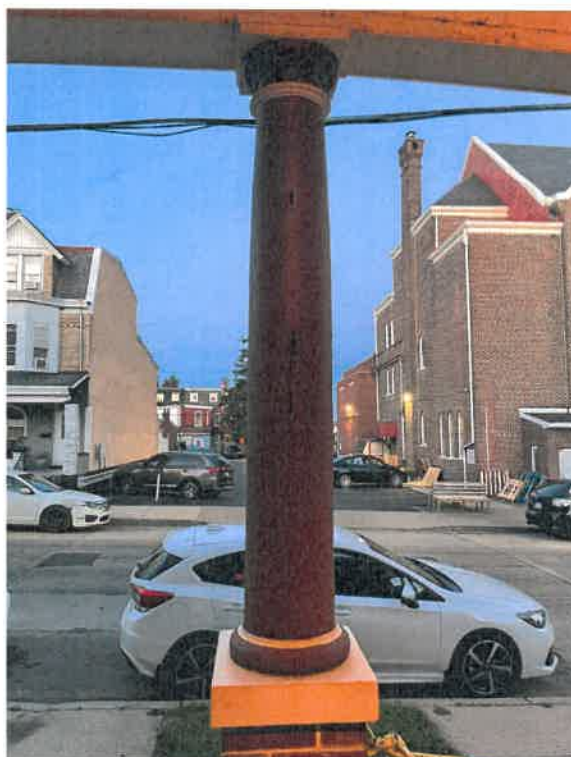
**Porch column to be replaced, 2023.  
(Applicant)**

Building Standards has inspected the property and determined that two porch columns are rotted and require replacement. The owner has provided staff with specs on matching columns in fiberglass (PermaCast) and wood. The owner noted that the wood columns are hollow, though loadbearing, and that he prefers the fiberglass columns. The proposed columns have a tapered shaft and matching components. While a material change, they would replicate the appearance of the historic. Staff finds that the columns do not comply with Guideline 3.7.4 because of the material change, but do comply with Guideline 3.7.8. Despite the material change, staff finds the proposed alternative to be compatible and acceptable.

Approval of the replacement of the wood porch columns with fiberglass columns, pursuant to Chapter 3, Section 3.7 Porches & Steps, but denial of the infilling of the window with brick veneer, pursuant to Chapter 3, Section 3.5 Windows.

Mr. Lichtenwalner moved to approve with conditions the application presented on 10/2/2023 to replace wood porch columns with fiberglass columns and to reinstall window sashes at an infilled second-story opening, pursuant to Chapter 3, Section 3.5 Windows and Section 3.7 Porches & Steps, provided that the reinstalled window sashes have either spandrel glass or a painted panel behind the window. Mr. Huber seconded the motion, which carried with unanimous support.

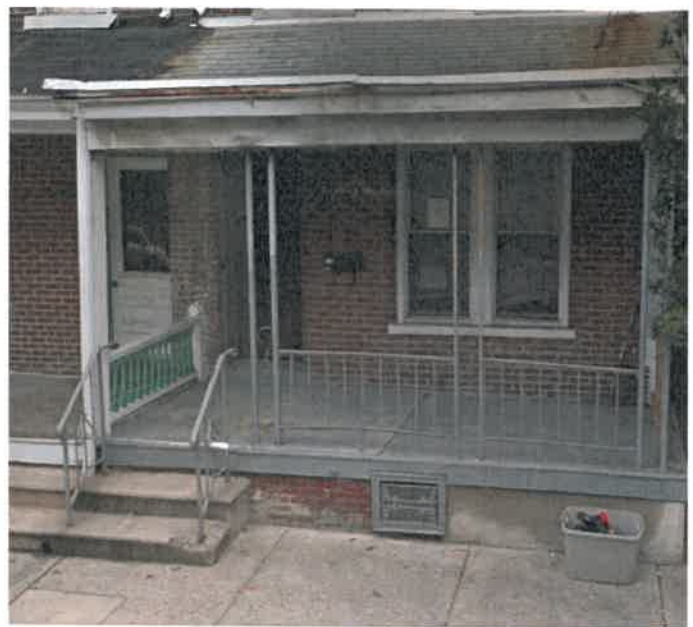
**Metal posts and railings prior to replacement, 2018.  
(Google StreetView)**

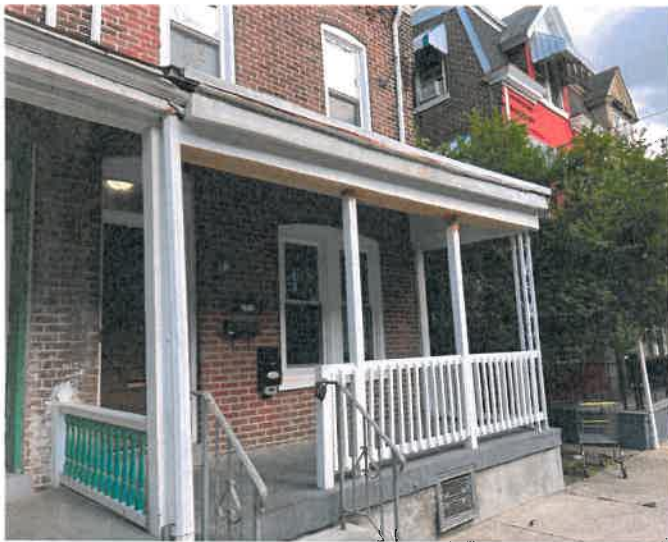
**Porch following replacement of the posts and railings, 2023.  
(Applicant)**

The applicant purchased the property in June 2023 and contends that the work was done prior to the sale. The historic wood porch had been altered at some point in the past and metal posts and railings were installed, and the porch floor was changed from wood to concrete. The current alteration removed the inappropriate metal railings and posts. Three of the metal posts were replaced with wood, and one metal post remains. The railings were replaced with wood pickets. While the work does not replicate the historic appearance of the porch, the guidelines recommend but do not require a full

restoration to the porch's original appearance. Guideline 3.7.6 states that applicants should “*consider* restoration of previously altered porches with historically appropriate elements.” Staff finds the installation of wood to be more appropriate than metal but contends that the materials do not reflect the architectural style of the building. The guidelines advise against altering the architectural style of the porch (p. 67). Staff suggests installing turned wood columns and balusters, and installing post brackets that approximate the porch's historic appearance and better relate to the style of the original porches in the row.

The carpet does not comply with Guideline 3.7.8 and should be removed.

Mr. Lichtenwalner moved to approve with conditions the application presented on 10/2/2023 to legalize the installation of the porch header, posts, and railings, pursuant to Chapter 3, Section 3.7 Porches & Steps, provided the following:

- The corner metal porch post is replaced with a solid wood post;
- The existing spindles are reused and inserted into the top and bottom rails;
- The top rail is of an appropriate size and form to fit the spindles as presented in the application;
- All wood elements are painted; and
- The carpeting is removed to expose the concrete porch floor.

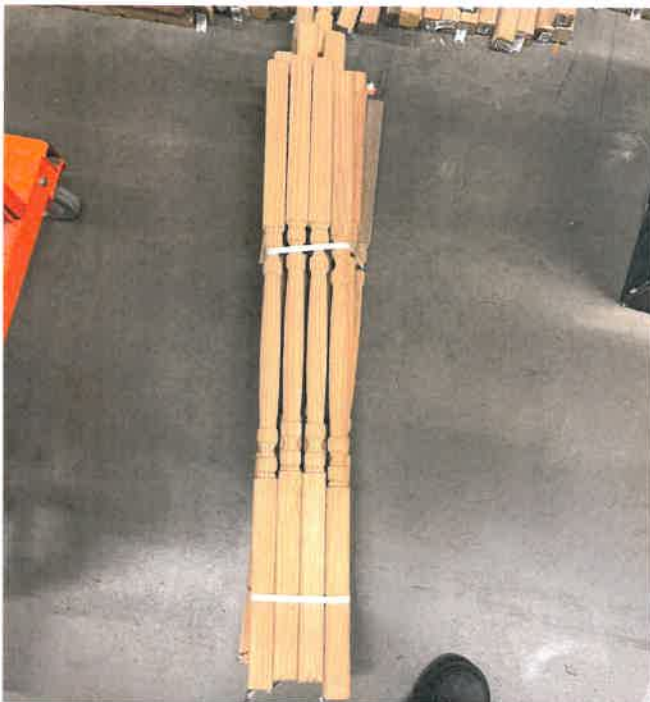
The applicant has revised the application and is proposing to correct some of the work completed without permits by the previous owner. The application proposes to replace the railings with more appropriate wood railings and to install brackets at the top of the posts to approximate the brackets at the adjacent properties. The applicant is requesting to leave the existing wood posts in place rather than replacing them for a more appropriate post. Staff notes that the porch post shared between 619 and 621 N. Park Street was existing and matches the new posts installed at two locations within the porch of 619 N. Park Street. Staff further notes that the southernmost column was not recently replaced and is metal.

**Proposed spindles for the porch railings.  
(Applicant)**

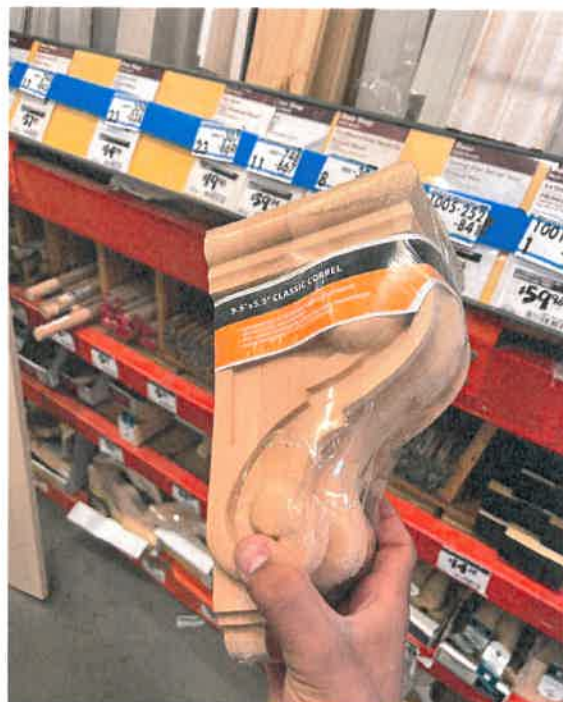
Staff contends that because the porch posts do not currently match, installing two more appropriate posts would not improve the overall appearance of the porch and would result in three different types of posts. Staff recommends installing only the proposed wood railings to legalize the work. Staff further suggests that the brackets and decorative elements proposed to be installed at the existing posts be left out of the scope, since those details are intended for turned wood columns and not the existing utilitarian posts.

**Proposed brackets for the porch posts.  
(Applicant)**

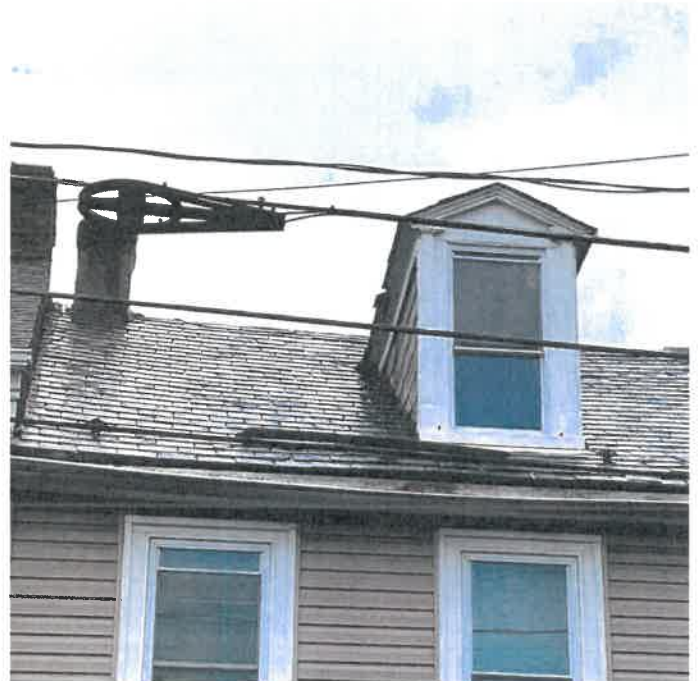
**Detail of roof, 2023.  
(Applicant)**

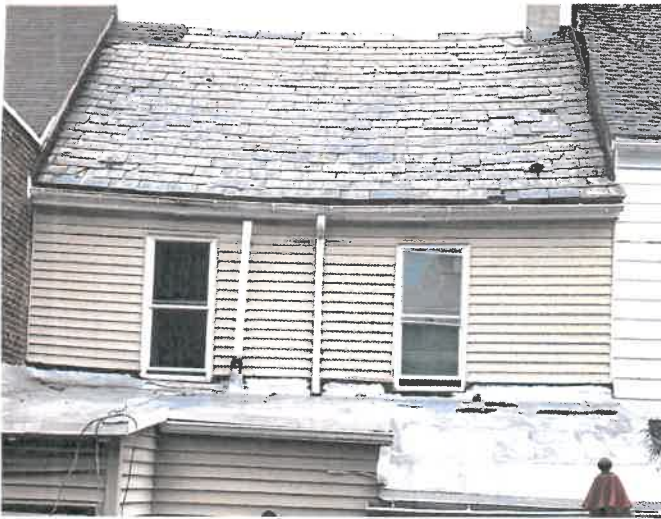
**Rear roof of 918 W. Chew Street, 2023.  
(Applicant)**

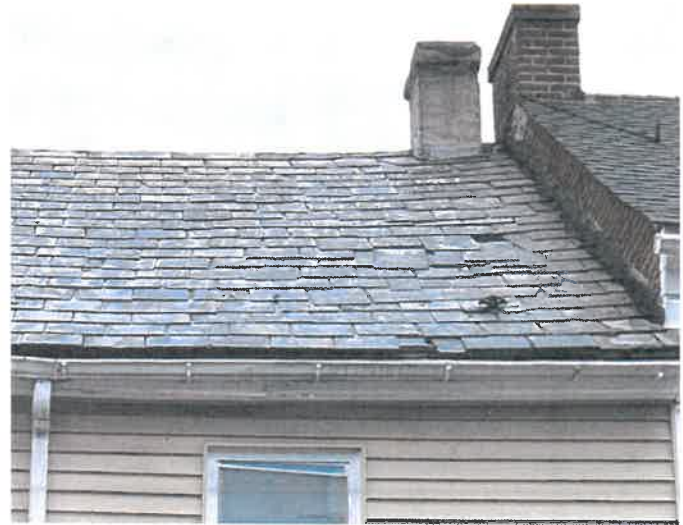
**Condition of rear roof, 2023.  
(Applicant)**

The applicant contends that the existing slate roof is failing and in poor condition. Photographs show that there are displaced shingles throughout the roof. The applicant has temporarily tarped the roof to prevent water infiltration.

The application proposes to install GAF Slateline shingles, which are an appropriate alternate that generally matches the existing slate in dimension, shape, profile, color, exposure, and overall appearance. Staff finds that the proposed shingle complies with the guidelines in Section 3.1 Roofs.

Mr. Jordan moved to approve the application presented on 10/2/2023 for removing slate shingles and installing asphalt shingles at 918 W. Chew Street, pursuant to Chapter 3, Section 3.1 Roofs. Mr. Huber seconded the motion, which carried with unanimous support.
