**Historical Architectural Review Board
COA Final Review Sheet**

BST-2022-00024

Address: 1550-52 W. Chew Street

Proposal: Legalize turret roof replacement (Violation Correction)

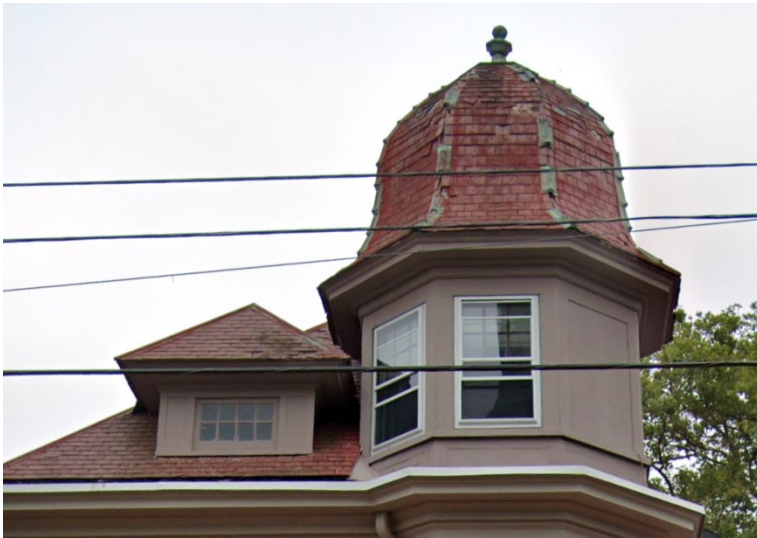
1550-52 W. Chew Street turret roof in 2019.
(Google StreetView)

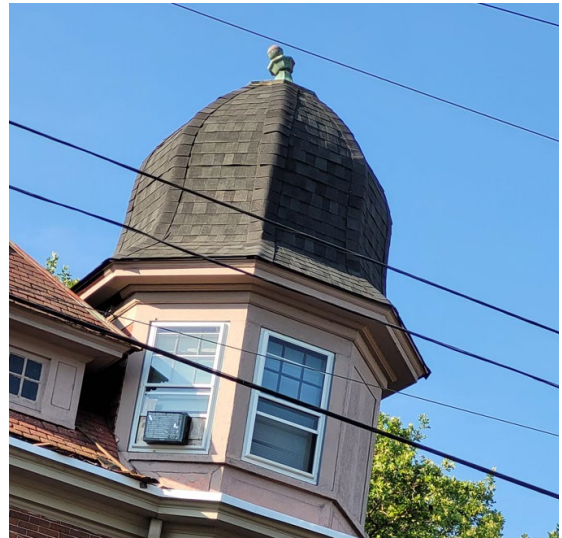
On July 1, 2022, a Stop Work Order was issued by a building inspector from Building Standards and Safety at the request of the Staff for the removal of the historic red slate and decorative copper ridge caps at the turret roof. The work was undertaken without a COA or building permit. This application proposes to legalize the installation of Tamko Heritage Series asphalt shingles at the turret roof.

1550-52 W. Chew Street turret roof after work was completed. (Staff)

While the historic roofing material was in disrepair with displaced and missing shingles and missing sections of the decorative ridge caps, the roof should have been surveyed by a professional for the potential to repair rather than replace the entire turret roof. If complete replacement was truly necessary, the design guidelines stipulate that appropriate materials be used. In this case, a slate alternative such as a synthetic slate or an architectural shingle that replicates the dimensions, shape, profile, color, and exposure would have been more appropriate. The decorative ridge caps were a character-defining feature of the roof and should have been salvaged and reinstalled where possible, with missing sections replicated. The replacement roofing does not replicate the original roofing in material, dimension, shape, profile, color, exposure, or overall appearance. The work does not comply with the design guidelines and should not be legalized.

Denial, pursuant to Chapter 3, Section 3.1 Roofs. The staff recommends that a more appropriate roofing material be installed to replicate the historic roof in its dimension, shape, profile, color, exposure, and overall appearance and that the decorative ridge caps be replicated as closely as possible in material, dimension, shape, and profile.

Mr. Encelewski moved to approve with conditions the application presented on 2/6/2023 for the legalization of the turret roof at 1550-52 W. Chew Street, as agreed to by the applicant and with the staff to review details, pursuant to Chapter 3, Section 3.1 Roofs, provided Boral Inspire Classic Slate Shingles in Brick Red are used and that ridge caps matching the historic in material, dimension, and profile are installed. Mr. Huber seconded the motion, which carried with unanimous support.
