CITY OF ALLENTOWN

R63 – 2024

Certificate of Appropriateness for work in the Historic Districts:

**Historical Architectural Review Board
FINAL Review Sheet**

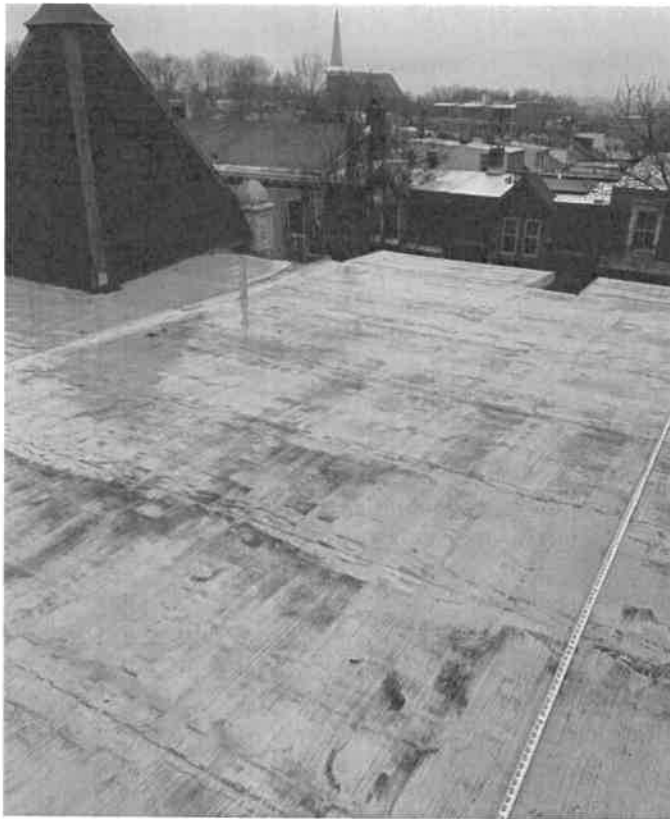
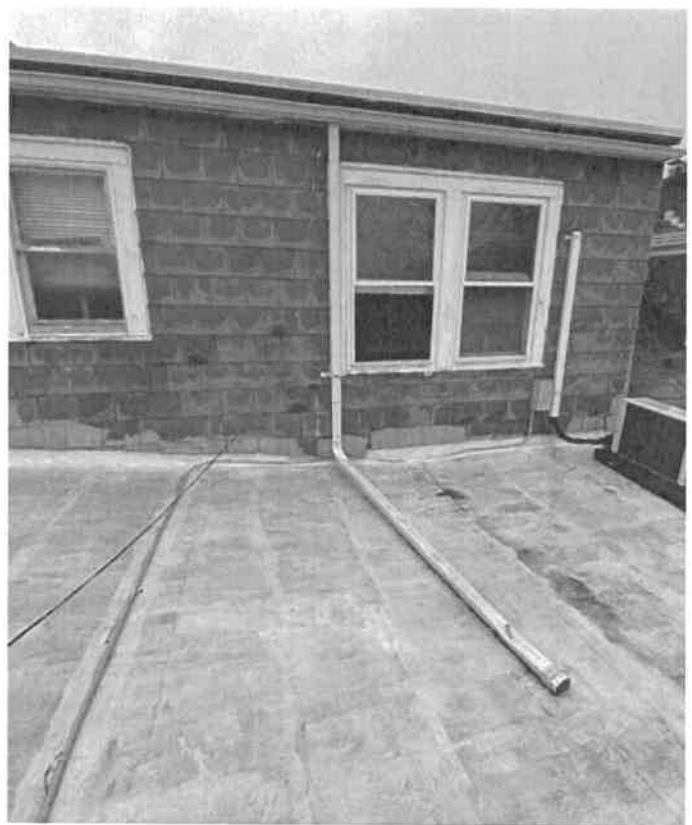
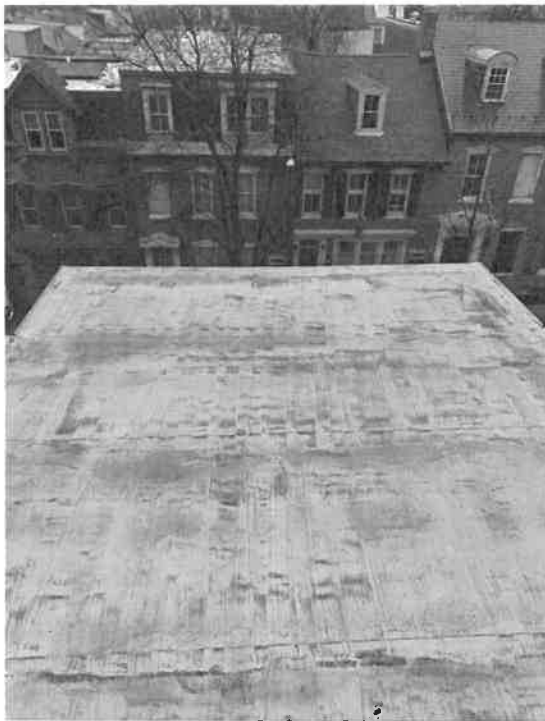
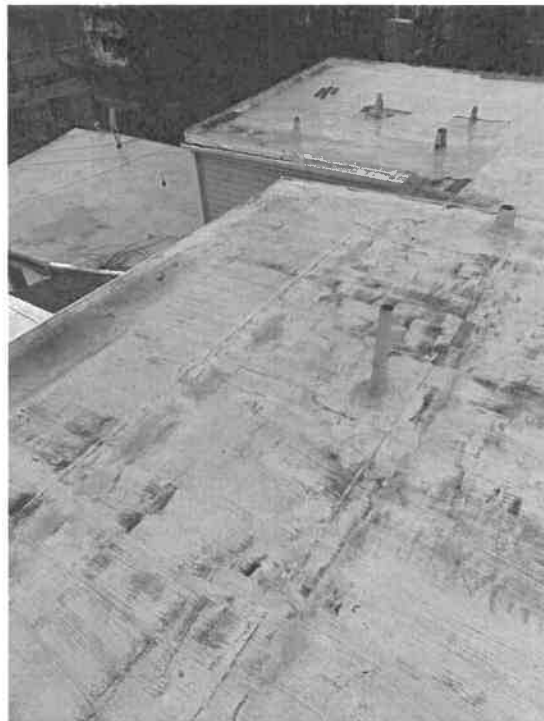
Roof Being Replaced (Applicant)

Observations & Comments: The flat roofs are not visible from the public right-of-way. The only question I have after reviewing the material is if they plan to re-line the box gutter on the front elevation with EPDM rubber roofing. Based on the design guidelines, it would be recommended that they reline the box gutter with copper sheet metal rather than covering with EPDM.

Staff Recommendation: It is recommended to approve, with conditions related to box gutter clarifications.

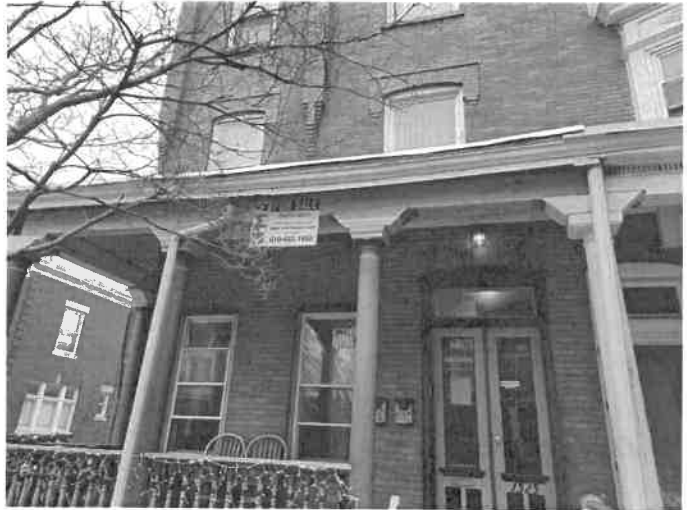
Repaired Porch (Applicant)

Observations & Comments: This is a relatively straightforward in-kind repair and appears to match the existing configuration well. Although no existing photographs were provided and it is not clear if there was any additional detailing at the header (similar to what is present at the adjacent porch header).

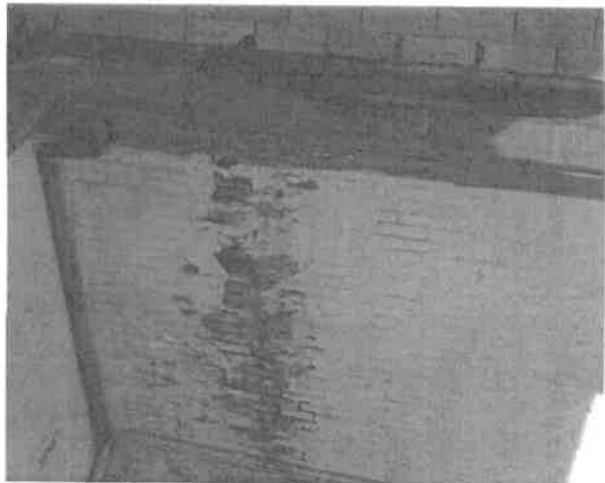
Damaged Wall Paint (Applicant)

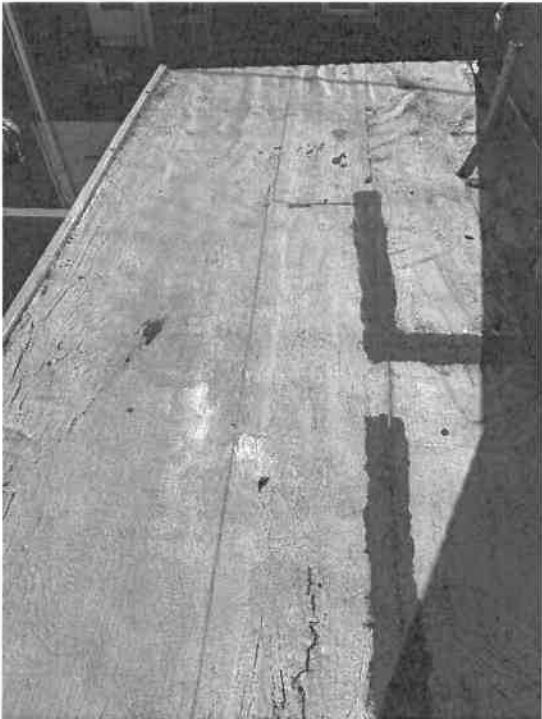
Flat Roof Being Replaced (Applicant)

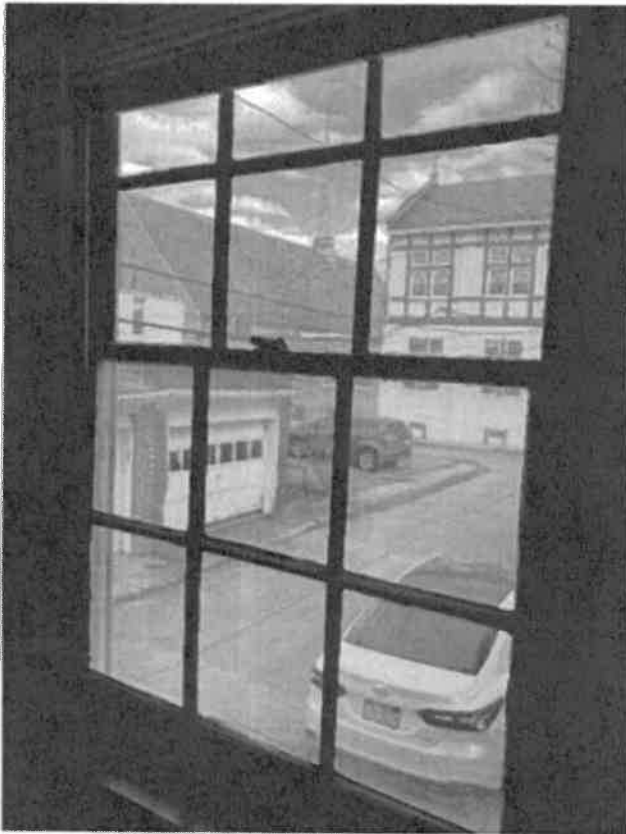
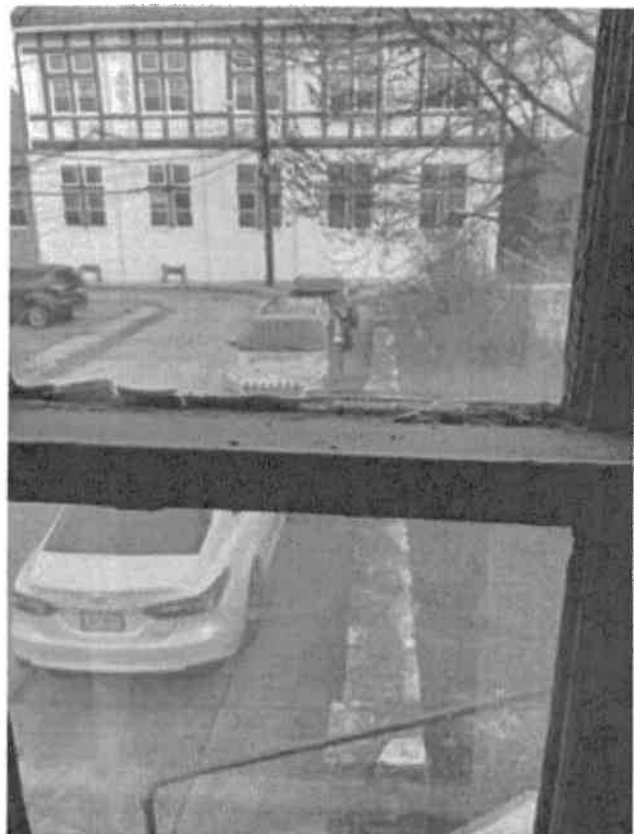
Window Condition (Applicant)

View: North side of the building towards N Baxter St, first floor; window doesn't work, paint is coming off.

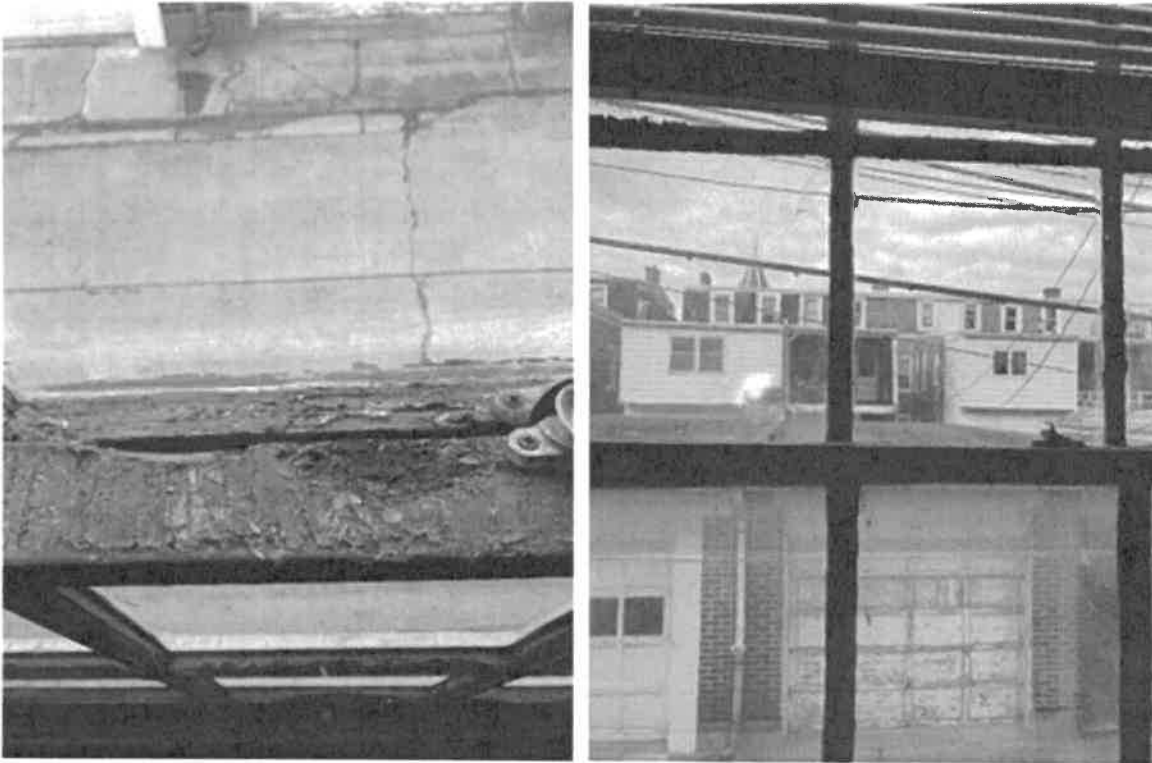
Window Condition (Applicant)

View: West side of the building in alley, first floor; window is damaged, doesn't work.

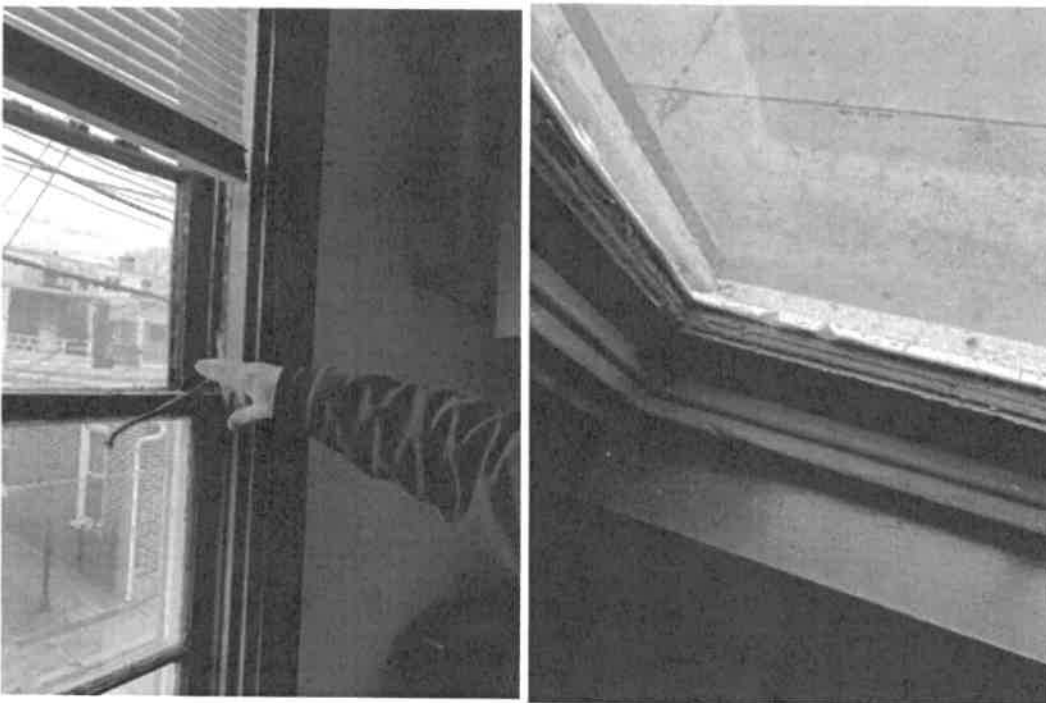
Window Condition (Applicant)

View: West side of building in alley, first floor; window doesn't work, gaps at the bottom, broken pulls.

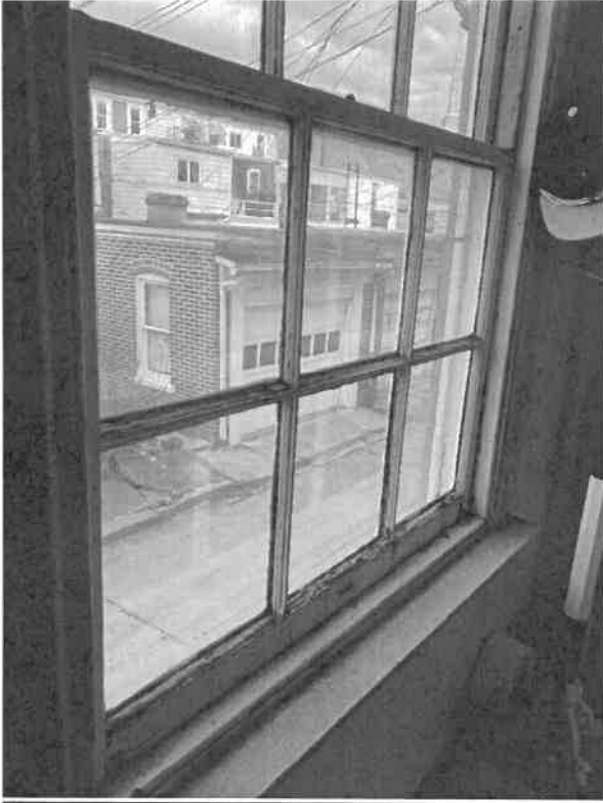
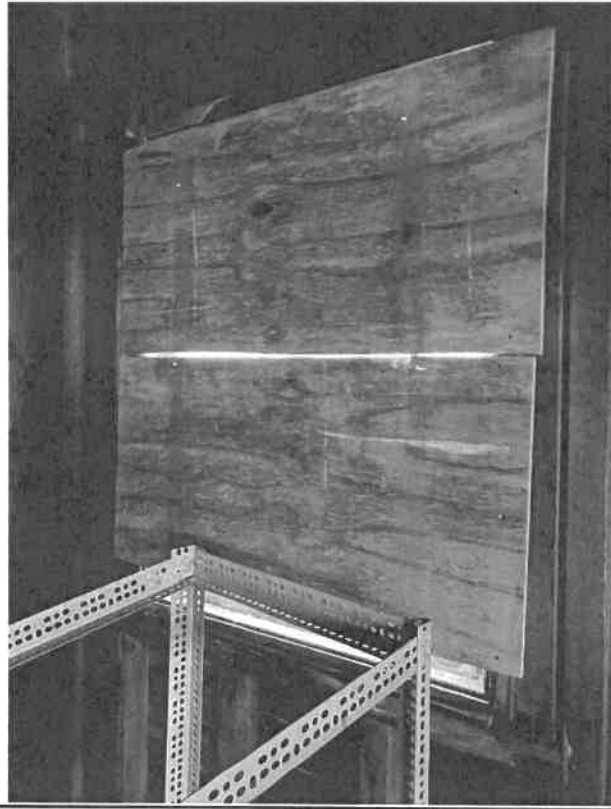
Window Condition (Applicant)

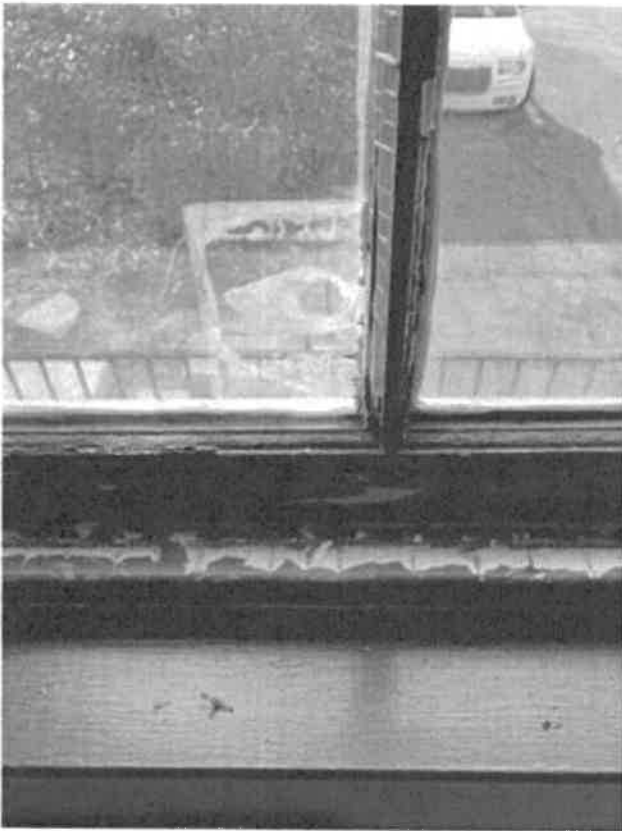
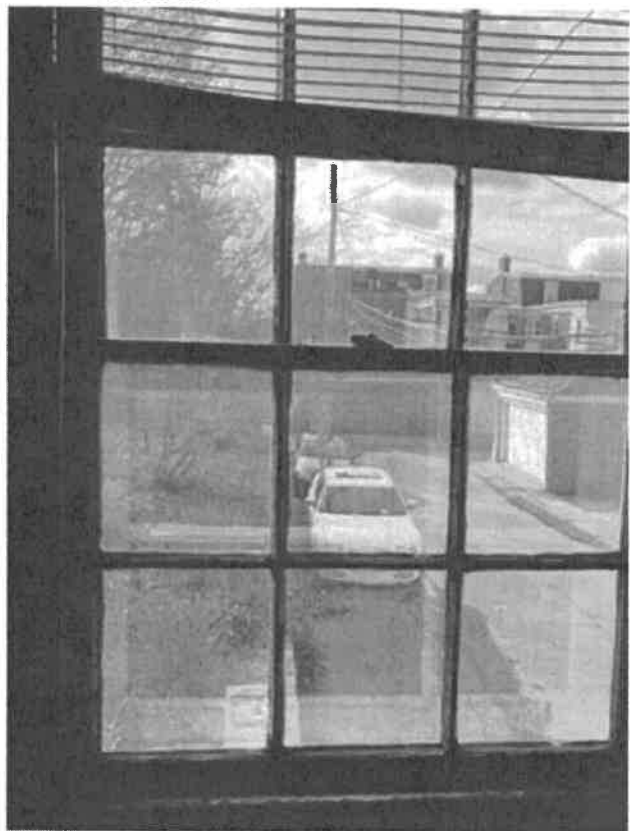
Window Condition (Applicant)

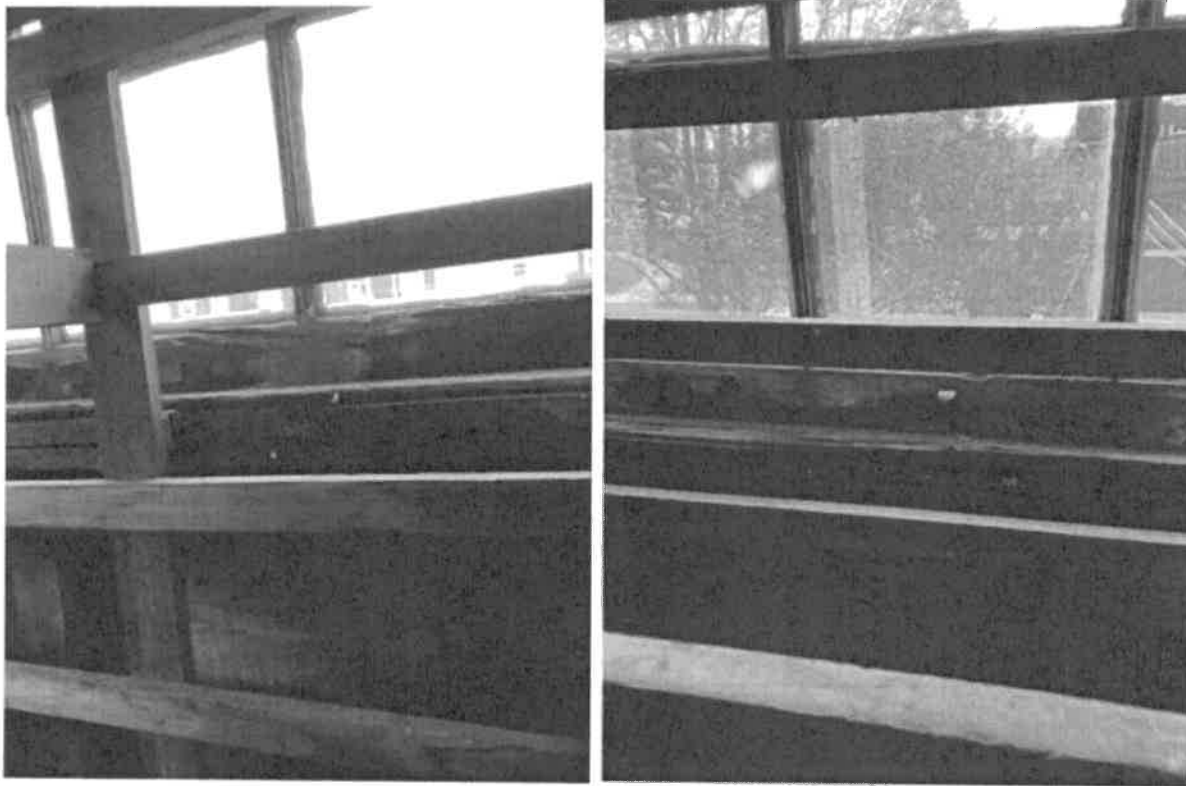
Window Condition (Applicant)
