CITY OF ALLENTOWN

R58 – 2026

**Historical Architectural Review Board
COA Preliminary Review Sheet**

Address: 334 N. 9th Street

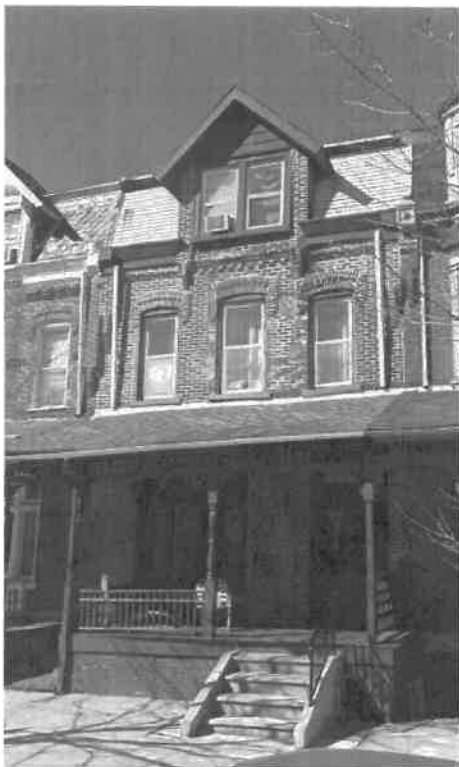
Front Elevation (Google Maps, April 2024)

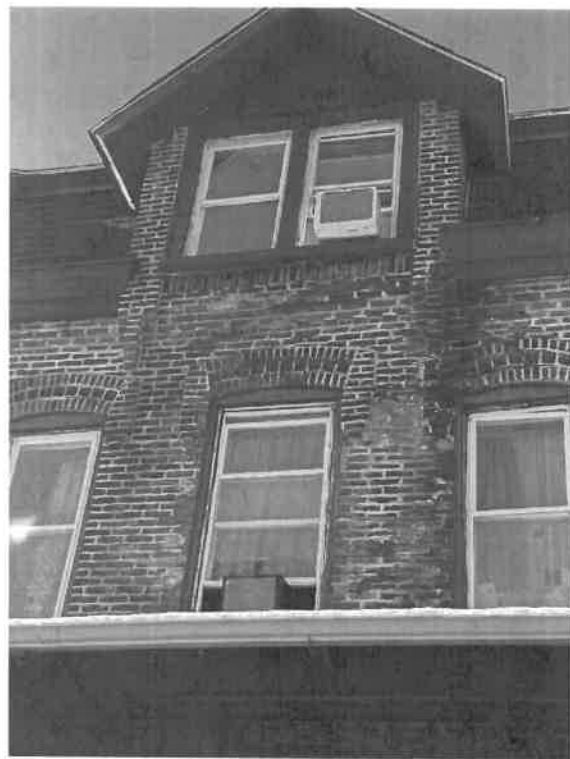
Existing Upper Floor Condition (Applicant)

Overview:
334 North 9th Street Allentown PA, contractor upon sight visit noticed the following. Severe water and structural damage on the right side of the building above the window arch. Upon further assessment it was noted that water damage and wrong use of mortar was the main cause of damage. Damage is way too far

Key Repairs:
Due to severe structural damage, shoring will need to be installed before any of the construction process begins. Once permits are pulled and in place the first thing to be done is the installation of the helibeam system. This system is a shoring method in masonry restoration to prevent further structural damage by installing stainless steel heli beam bars all through the masonry structure to distribute the load bearing weight. Once these bars are installed they require 24-48 hours of cure time before any demo will take place. While these bars are being installed the roof underneath will be shored up to withstand the weight of bricks materials, workmen, and demo process. The protection of the building's roof is also a concern and 4 plywood will be installed as a "protection board" during the construction process. After all shoring and safety measures are taken the main repairs will take place, demo of failed brick, relay to historical guidelines, install proper flashing and wall ties. After these repairs take place a permanent solution to the water damage will be resolved.

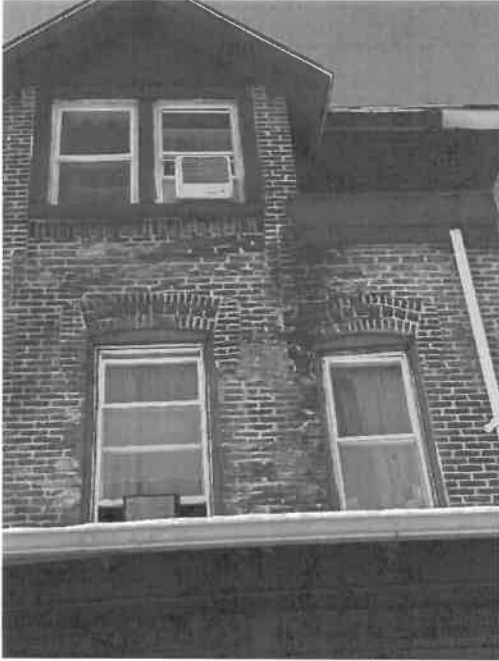
Existing Upper Floor Condition (Applicant)

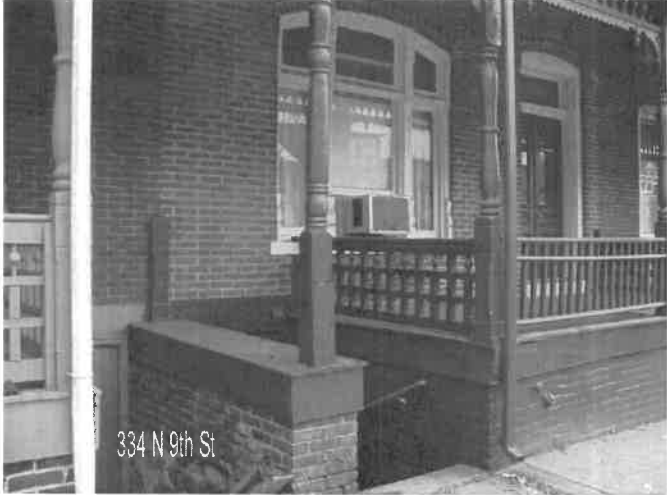
Existing First Floor Condition (Applicant)

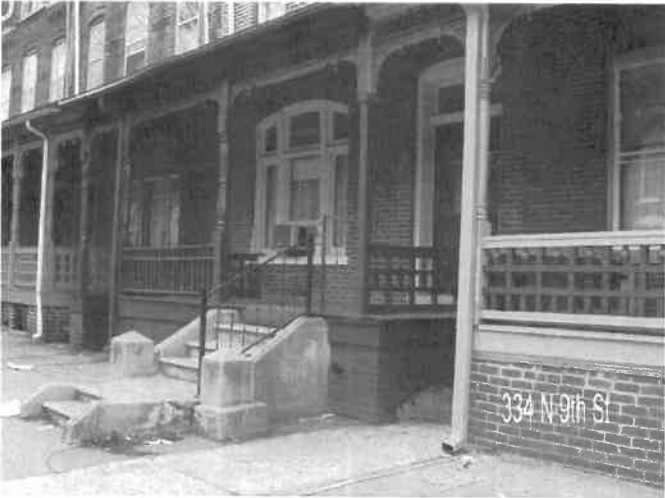
Existing First Floor Condition (Applicant)

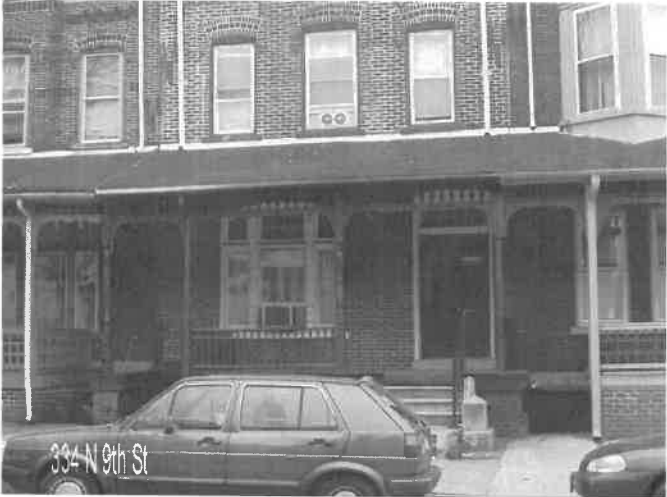
Existing Condition (Applicant)
