CITY OF ALLENTOWN

R64 – 2023

**Certificate of Appropriateness for work in the
Historic Districts: 325 N. 9th St. and 328 N. 8th St.**

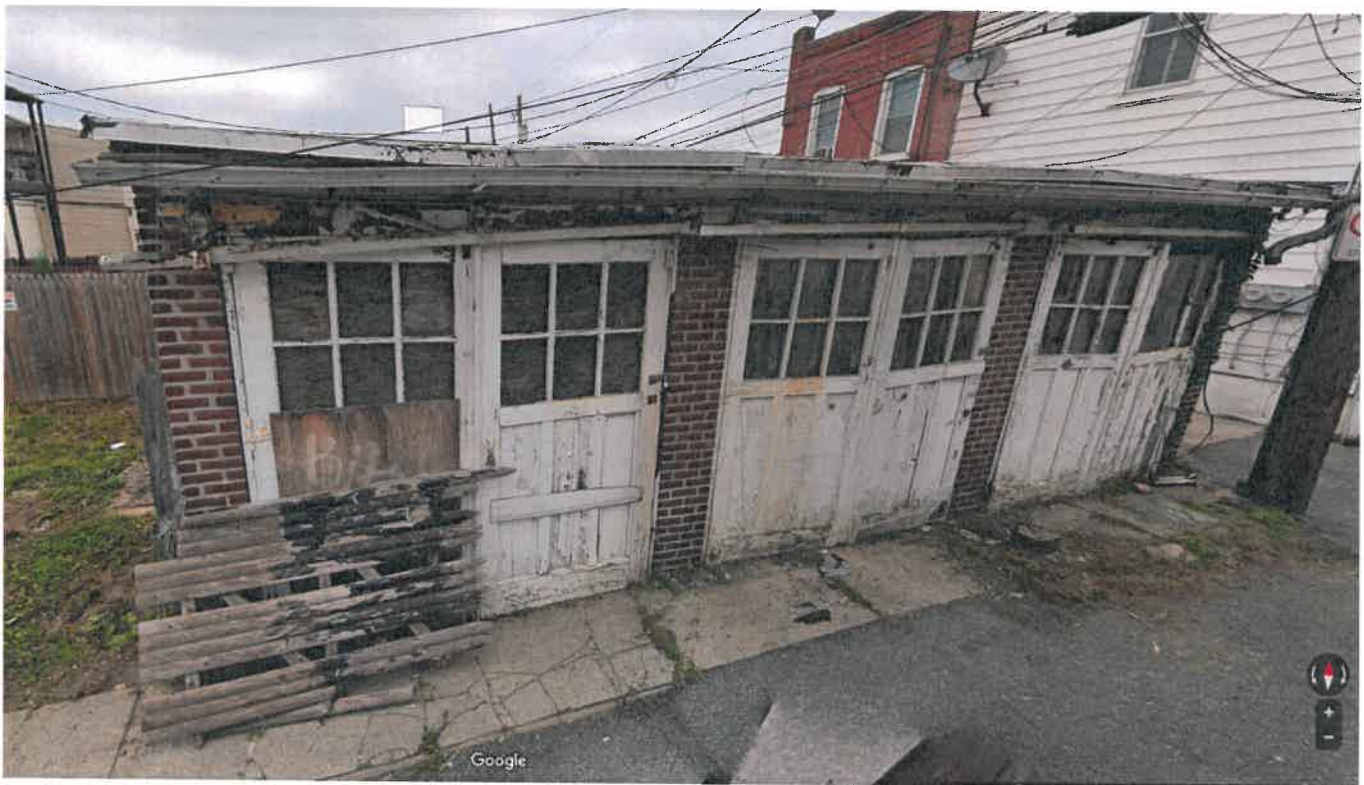
**Rear garage of 325 N. 9th Street, 2019.
(Google StreetView)**

While the design guidelines provide recommendations for door replacement, they do not specifically address door replacement at accessory structures. Staff notes that the garage is somewhat visible from a primary street and fronts a secondary street and recommends following the guidelines with some flexibility. Staff also notes that the doors have been in poor condition since at least 2004. No glazing remains, and all doors show visible signs of deterioration.

Denial of the application as presented, but approval of a vertically paneled metal or composite door with glazing, with the staff to review details, pursuant to Chapter 3, Section 3.6 Doors.

Mr. Encelewski moved to approve with conditions the application presented on 3/6/2023 for the installation of three garage doors at 325 N. 9th Street, as agreed to by the applicant and with the staff to review details, pursuant to Chapter 3, Section 3.6 Doors, provided the garage door openings are preserved and that the doors are cut symmetrically in design, noting that the brick piers present a unique circumstance. Mr. Hart seconded the motion, which carried with unanimous support.

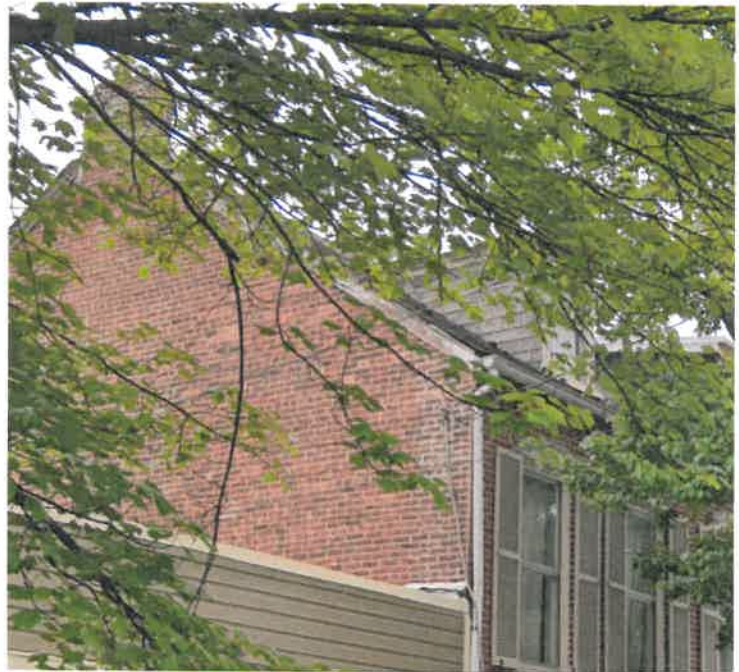
**Detail of slate at dormer, 2019.
(Google StreetView)**

Staff requests clarification on whether the front dormer cheek walls are proposed for replacement and recommends retaining the historic slate if it remains in good condition.

Mr. Long confirmed that the dormer cheek walls would be replaced, adding that the dormer roof has already been replaced with asphalt shingles. Mr. Jordan stated that he sees value in replacing the entire roof with one type of shingle but noted that he struggles with approving the Timberline architectural shingle that replicates the shape of cedar shakes.

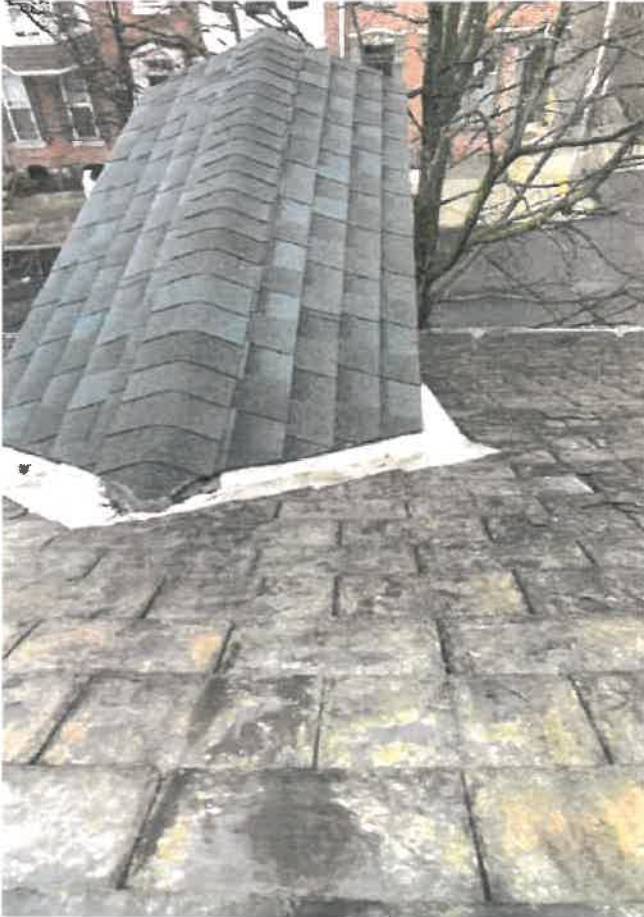
**Front slope of roof with original slate (replacement at dormer).
(Applicant)**

The applicant contends that the existing slate requires replacement because the slate is highly deteriorated. Staff notes that the condition photos show that the slate is delaminating, with some fractured slate shingles, and is in generally poor condition at the front roof slope. The rear roof slope has been replaced with asphalt shingles, and no historic material remains.

Approval, pursuant to Chapter 3, Section 3.1 Roofs, with the staff to review details, provided the new roofing material matches the historic slate on the front roof slope in dimension, shape, profile, color, exposure, and overall appearance.

Mr. Hart moved to approve with conditions the application presented on 3/6/2023 for roof replacement at 328 N. 8th Street, as agreed to by the applicant and with the staff to review details, pursuant to Chapter 3, Section 3.1 Roofs, provided the shingles on the front roof slope match the dimension, shape, profile, color, exposure, and overall appearance of the historic slate, that flashing complies with the guidelines, and with the suggestion that the approved materials are used on the entire roof, noting that there are no unique circumstances. Mr. Encelewski seconded the motion, which passed by a vote of 4 to 1. Mr. Huber dissented.

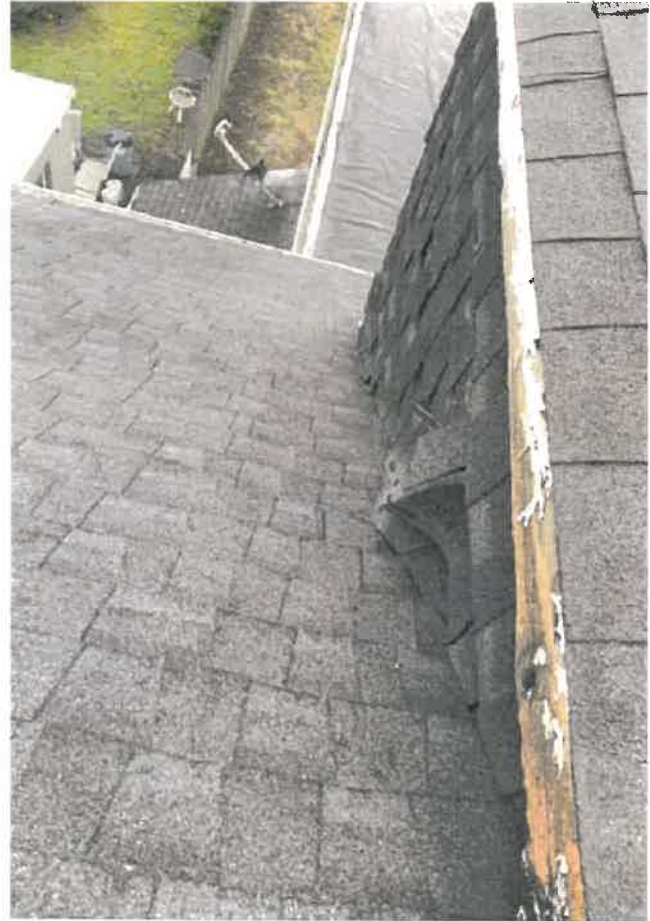
**Rear asphalt shingles.
(Applicant)**
