**Historical Architectural Review Board**  
**COA Preliminary Review Sheet**

**HDC-2025-00102**

**Address: 521 N 6<sup>th</sup> Street**

**Proposal: Remove and install new decorative paneling around second floor bay window (Violation Correction)**

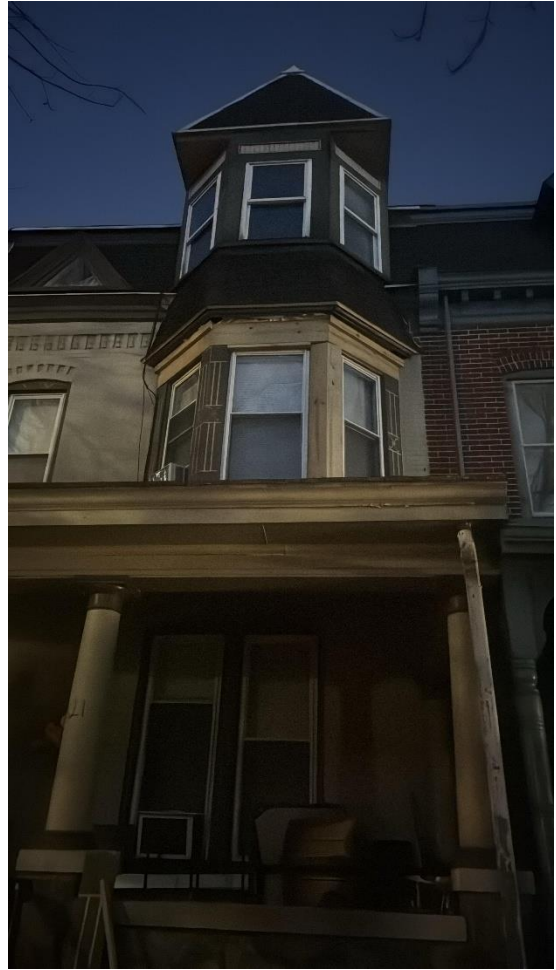
From application: The existing exterior window panels and surrounding wood components exhibit deterioration, including rot in multiple locations. In addition, sections of the soffit board are missing, leaving the assembly exposed and vulnerable to further damage.

**Current Condition (Applicant)**

The scope of work includes the careful removal of all deteriorated and damaged wood elements around the affected window areas and soffits. Any unsound material will be replaced with new pressure-treated lumber where structural integrity or moisture exposure is a concern.

On top of the pressure-treated substrate, new exterior trim boards will be custom carved and installed to match the existing architectural pattern and profile, ensuring visual continuity with the original design. All replacement components will be securely fastened, properly aligned, and prepared for exterior finishing.

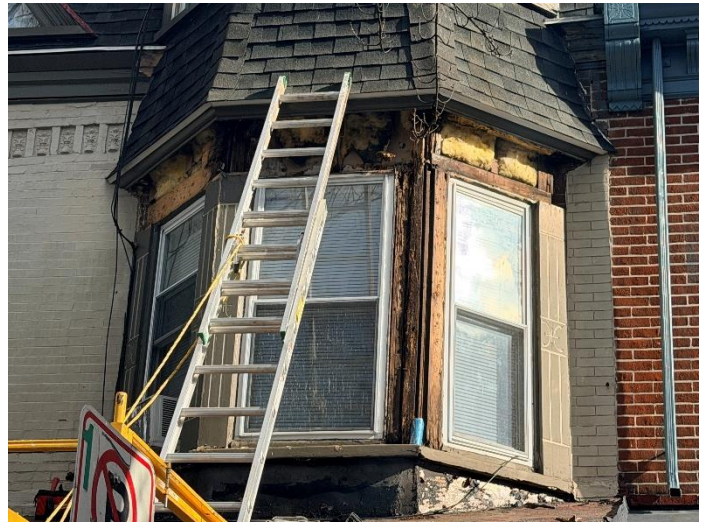
**Wood Removal (Applicant)**

The applicant stated that his company was hired to replace the deteriorated wood panels; many were severely rotted and in poor condition. The rotted wood was removed and replacement wood added to create a sound, weathertight condition. The applicant proposed taking a physical tracing of the original panels as a basis for recreating the trim. The Board discussed a few options for how that could be achieved, such as using a router, a CNC machine, or handcarving. Mr. Hart suggested that the means of creating the panels is up to the contractor; the goal is for the panels to be visually similar to the original ones.

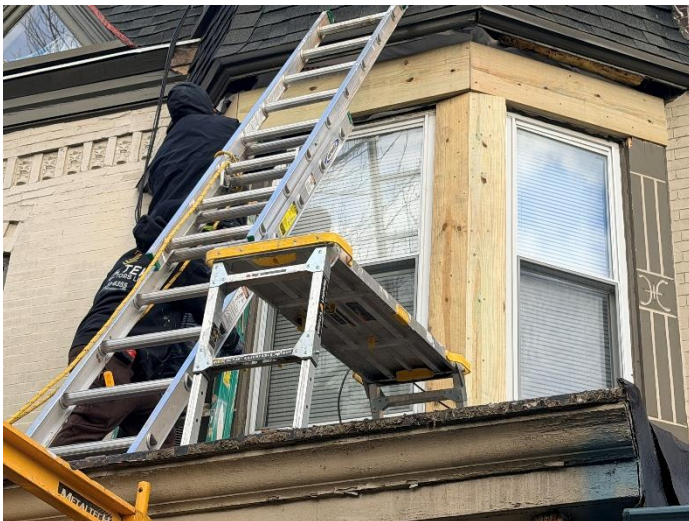
**Wood Replacement/Current Condition (Applicant)**

The proposed scope calls for adding new scribed trim onto replaced substrate. Based on the submitted photos, it appears that replacement wood is in plane with original scribed trim. More information would be helpful to understand how a consistent finished plane will be achieved; ensuring that edges align appropriately to adjacent elements, such as other trim and window sills.

**Staff Recommendation:** Staff request more information on the extent of the work area and the approach for achieving a consistent plane of the trim's surface. Generally, the proposed approach to replacing the wood trim is appropriate. All exposed wood surfaces should be painted.
