Historical Architectural Review Board FINAL Review Sheet

HDC-2024-00022 Address: 213 N Poplar Street District: Old Allentown Historic District Owner: LPR Homes, LLC (Pratik Patel) Applicant: LPR Homes, LLC (Pratik Patel) Proposal: Replace roof

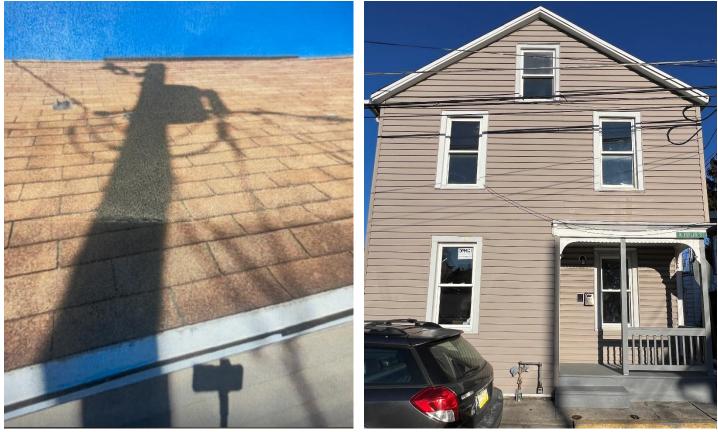
Existing Roof (Applicant)

Front of House (Applicant)

Observations & Comments: The current 3-tab asphalt shingles on the main gable roof are not historic and the proposed replacement material (GAF Timberline HDZ Shingles) are architectural shingles that have an exaggerated taper and overlap; it would be historically appropriate to either replace with 3-tab shingles to match the existing in style or color, or to replace with GAF slateline shingles, which would be more historically appropriate. The flat slope roof is not visible and therefore, the replacement with the SBS roofing is acceptable. The description did not include any work done to the gutters, but if any work is done, it is recommended to use half rounds, as opposed to the k-style that are currently installed.

• A 3-tab shingle or a GAF Slateline or similar shingle to match the existing style and color is utilized for the replacement.

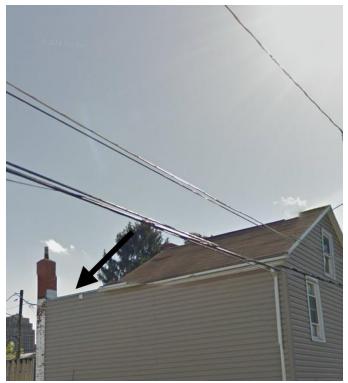
Back of Roof (Applicant)

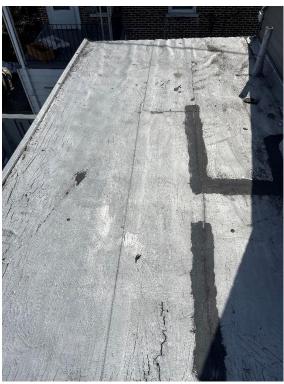
Flat Roof Being Replaced (Applicant)

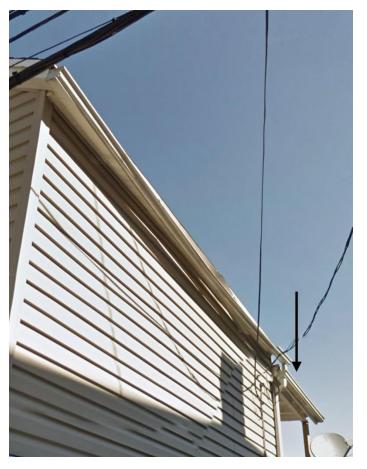
Side of House (Applicant)
