**Historical Architectural Review Board
COA Final Review Sheet**

HDC-2023-00065

Address: 614 N. 5th Street

Proposal: Replace wood porch columns with fiberglass columns; infill opening

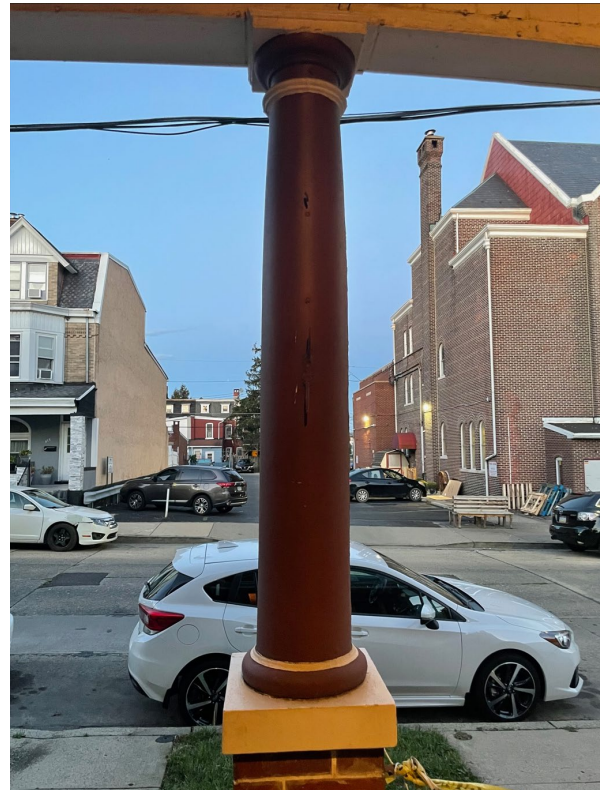
**Porch column to be replaced, 2023.
(Applicant)**

Building Standards has inspected the property and determined that two porch columns are rotted and require replacement. The owner has provided staff with specs on matching columns in fiberglass (PermaCast) and wood. The owner noted that the wood columns are hollow, though loadbearing, and that he prefers the fiberglass columns. The proposed columns have a tapered shaft and matching components. While a material change, they would replicate the appearance of the historic. Staff finds that the columns do not comply with Guideline 3.7.4 because of the material change, but do comply with Guideline 3.7.8. Despite the material change, staff finds the proposed alternative to be compatible and acceptable.

Approval of the replacement of the wood porch columns with fiberglass columns, pursuant to Chapter 3, Section 3.7 Porches & Steps, but denial of the infilling of the window with brick veneer, pursuant to Chapter 3, Section 3.5 Windows.

Mr. Lichtenwalner moved to approve with conditions the application presented on 10/2/2023 to replace wood porch columns with fiberglass columns and to reinstall window sashes at an infilled second-story opening, pursuant to Chapter 3, Section 3.5 Windows and Section 3.7 Porches & Steps, provided that the reinstalled window sashes have either spandrel glass or a painted panel behind the window. Mr. Huber seconded the motion, which carried with unanimous support.
