Historical Architectural Review Board
COA Preliminary Review Sheet

HDC-2025-00008

Address: 1528 Linden Street

Proposal: Violation correction - Vertical platform lift installation with landing infill and railings.

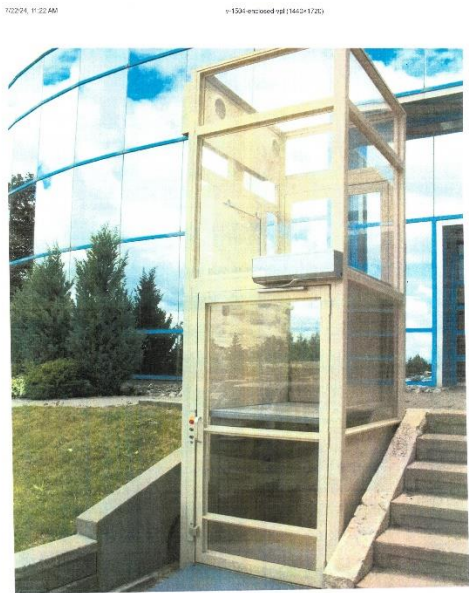
Proposed Lift (Applicant)

Information has been submitted regarding the configuration of the lift. The metal components in the sample image appears to be a buff color. A color that complements the existing surrounding stone would be appropriate. It would be helpful for the applicant to confirm the intended finish color of the lift.

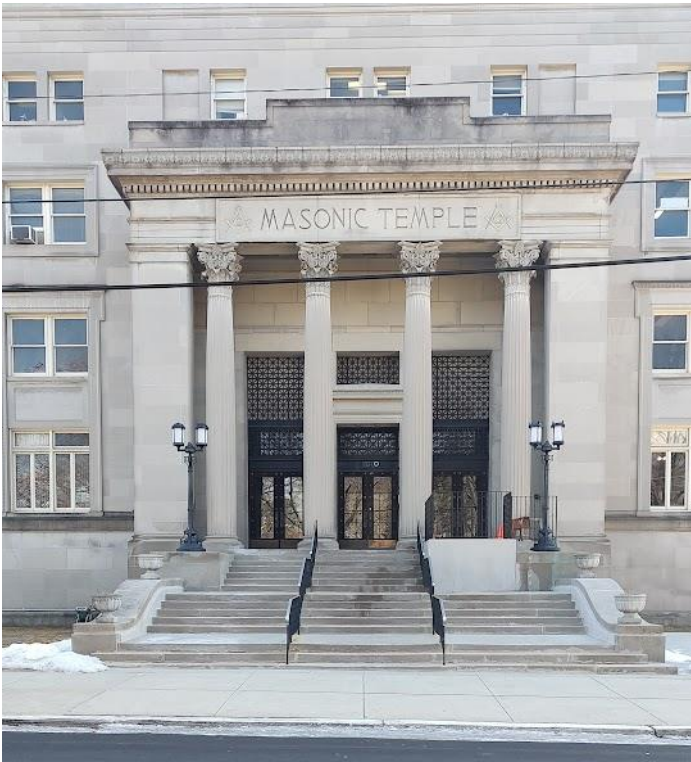
Current Condition – Front Elevation (Staff)

While providing an accessible entry at the main entry is desirable, the top landing does affect the composition of the front elevation and the original historic entry. Given that the first floor is quite elevated above grade and there are limited access points to the building, providing an accessible entry would be challenging. More information from the applicant would be helpful to understand the process for coming to this solution and if other options were explored, such as a ramp, and if there were dimensional requirements that resulted in the top landing extending past the lamppost.

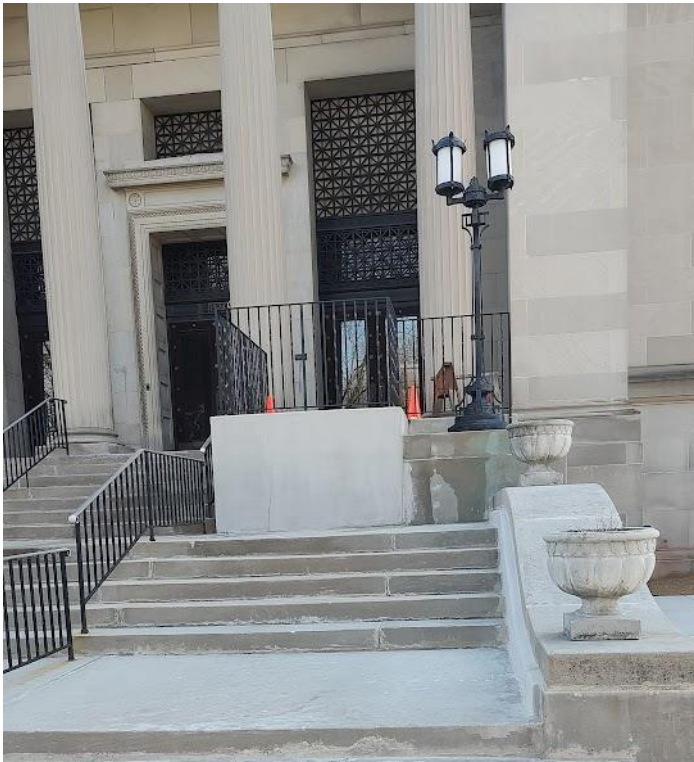
Current Condition – Railing/Top Landing (Staff)

The new railings at the top landing are similar to the existing stair railings in materiality and finish but appear to have a different profile.
