**Historical Architectural Review Board  
COA Final Review Sheet**

**HDC-2023-00031**

**Address: 449 N. 10<sup>th</sup> Street**

**Proposal: Replace windows and doors**

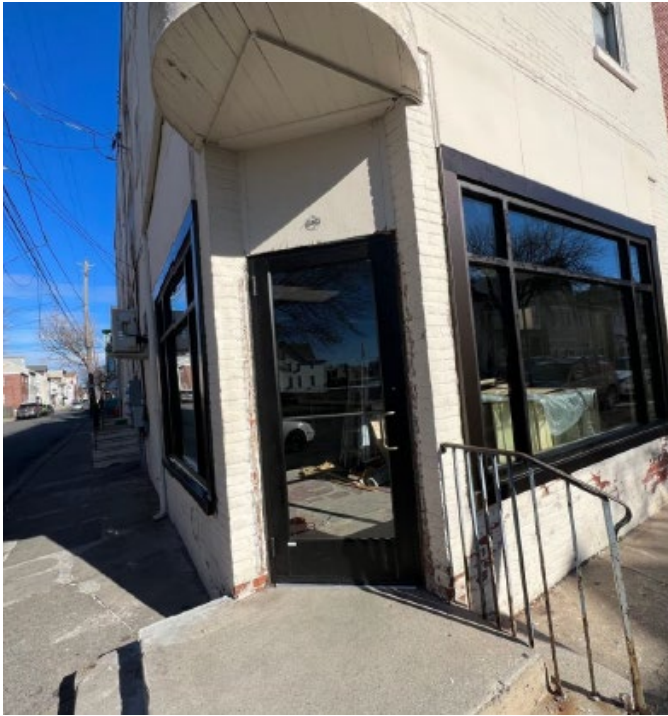
**Aluminum entry door.  
(Applicant)**

The previous door system included a wood paneled door with non-original trim and an infilled transom that extended over the top rail of the door. The new aluminum door system has been moved forward to align with the infill panel above. Staff questions whether the historic transom remains behind the infill panel. If no transom exists, staff finds the new configuration to be acceptable. However, if the transom does exist, staff recommends installing a wood door that matches the replaced door and that is installed in the plane of the historic transom.

- The transom at the storefront door is investigated to see if there was a historic transom and that it be replaced with a new transom to match the aluminum door system.
- The vinyl windows along Liberty Street be replaced with wood, aluminum-clad wood, or composite windows under a phased program in which the owner must replace the first-story windows within one year, the second-story windows within three years, and the third-story windows within five years.
- The pre-hung door at the Liberty Street elevation be removed and a new door that meets the design guidelines be installed within the original opening.

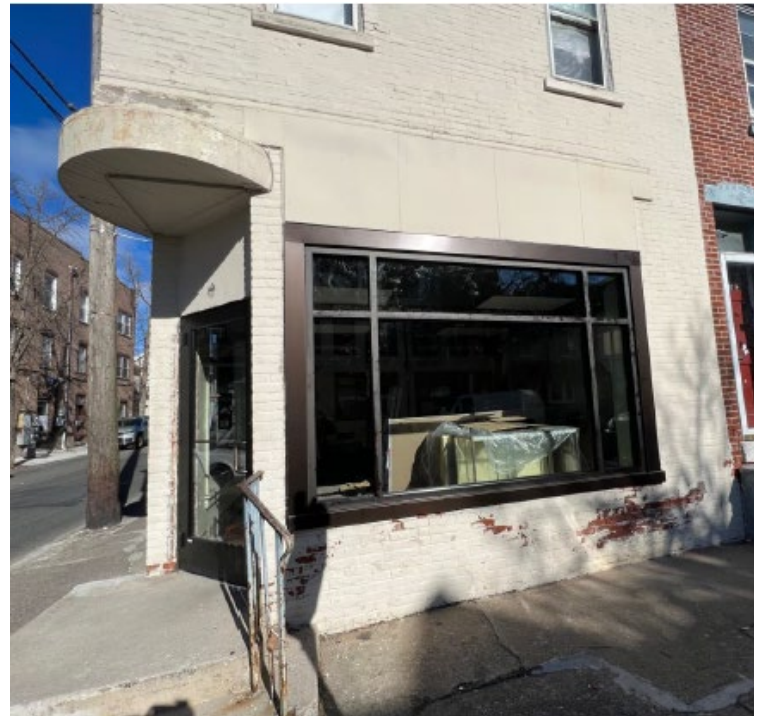
**Aluminum storefront window.  
(Applicant)**

Staff finds the proposed configuration to be appropriate, given that the window openings are highly altered and have no historic significance. Staff also finds aluminum to be acceptable because of the size, location, and commercial purpose of the windows. Because of the significant build-down and infill, staff considers the historic storefront to have been removed and notes that Guideline 3.13.9 allows for greater flexibility in design and materials. Staff finds the new configuration to be consistent with other storefronts in the immediate area.

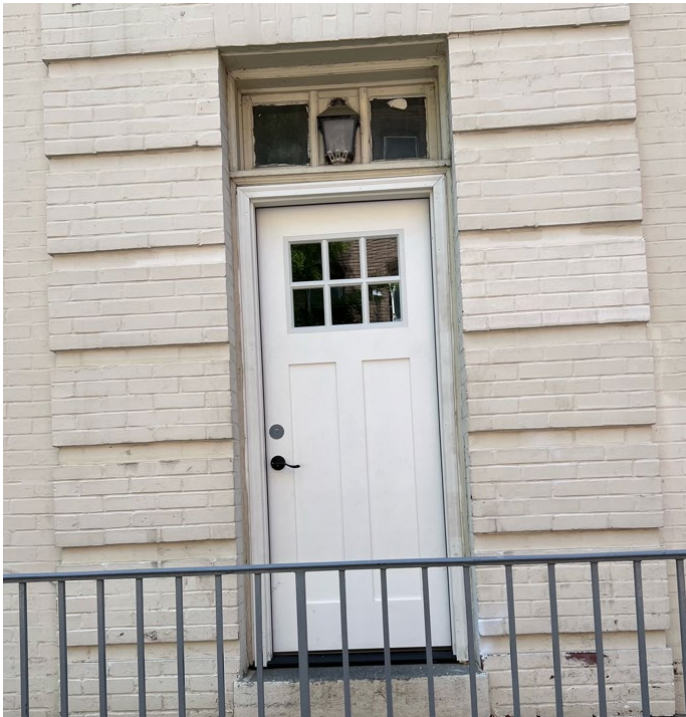
**Fiberglass door at Liberty Street façade.  
(Applicant)**

One pre-hung fiberglass door was installed on the Liberty Street façade. The design guidelines advise against pre-hung doors because they build down openings. Staff recommends installing an appropriately-sized (not pre-hung) six-panel door in wood, composite wood, or fiberglass to comply with Guideline 3.6.9.

The HARB reviewed the Liberty Street door and found that the door also does not comply with Section 3.6 of the guidelines, since the guidelines do not permit pre-hung doors that build down openings. The HARB contended that the door would need to be replaced with an appropriately-sized door.

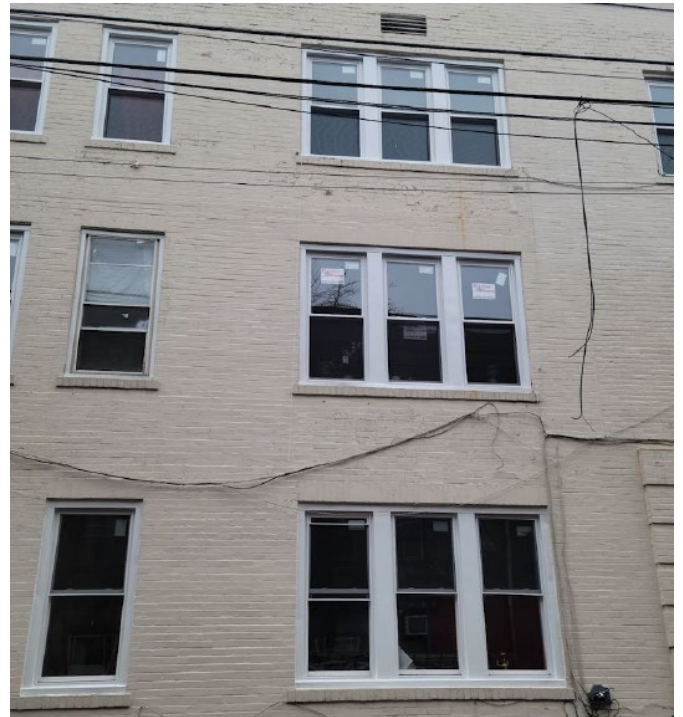
**Vinyl windows at Liberty Street façade.  
(Applicant)**

The vinyl windows on the Liberty Street façade are inappropriate and do not comply with Guideline 3.5.9. Staff also notes that the mullions in the tripartite windows should be wood. Owing to the expense of complete replacement, staff suggests that a compromise be reached. Staff recommends that the HARB consider one of the following options:

The HARB discussed the vinyl windows along the Liberty Street façade, contending that the vinyl windows do not comply with the design guidelines in Section 3.5. The HARB noted that the staff presented two options for legalization, including a five-year phased approach, which would offer the applicant ample time to replace the windows and bring the building into compliance.

1. Allow a phased replacement program to be implemented, where the first-story windows are replaced within one year, the second-story windows are replaced within three years, and the third-story windows are replaced within five years. Replacement windows should be wood, aluminum clad wood, or a composite.
2. Require the first-story windows to be replaced with wood, aluminum clad wood, or a composite, while the upper-story windows remain in violation with the note that any future replacement will need to be wood, aluminum clad wood, or a composite.
