# Historical Architectural Review Board COA Preliminary Review Sheet

**HDC-2025-00086**

**Address: 126-128 N 15<sup>th</sup> Street**

**Proposal: Roof Replacement (Violation Correction)**

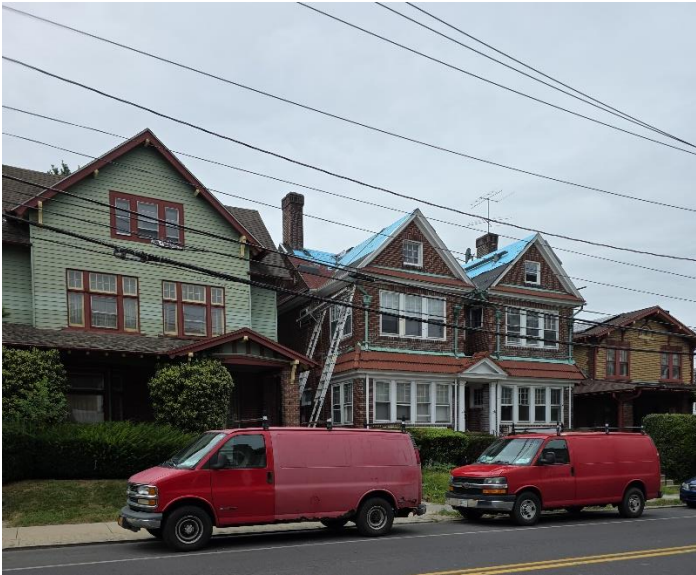
Current Condition (Applicant)

**Observations & Comments:** The original roof of 126-128 N 15 Street was Spanish barrel terra cotta clay tile. It appears that the original roofing materials have been completely removed at the main roof areas, and replacement with a red shake style architectural asphalt shingle was begun until work was stopped. The applicant has submitted an alternate material for review: Brava's Spanish Barrel Tile, a synthetic material that matches the original clay tile. This product appears to be an appropriate alternate material, as color options, profile, and appearance are consistent with the original historic clay. No specific color was proposed by the applicant. From the color chart, Antique Clay appears to be the closest match to the original clay; the applicant may obtain samples and submit photos to Staff showing the sample and the remaining original tile for final color selection.

- The original clay tile at the projecting eaves at the first floor and gable ends are maintained and not replaced
- Proposed changes to any other roof-related elements such as gutters or downspouts are submitted in a separate application.
- Final color is approved by Staff

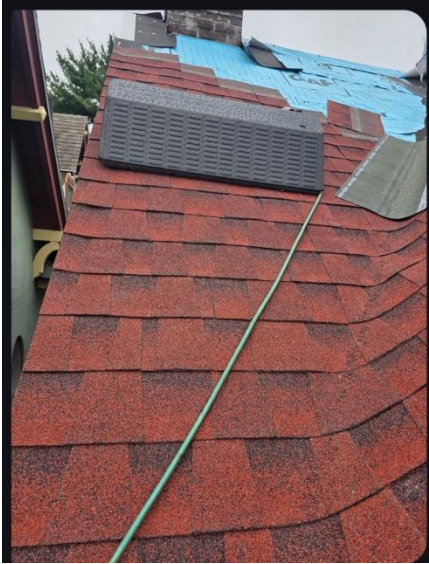
Current Material on Roof (Applicant)

The application does not indicate if the original clay tile at the projecting eaves at the first floor and the gable ends are intended to remain or be replaced with the other roof areas. If these areas are in sound condition, they should be

maintained or repaired where required. If they are intended to be removed, evidence of the condition of these areas should be submitted for review prior to any material removal. Evidence includes detailed photographs that show damage or deteriorated conditions.
