**CITY OF ALLENTOWN**

**RESOLUTION**

**R45 – 2024**

**Certificate of Appropriateness for work in the Historic Districts:**

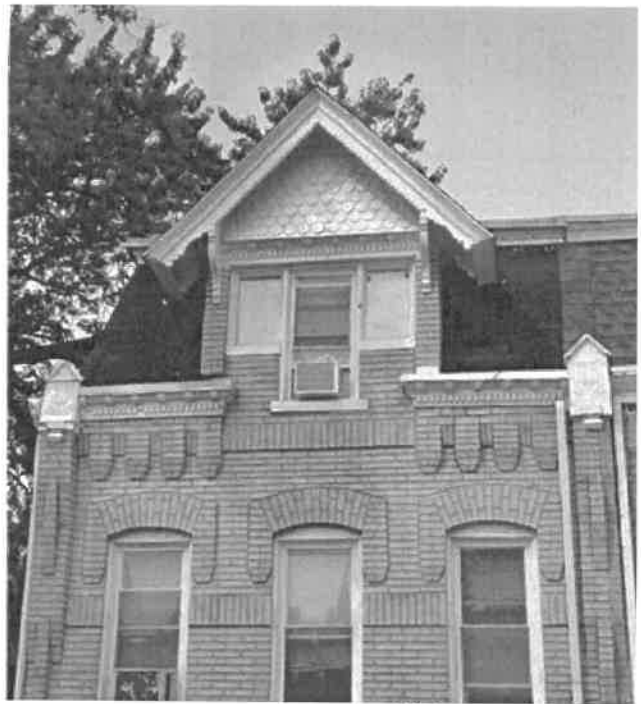
**Front windows of 112 N. 11<sup>th</sup> Street, current  
(applicant)**

**Observations & Comments:** This is a unique case. The current owner purchased the property with a tenant at a mid-lease point of time. The new owner asked the tenant to vacate per lease requirements at the end of the initial term (which was extended due to Covid moratorium on evictions). The tenant had damaged a window (just one?) and part of the legal eviction settlement included repair/replacement of the broken window(s). The tenant replace 2 historic multi-light sash

windows with fixed single light of glass in the existing openings. The new owner did not realize a building permit was needed to replace a window.

**Staff Recommendation:** As a preservation compromise, it is recommended to replace the two single light windows with new aluminum clad wood, composite wood, or fiberglass 1 over 1 double hung windows to match the majority of the windows in the row.

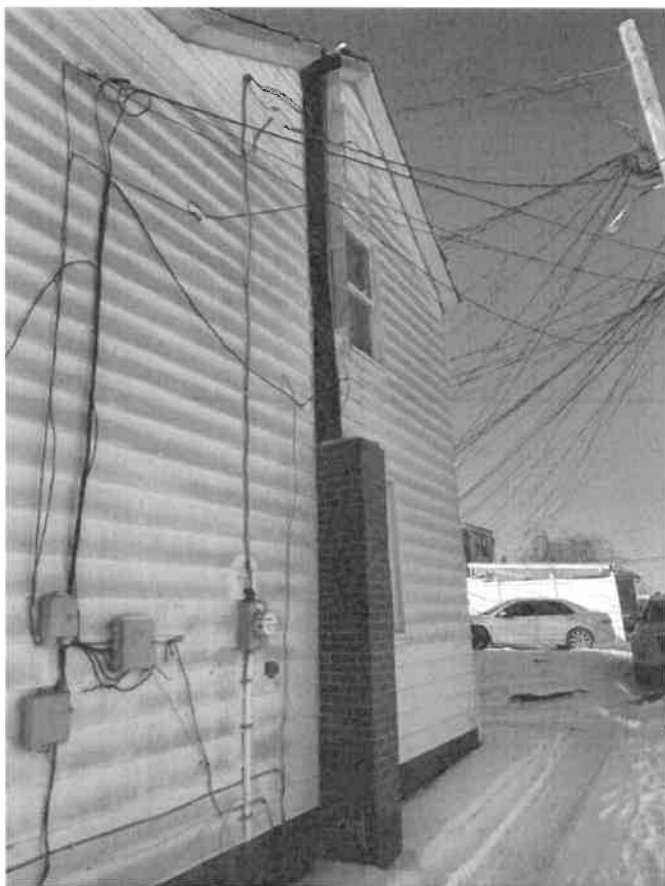
This application proposes to remove the existing chimney that was detaching from the structure and install stone to fill the chimney void. It also proposes to fix the siding.

**Side facade with chimney at 1142 Emmett Street  
(applicant)**

**Staff Recommendation:** It is recommended to approve either infilling the area with brick or infill the area with new siding that ties into the siding on one of its sides.

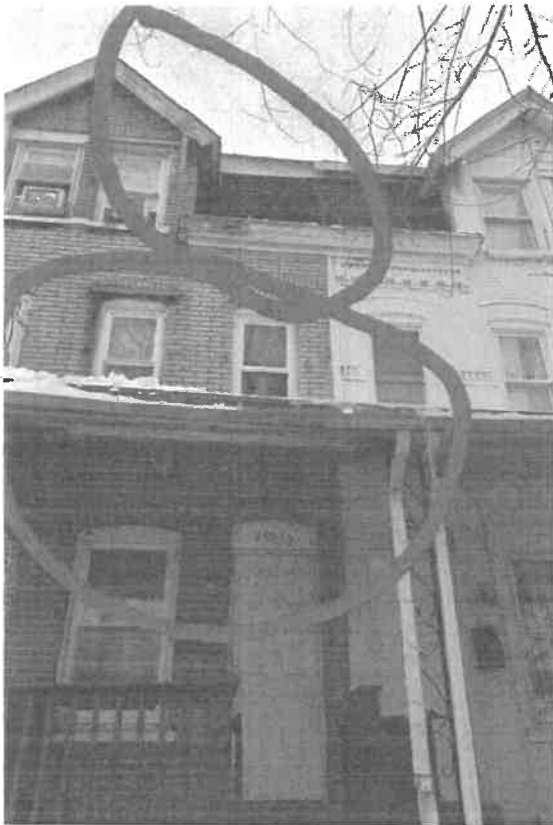
**240 ½ Hall St Front  
(applicant)**

**Observations & Comments:** The upper flat roof areas proposed to be replaced with rubber membrane roofing are not visible from the public ROW, however the edge metal will be visible. The upper edge of the Mansard is currently covered with loose aluminum flashing. It is not known if the historic wood molding (seen on the neighboring property) is still extant. The aluminum flashing piece should be removed and the molding repaired or replaced in-kind and painted. The membrane roof edge should match the trim color (white)

The replacement of the existing 3 tab asphalt/fiberglass shingles on the Mansard and one side of the dormer gable is historically appropriate if the shingles are 3 tab shingles to match existing in style and color or GAF Slateline shingles in the Antique Slate color or equivalent. The proposed architectural shingle does not recall slate and is not supported by the Design Guidelines. The replacement of flat seamed metal roofing on the front and rear porches is also proposed. The surface of the front porch roof is hard to see from the street, the rear roof is visible from Emmett St. which is a short narrow alley. The proposal to replace the metal roofing with shingle is not historically ideal but other nearby or adjacent roofs have been replaced with asphalt shingles. Because of the lack of visibility of the front roof and the low level of visibility of the rear roof, the HARB should consider replacement with 3 tab shingles to match the existing Mansards or with GAF Slateline shingles.

The built-in gutter at the third floor needs to be repaired in kind and the box gutter relined to extend its use. The K gutter at the front porch is shared with the neighbor. It should be repaired and replaced in kind or replaced with a more historic half-round gutter. Adequate hangers must be used to deter failure.

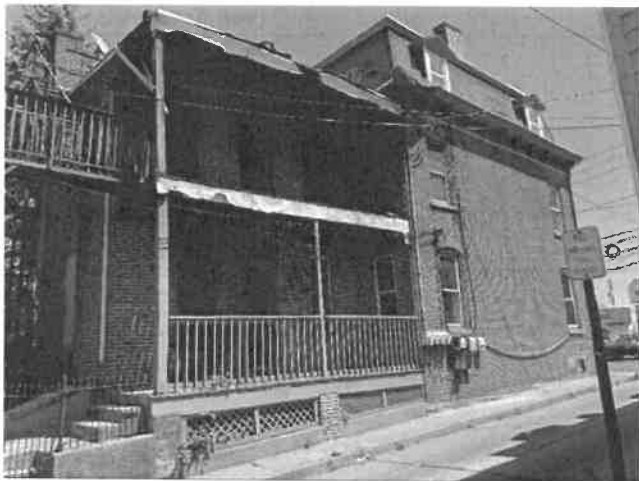
**Building Description:** This structure is a 3 story 3 bay red brick dwelling with a Mansard roof, tower roofed front dormer, deep bracketed cornice with Eastlake carving, 1 over 1 double hung windows with segmental brick arches, a rear ell with double story wood porch, and historic front door. The house dates from the late 19<sup>th</sup> century and is Queen Ann Eastlake in style. The house has a high level of historic integrity. The rear part of the house and 2 story porch were fire damaged in 2019.

**1021 Linden St after fire damage May 2023  
(applicant)**

**Observations & Comments:** The reconstruction of the second floor of the existing porch is historically appropriate in concept. The treatment of the wood fascias, and spec for the vented soffit should be discussed or supplied. It would be an historic improvement if vented beaded soffit material was used. The pressure treated floor decking and balusters must be painted when appropriately dried. Eastlake style railings included both straight and turned, historically. The proposed turned balusters would be historically appropriate if painted. Since the former windows were vinyl, replacement with vinyl is supported by the Design Guidelines. The new door should match the existing as proposed.

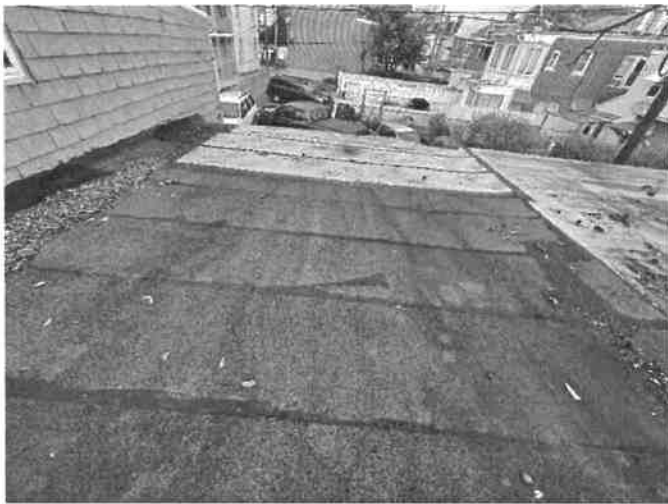
**Garage roof -From applicant**

**Observations & Comments:** The proposed roof replacements are for flat roofs and the roof surfaces are not visible from the public ROW

**Staff Recommendation:** It is recommended to approve as submitted.
