**Historical Architectural Review Board  
COA Final Review Sheet**

**HDC-2023-00082**

**Address: 531 W. Allen Street**

**Proposal: Remove slate shingles; install asphalt shingles**

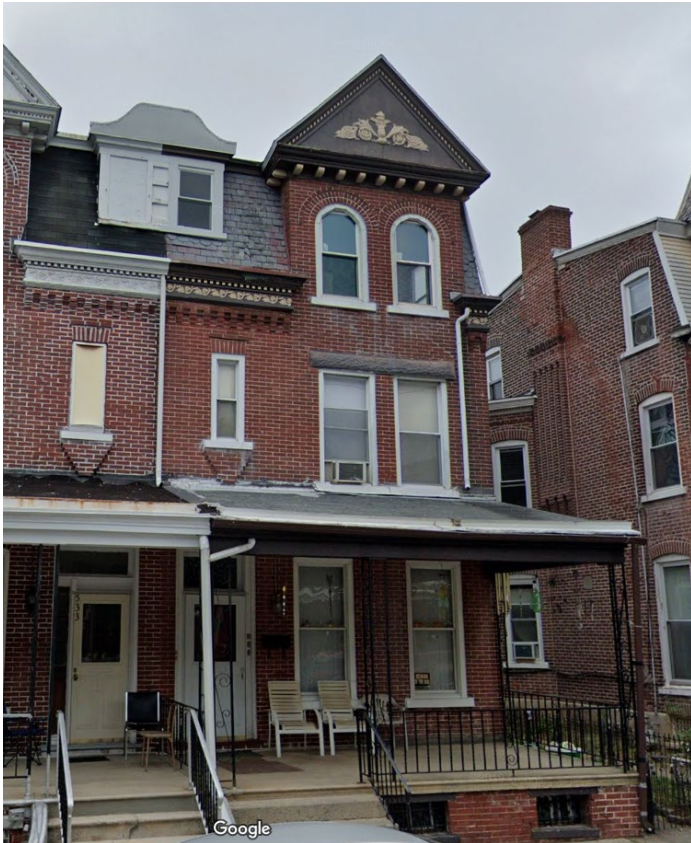
**Front façade of 531 W. Allen Street, 2019.  
(Google StreetView)**

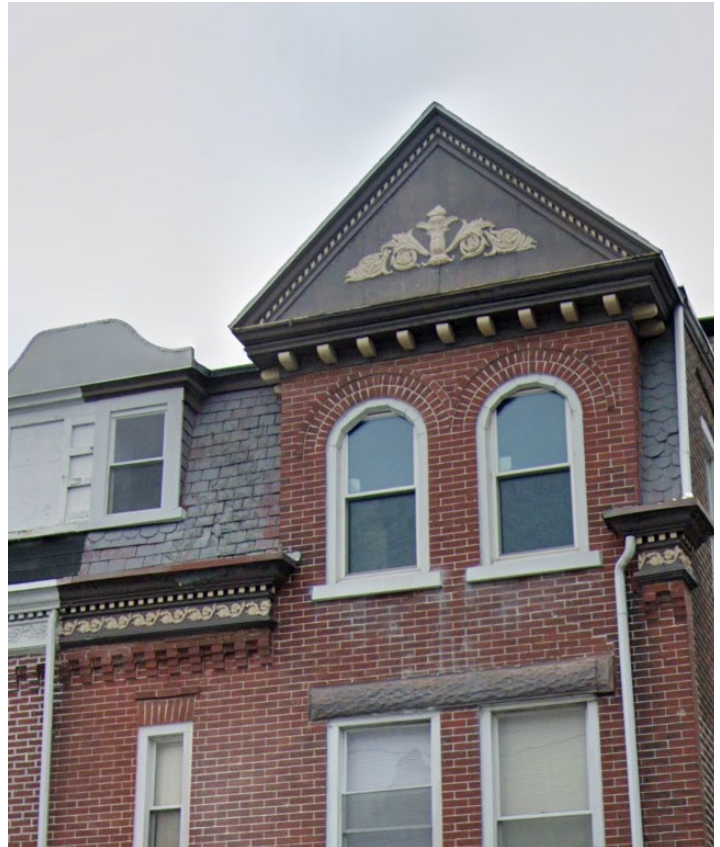
**Detail of roof, 2019.  
(Google StreetView)**

The applicant contends that the existing slate roof is failing and in poor condition. Photographs show that there are displaced shingles throughout the roof. Staff notes that the roof currently contains slate shingles in rectangular and beveled shapes, though there is no discernible patterning. Based on the beveled slate shingles at 527 and 529 W. Allen Street, staff contends that the mansard at 531 W. Allen Street historically had beveled shingles and that rectangular shingles were installed to replace many of the failing original shingles; however, no documentation exists to confirm this assumption.

The application proposes to install GAF Slateline shingles, which are an appropriate alternate that generally match the existing rectangular slate in dimension, shape, profile, color, exposure, and overall appearance. Staff finds that the proposed shingle complies with the guidelines in Section 3.1 Roofs.

Approval, pursuant to Chapter 3, Section 3.1 Roofs.
