CITY OF ALLENTOWN

**R200 - 2024**

Certificate of Appropriateness – 1028 W. Chew Street  
Re: Legalization of unauthorized 3<sup>rd</sup> floor addition, roofing, siding.

HDC-2024-000105

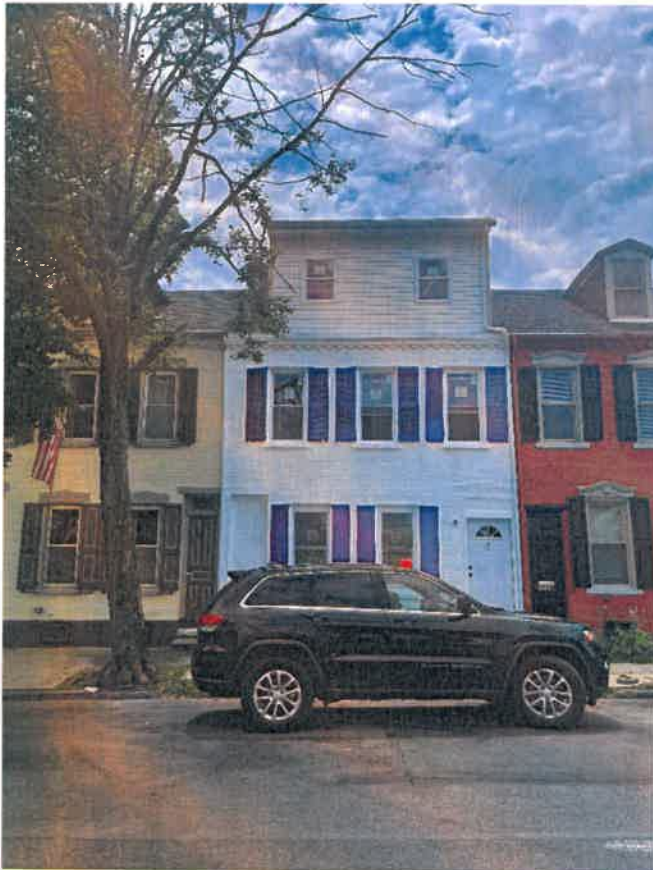
Current Front of House (Applicant)

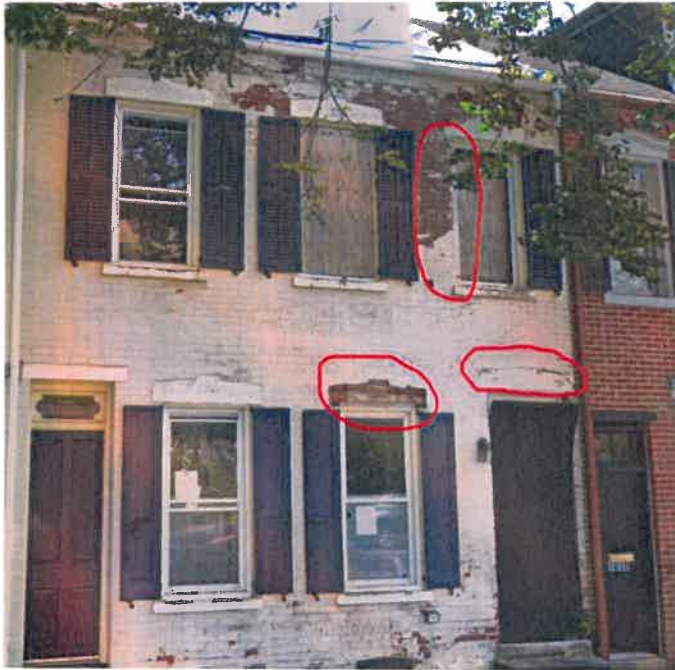
**Front Elevation, Missing Window Header (Previous Application)**

- There were originally two entry doors to the building along Chew Street. A fiberglass door with a fan lite has been installed at the right entry, which is not appropriate in configuration. A four-panel door that matches the original shown in the previous application would be appropriate. The left side entry door has been removed entirely, and while there is a recess where the doorway and transom were, the door and transom were removed and the opening bricked in and painted. This is not an appropriate treatment.

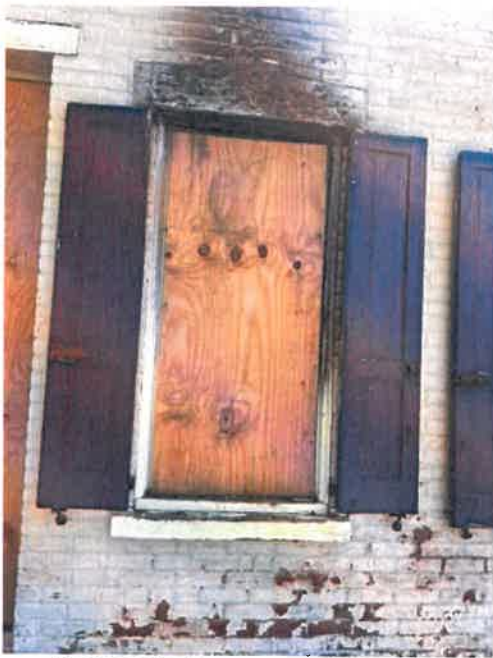
**Existing Window (Previous Application)**

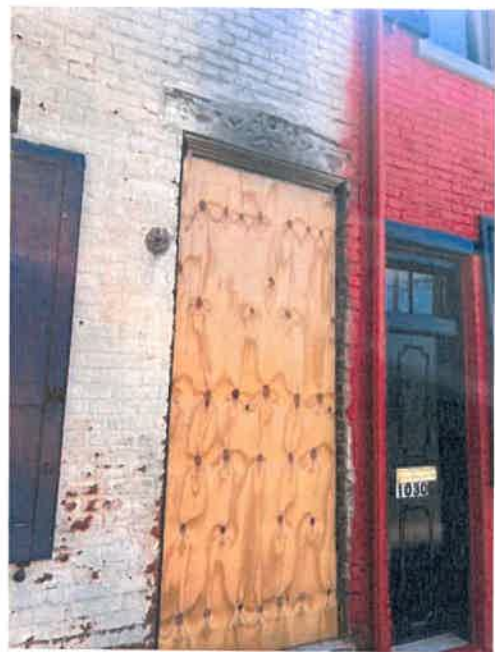
**Existing Entry (Previous Application)**

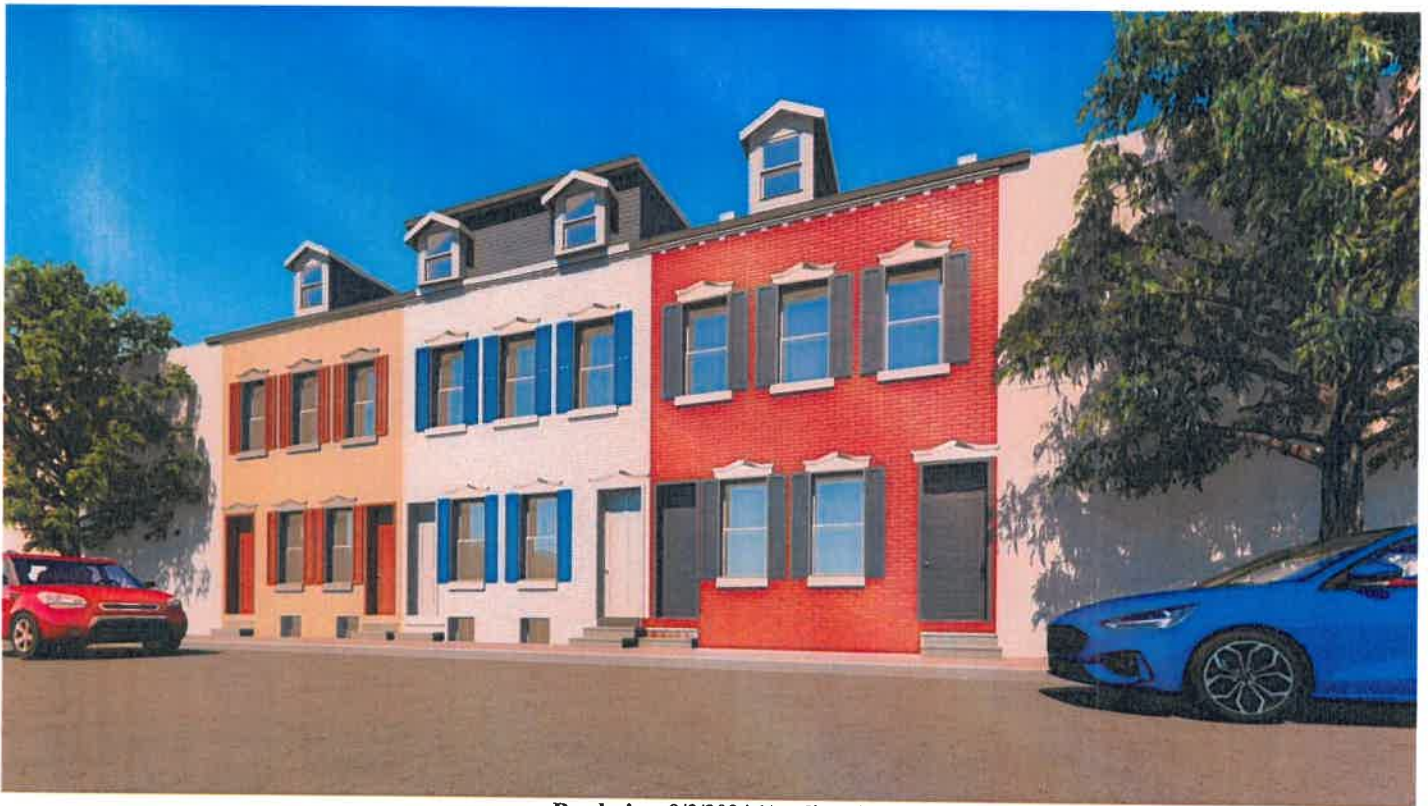
Rendering, 9/3/2024 (Applicant)

- Windows protruding from the third-floor addition, to allude to the geometry of neighboring dormers
- Modified materials at the third-floor addition walls to replace the vinyl siding. More information is needed to comment on the proposed alternate material.
- Paneled doors at the main entry and grocer's alley

While these proposed modifications do not eliminate or reduce the third-floor addition, the applicant appears to be taking steps to mitigate the negative effects of the new work.

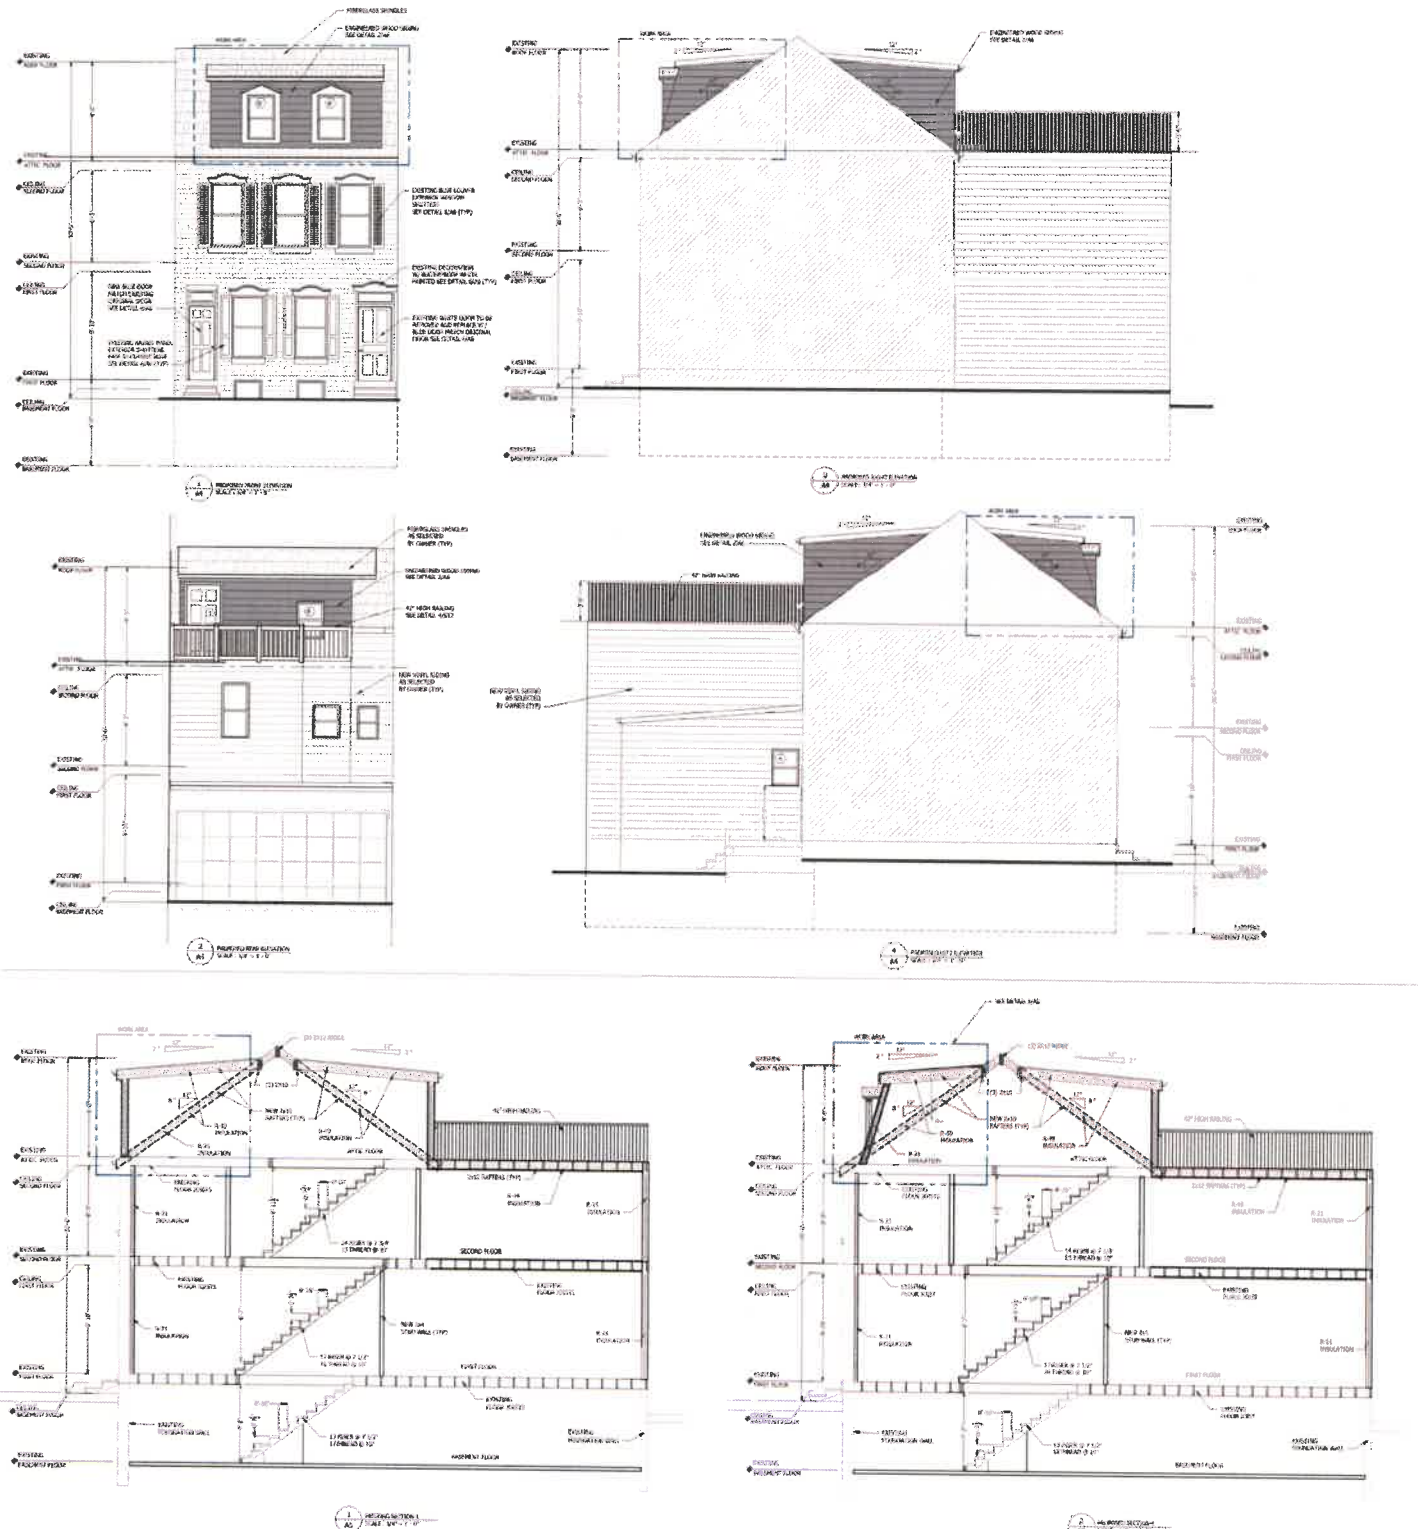
- The third-floor addition is proposed to be modified, including relocating the windows, adjusting framing so that the windows appear to have a configuration closer to a traditional dormer, and revising the vinyl siding to engineered wood siding.
- A 6-panel door is proposed to be installed at the historic baker's alley.
- A 5-panel entry door is proposed to replace the previous door with fanlite.
- The engineered wood siding is proposed to be the cladding on the third floor addition at the rear.

While these proposed modifications do not eliminate or reduce the footprint of the third-floor addition, the applicant appears to be taking steps to mitigate the negative effects of the new work. The third-floor addition does not maintain the original configuration of the dormer. Per Guidelines Section 4.1.9 (Additions to Existing Buildings), "dormer additions should not overwhelm the historic roof and should be scaled to preserve the predominance of the original roof form. New dormers are inappropriately large if they span from end to end of the original roof or if they reach from eave to ridge, or if they occupy the majority of the roof slope's area. New dormers on primary facades are rarely appropriate."
