## CITY OF ALLENTOWN

**R130 – 2023**

#### **Certificate of Appropriateness for work in the Historic Districts:**

## COA Final Review Sheet

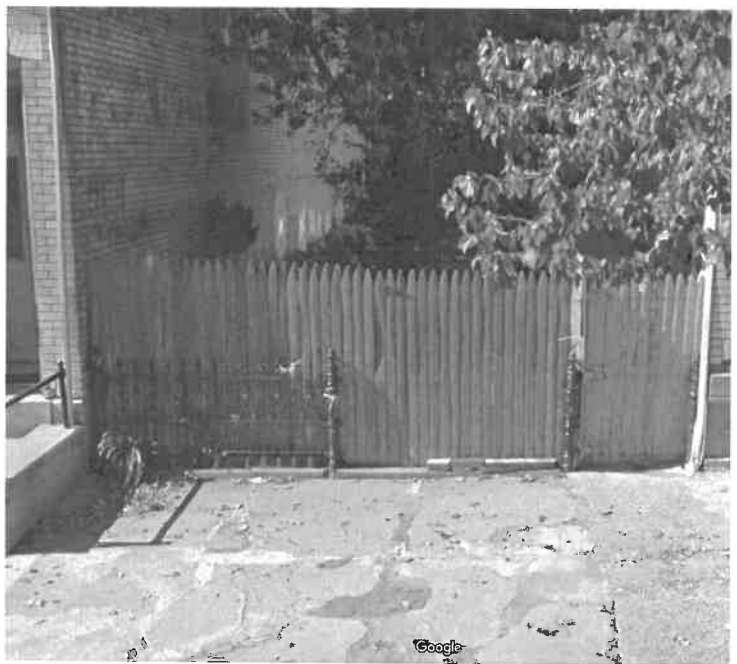
**Detail of wrought iron and wood fencing, 2014.  
(Google StreetView)**

The previously installed wood privacy fence had been in place behind the historic wrought iron fence for approximately ten years. The 2014 photo shows both fences, and staff notes that a large section of the wrought iron fencing was missing at that time. While the design guidelines advocate for in-kind replacement of historic fences, they also allow for wood shadow box or picket fences, provided primary or highly visible facades are not obscured. In this case, the fence encloses a side yard and does not significantly impact the building's facades. Staff finds the proposed wood privacy fence to be acceptable, provided it is painted, since much of the historic wrought iron fence has been missing for approximately ten years.

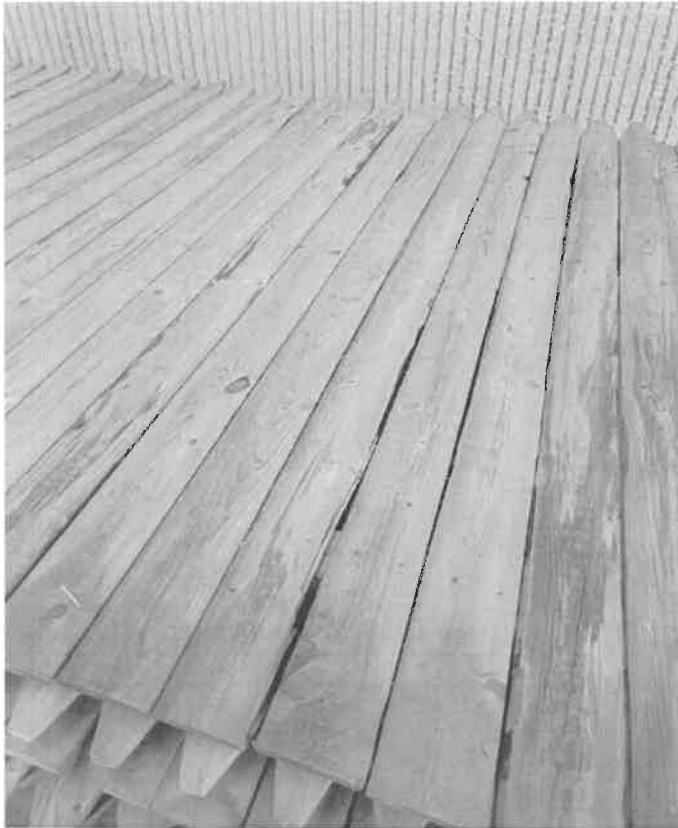
**Proposed wood fence to replace vinyl fence.  
(Applicant)**

Approval, provided the fence is painted and with the staff to review details, pursuant to Chapter 3, Section 3.12 Fences & Streetscape Features.

The HARB recommended following the guidelines as closely as possible and suggested changing the vinyl fence to either a picket fence or shadow box fence. The HARB discussed the proposed wood stockade fence and agreed it would be acceptable with the pointed ends either placed in the ground or squared off at the top. The HARB agreed that the fence should be painted to meet the guidelines.

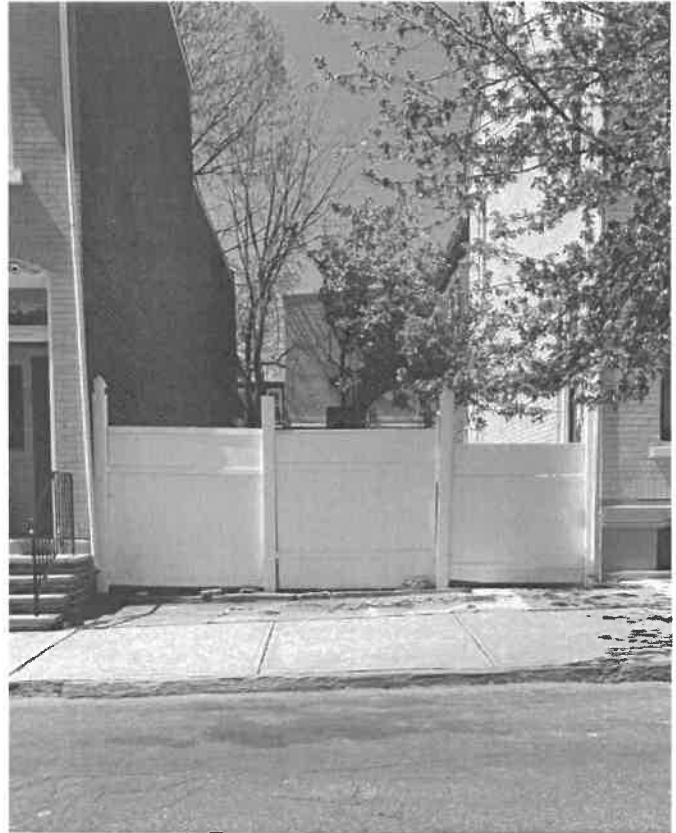
On May 12, 2023, staff issued a notice of violation for the installation of a vinyl fence where a historic wrought iron and wood privacy fence were previously located. In speaking with the property owner, staff learned that the historic wrought iron fence was stolen at some point in the past. To address the violation, the owner is proposing to remove the vinyl fence and install a 6-foot tall wood privacy fence.

**Vinyl fence installed without permits.  
(HARB files)**

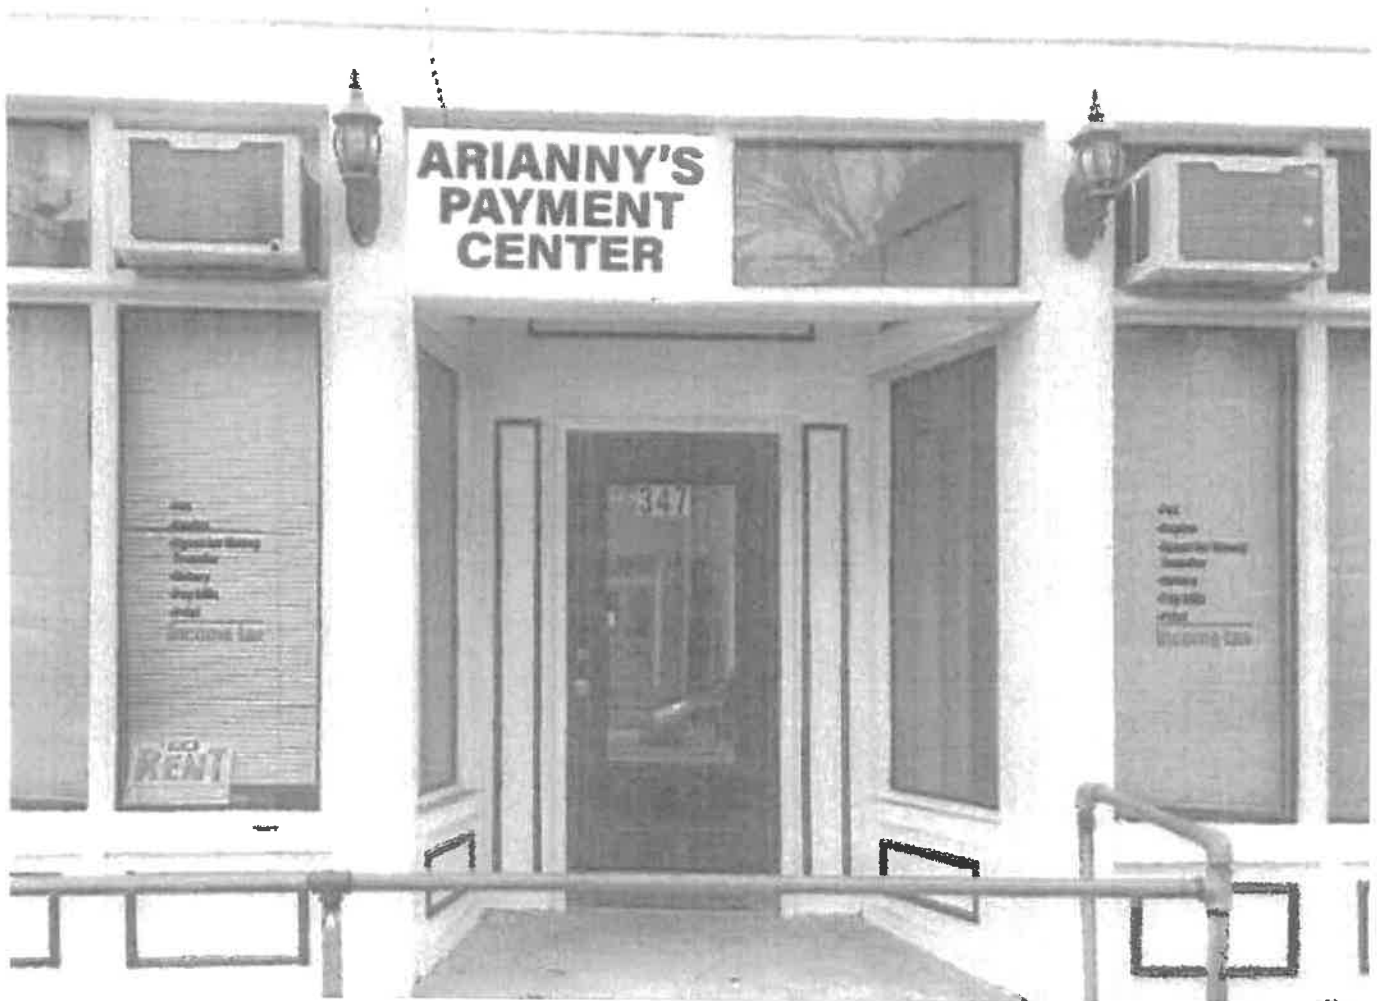
This application proposes to install window signage in three locations within the storefront. Two vinyl decals would be installed on the windows flanking the entrance, and a larger vinyl decal would be installed within the transom.

**Rendering of signage in the three proposed locations of the storefront.  
(Applicant)**

The design guidelines support the installation of surface-applied window signage with transparent backgrounds, because the signage type does not damage historic materials. Staff questions whether the sign in the transom includes an opaque background and suggests that no background color be included. Provided none of the signage includes opaque backgrounds, staff finds the application complies with the design guidelines for commercial storefronts, and more specifically with Guideline 3.13.18.

Approval, provided no signage contains an opaque background, with the staff to review details, pursuant to Chapter 3, Section 3.13 Commercial Storefronts.

The HARB discussed the appropriateness of the proposed signage and inquired whether the sign in the transom would have a transparent or opaque background. Ms. Manzueta confirmed that the sign would have only letters and would include no background. The HARB requested that the lettering be centered across the transom and not contained on one pane of glass so that it was more symmetrical. Ms. Manzueta agreed to the request. The HARB found that the signage complies with the design guidelines.

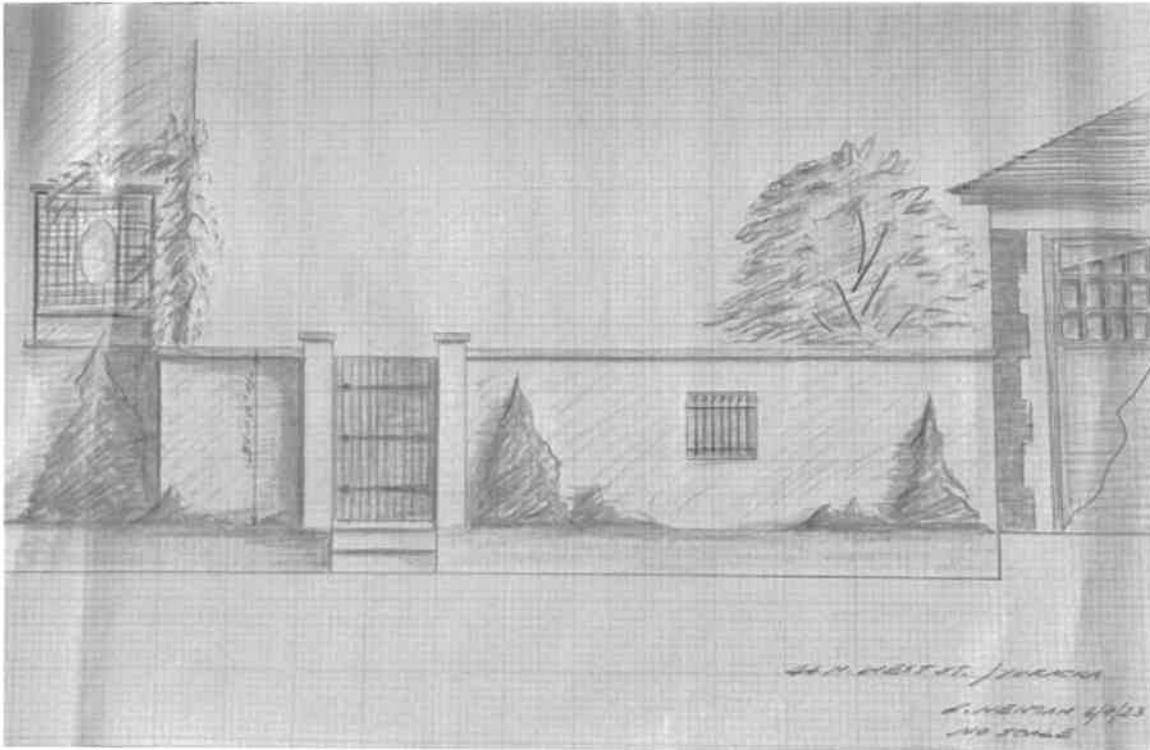
This application proposes to construct a masonry wall clad in stucco along Linden Street where a non-historic wood fence currently exists. The wall would be between 5-feet 4-inches and 6-feet in height and would be located at the rear of the house, terminating at the garage.

**Rendering of proposed site wall.**  
**(Applicant)**

Staff finds the proposed work satisfies the intent of the design guidelines since the masonry wall would match the height of the existing fence and other nearby fences along West Street, complying with Guideline 3.12.7. The wall would be low enough, at a maximum height of 6-feet, so as not to obscure views of the building and would have no impact on the primary façade. The site wall would also comply with Guideline 3.12.12, since it would be constructed of masonry materials and finished to match the historic structure.

The proposed gate is illustrated as being wood with metal strap hinges and is appropriate in material and design.

For final approval, staff recommends that the applicant submit specs and/or cut sheets on the stucco/finish of the wall, cap, and gate.

Approval, with the staff to review details, pursuant to Chapter 3, Section 3.12 Fences & Streetscape Features and the Secretary of the Interior's Standards for Rehabilitation.

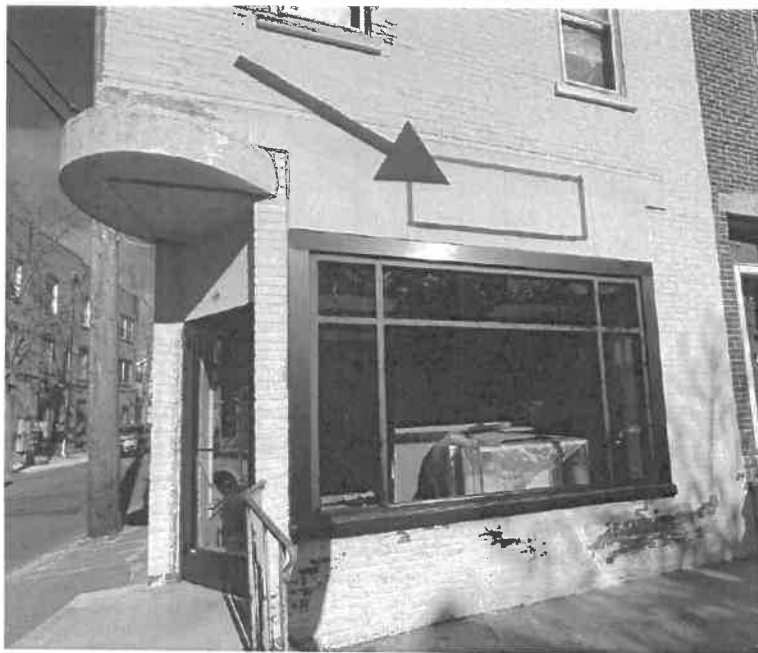
This application proposes to install two non-illuminated 2-foot by 4-foot vinyl signs above the storefront windows of the property at 449 N. 10<sup>th</sup> Street.

Proposed location of signage.  
(Applicant)

The proposed signs comply with Guidelines 3.13.12, 3.13.14, 3.13.15, and 3.13.16, because they would appropriately located above the storefront windows, would be easily reversible with no damage to historic fabric, and are of a size and scale that are appropriate for the building. However, the signs, proposed to be vinyl stickers, do not comply with Guideline 3.13.21, which recommends a high-quality and durable material. However, the guidelines do allow for surface-applied window signs with high transparency in a material similar to what is proposed. Staff recommends one of the following to comply with the design guidelines:

1. Print or paint the signs on wood or metal; or
2. Install surface-applied signs within the transom of the storefront windows.

The HARB discussed where the signage should be installed. Mr. Jordan suggested limiting the signage to the space below the former lintel. Mr. Huber stated that the signage could be installed within the upper pane of glass within the storefront window or on a wood sign above. Mr. Jordan read the staff recommendation, stating that the HARB seemed to be in agreement with the staff, but added that the sign should be centered above the storefront windows but below the former lintel. The applicant agreed to the HARB's comments and presented a revised signage plan that satisfies the design guidelines.

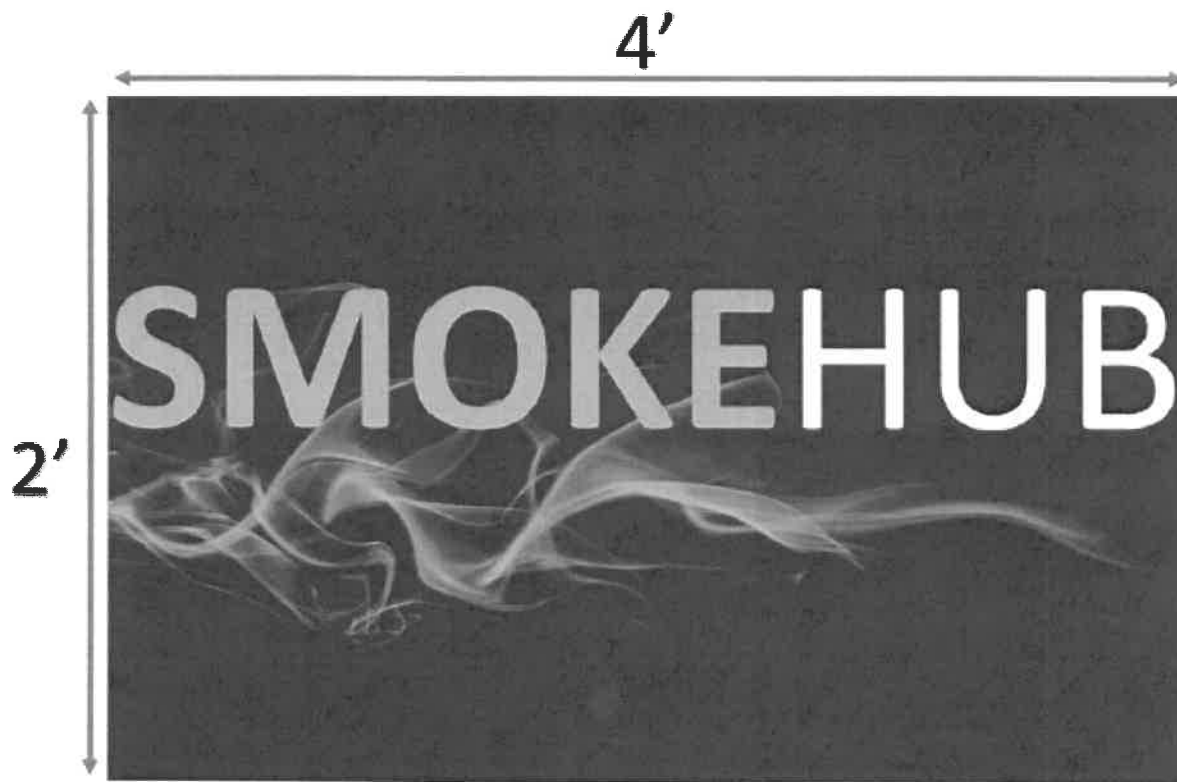
Proposed signage.  
(Applicant)

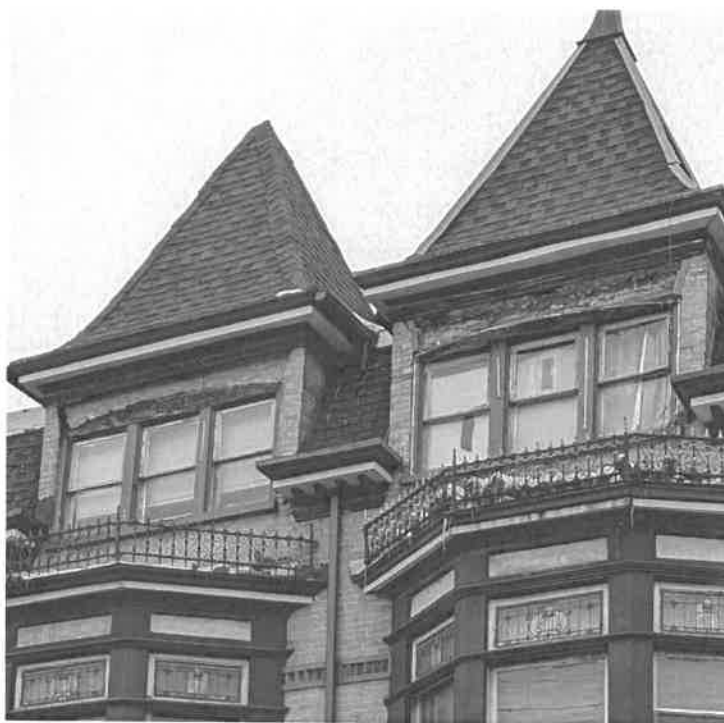
**Photo showing the temporary lintel repair at 747 and the fallen brick at  
the lintel of 745 W. Turner Street, 2022.  
(HARB files)**

The staff issued notices of violation on multiple occasions for the failing brick at the third-story lintels since 2021. In 2021, first and second notices of violation were issued, followed by a court filing in November. Because the court was unable to serve the owner, the court dismissed the case. City staff attempted to reopen the violation by issuing new notices in March and July 2022 and again in May 2023.

The HARB discussed Guideline 3.2.5, stating that the guideline requires replacement features to be replicated as closely as possible in material composition, size, profile, shape, pattern, and appearance. The HARB noted that the wood lintel would need to be curved and that the incised design would need to be replicated. The HARB also noted that the lintels failed at both buildings because of the arch and suggested that the mason investigate a method to properly install the brick and wood lintels to avoid a future collapse.

Mr. Encelowski moved to approve the application presented on 7/10/2023 for the legalization of the removal of the brick and wood third-story front façade window lintels and replacement of the lintels in-kind at the property at 745-47 W. Turner Street, with the staff to review details, pursuant to Chapter 3, Section 3.2 Wood Siding & Trim, Section 3.3 Masonry, and Section 3.5 Windows, with the following conditions as agreed to by the owner:

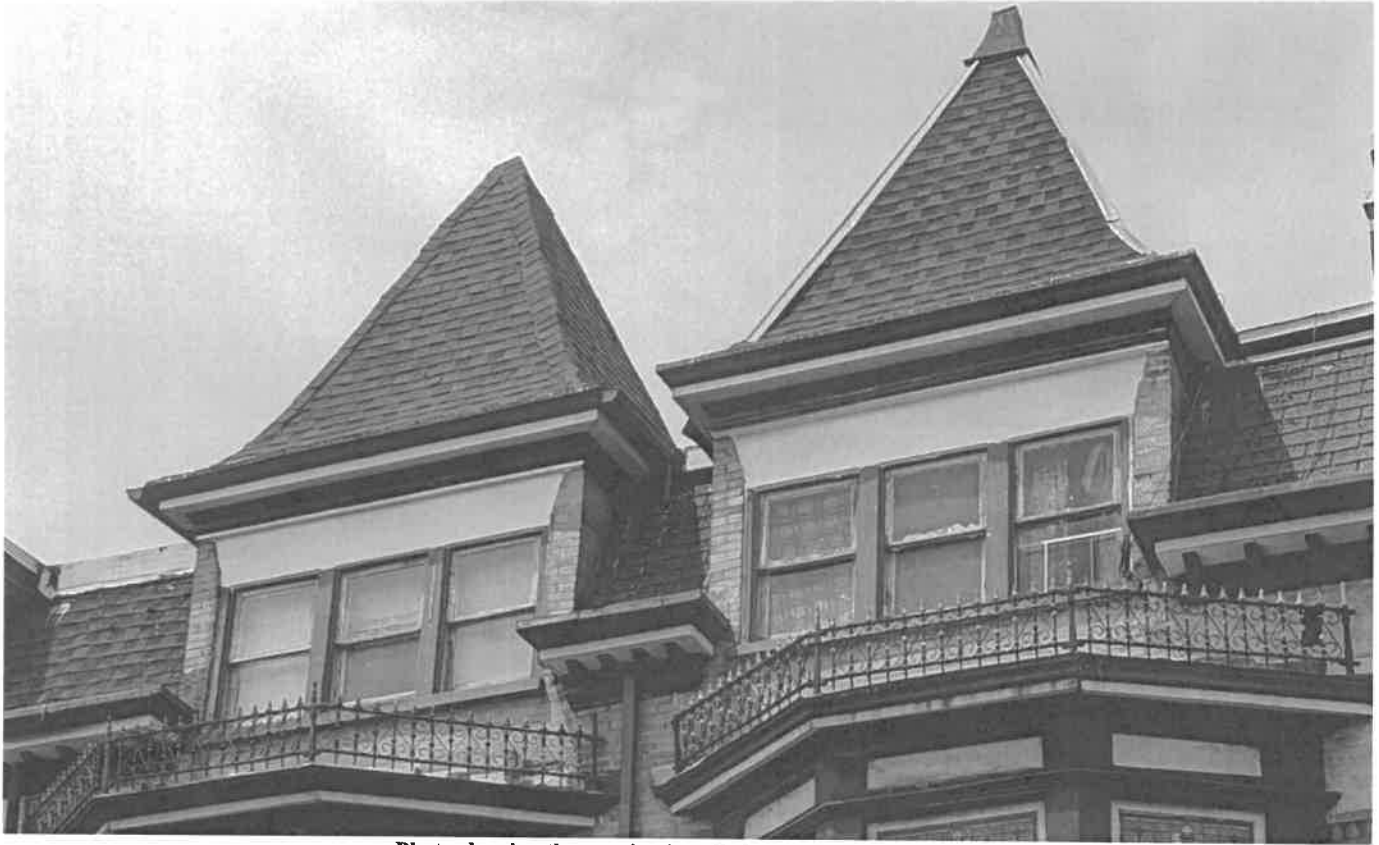
On May 12, 2023, staff issued a notice of violation for the removal of brick lintels and installation of capping at the third-story front façade windows of 745-47 W. Turner Street. This application seeks to legalize the work.

**Photo showing the capping installed over the lintels, 2023.  
(HARB files)**

The removal of the brick and wood lintels and installation of metal capping does not comply with the design guidelines. The guidelines recommend in-kind replacement and advocate against installing any type of capping, per Guideline 3.2.6.
