**CITY OF ALLENTOWN
HISTORIC ARCHITECTURAL REVIEW BOARD
FINAL REVIEW SHEET
June 4, 2018**

Case # HDC-2018-00018– Proposal to continue the installation of vinyl fence on side of property

Property located at: 25 N 15th St.

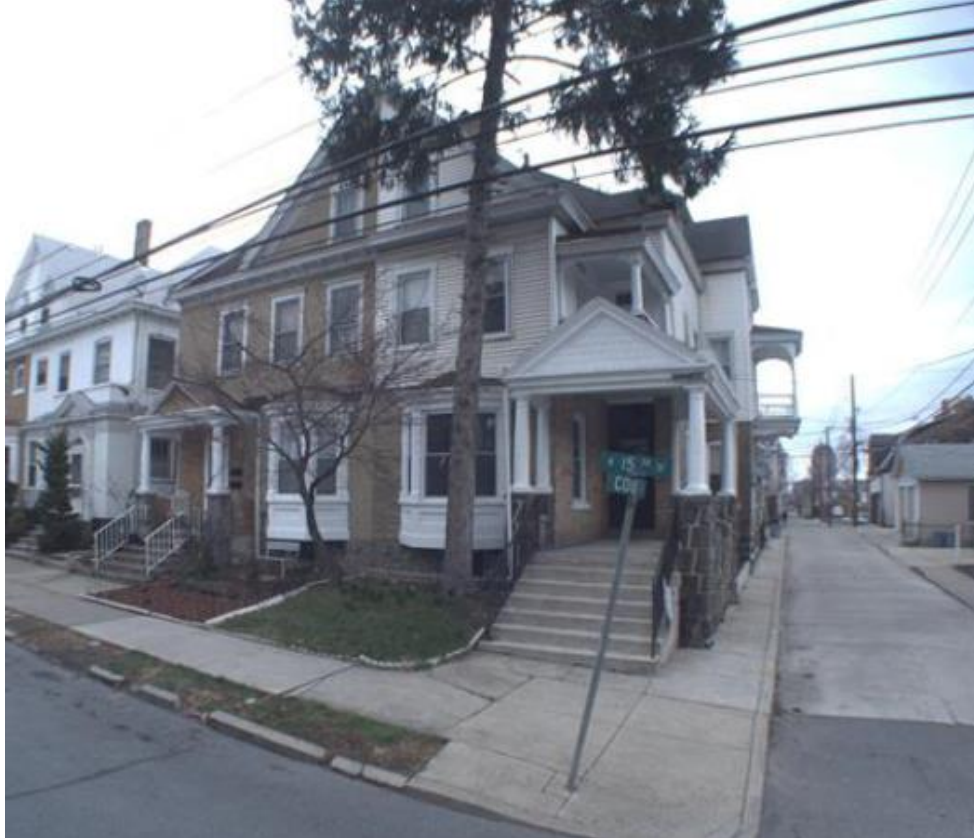
Building description, period, style, defining features: This structure is a 2 1/2 story, semidetached brick dwelling with hipped roof, a large, shared, front facing gable, corner porch with setback entry, balcony above the corner porch, cantilevered side balcony, 1 over 1 windows with front third floor window with arched transom with tracery, Doric columns on stone porch knee wall and piers, and siding covering the upper levels and rear. The house dates from c. 1910 and is Free Classic Queen Anne in style. Although the house has been altered with siding over the parts of the brick facades, it retains integrity. At the side of the property is a character defining wrought iron fence.

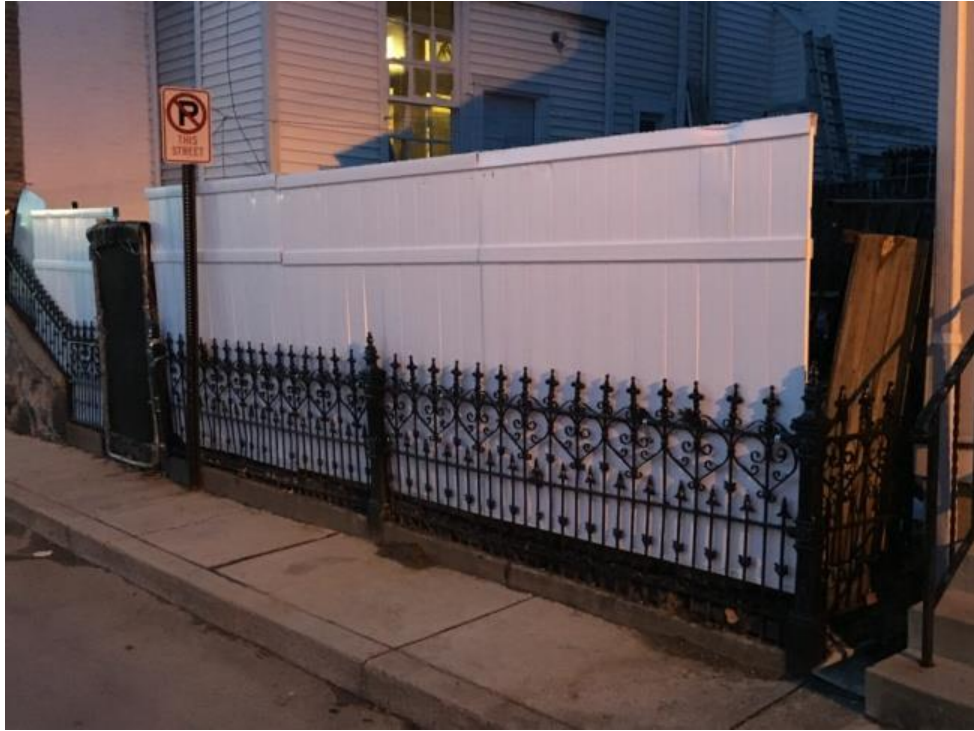
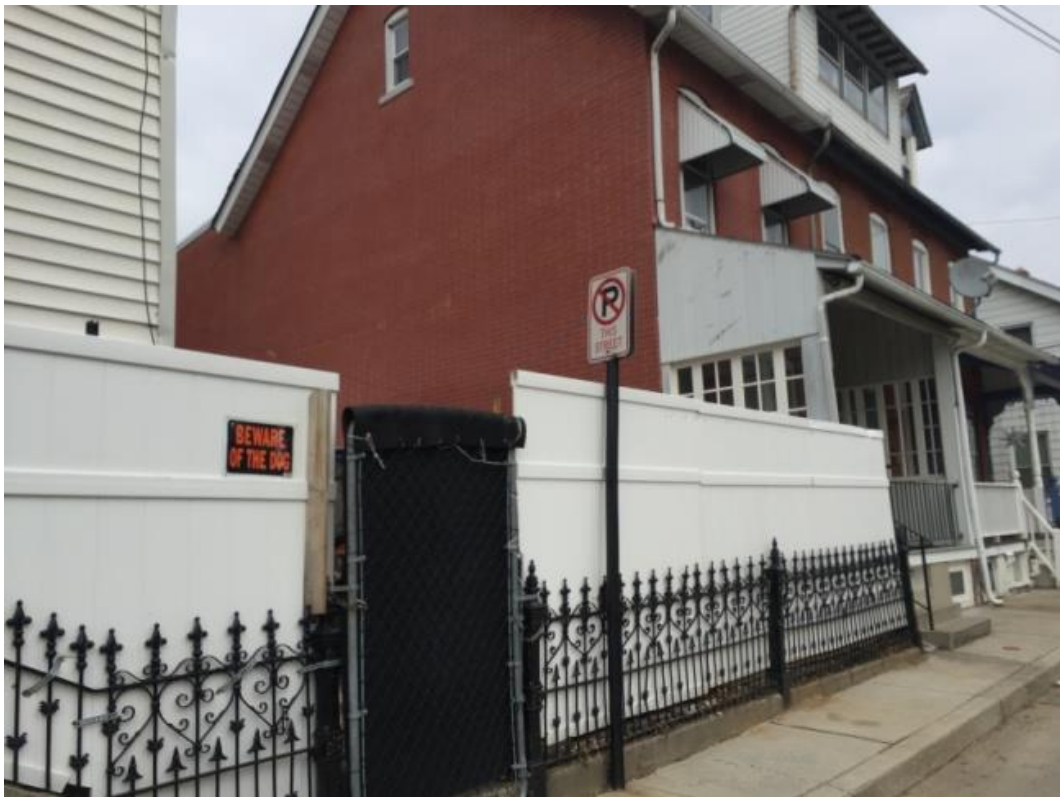
Proposed alterations: It is proposed to continue the installation of vinyl fence on side of property. The vinyl fence has been installed by attaching to the historic wrought iron fence and installing a chain link fence gate in place of the wrought iron gate.

Evaluation, effect on historic district, recommendations: The installed fence is not historically appropriate, nor does it appear to be safely erected. Vinyl fencing is not permitted in the historic district nor is the chain-link gate. As noted in the guidelines:

A wood vertical board fence, professionally installed with proper wood gate would be historically appropriate. Proper concrete footings and foundations would be necessary to support the fence. It is suggested that the fence be set back from the historic fence by approximately 3' (or more) so that it would meet with the neighboring building without a return, or perhaps be placed inward of the basement bilco type door. This set back might also allow the wrought iron fence gate to be reinstalled. The wood fence would also have a gate so there would be added distance and protection for the dog and passersby. A new fence should be stained and finished to better resist weather. The existing concrete paving would be visible between the two fences.

1. The proposal to continue the installation of vinyl fence on side of property at 125 N 15th Street was presented by Wilfredo Paniagua.
2. The vinyl fence must be replaced with a dog-eared wood fence no more than 6' high with proper foundations. It is recommended that the fence be stained to resist weather.
3. The fence will be set back approximately 3' from the existing historic ornamental iron fence. A site visit will be done by Mr. Kimmerly and Historic Consultant (if needed) to determine the exact placement of the fence around the basement door.
4. The original gate must be reinstalled.
5. The vinyl fence must be replaced within 3 months of the date of the HARB meeting or September 4, 2018.
