**CITY OF ALLENTOWN
HISTORIC ARCHITECTURAL REVIEW BOARD
FINAL REVIEW SHEET
January 10, 2018**

Case #HDC-2018-00040– Proposal to continue installation of the satellite dish installed on the front of the building.

Property located at: 425 N 10th Street

Case # HDC-2018-00040

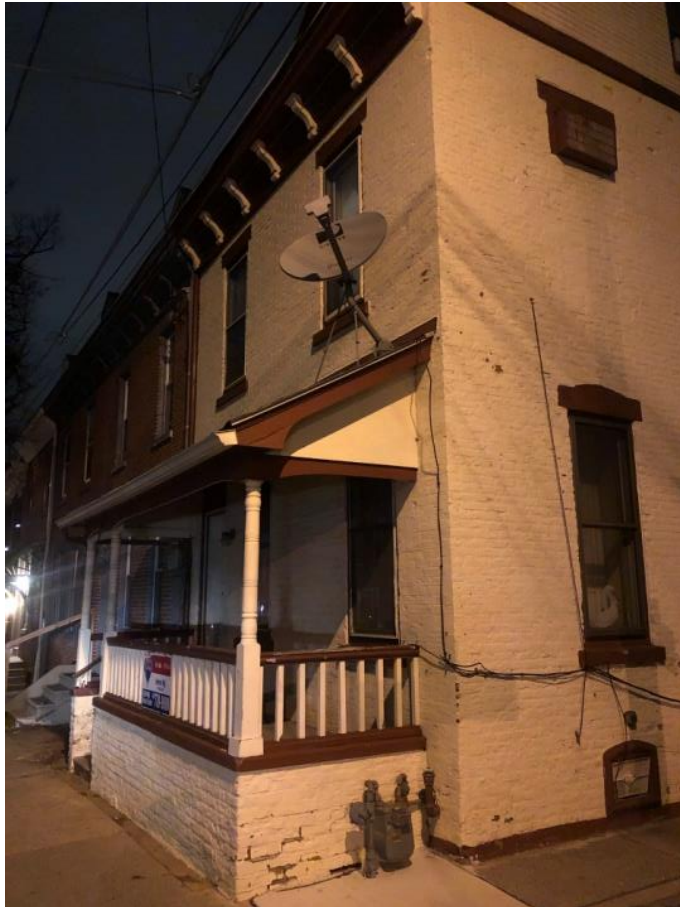
Allentown, Pennsylvania
Google, Inc.
Street View - Oct 2014

Building description, period, style, defining features: This structure is a 2 bay, 2 ½ story painted end-of-row brick dwelling with gable roof, dormer, projecting bracketed cornice, 1 over 1 double hung windows with carved Eastlake lintels, full front porch and full front porch with turned posts and square balusters. The building dates from c. 1895 and is Eastlake in style.

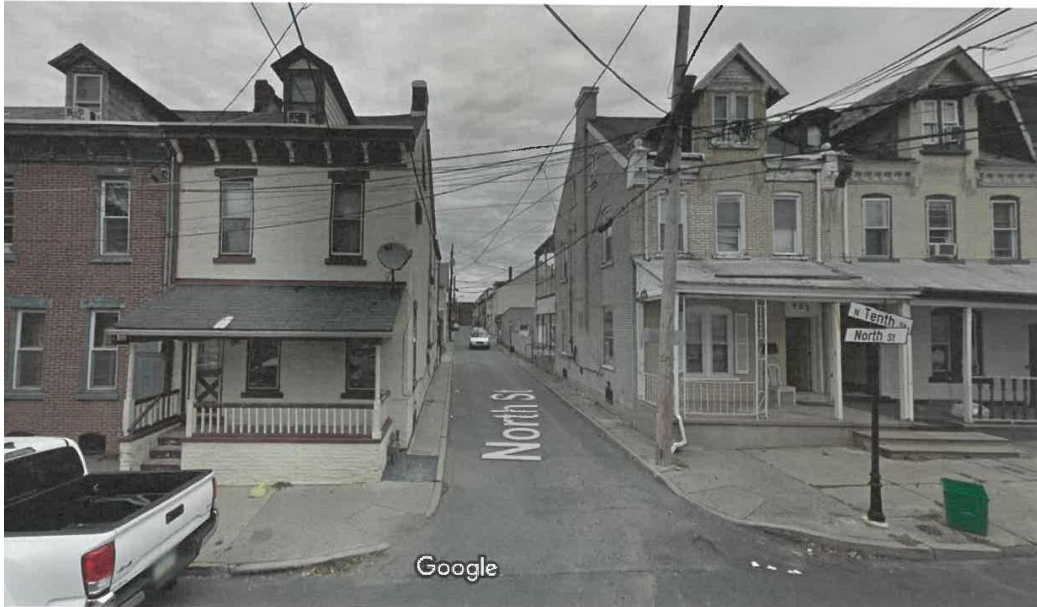
Street View - Sep 2017

Proposed alterations: It is proposed to continue installation of the satellite dish installed on the front of the building.

December 5, 2018 – Satellite dish installed on front of building.

Evaluation, effect on historic district, recommendations: The dish should be removed and relocated to a less visible side (rear).

1. The proposal to continue the installation of a satellite dish on the front of the building at 425 N 10th Street was not represented.
2. The installation is a clear violation of the historic design guidelines and must be removed from the front façade.
3. The satellite dish should be relocated to one of the rear flat roof areas of the building not visible from the street.
