**CITY OF ALLENTOWN  
HISTORIC ARCHITECTURAL REVIEW BOARD  
FINAL REVIEW SHEET  
January 10, 2018**

**Case #HDC-2018-00040**– Proposal to continue installation of the satellite dish installed on the front of the building.

**Property located at:** 425 N 10<sup>th</sup> Street

**Case #** HDC-2018-00040

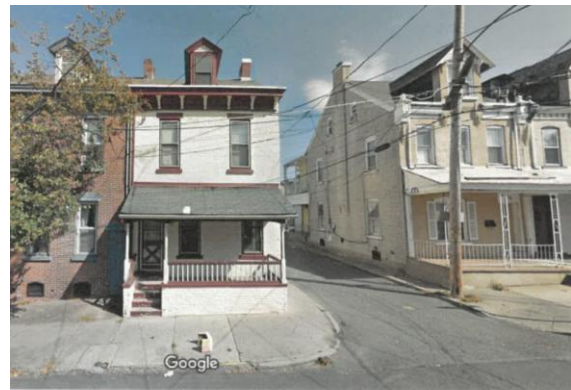
Allentown, Pennsylvania  
Google, Inc.  
Street View - Oct 2014

**Violations:** May 8, 2012 – Installed two satellite dishes on front porch roof. Dishes removed.

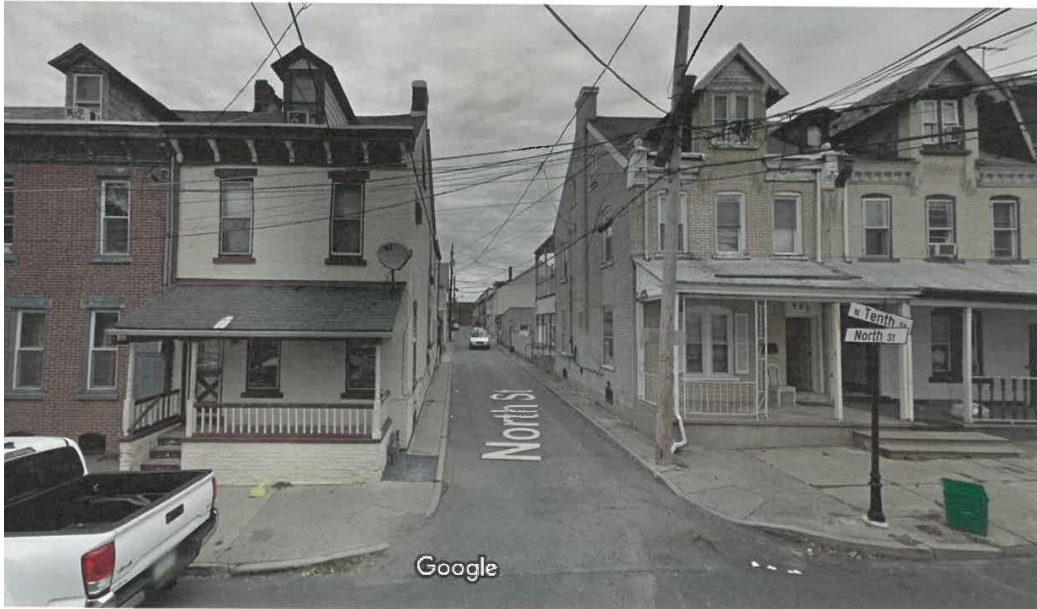
Street View - Sep 2017

**Proposed alterations:** It is proposed to continue installation of the satellite dish installed on the front of the building.

December 5, 2018 – Satellite dish installed on front of building.

**Evaluation, effect on historic district, recommendations:** The dish should be removed and relocated to a less visible side (rear).

1. The proposal to continue the installation of a satellite dish on the front of the building at 425 N 10<sup>th</sup> Street was not represented.
2. The installation is a clear violation of the historic design guidelines and must be removed from the front façade.
3. The satellite dish should be relocated to one of the rear flat roof areas of the building not visible from the street.
