HISTORIC ARCHITECTURAL REVIEW BOARD CITY OF ALLENTOWN, PENNSYLVANIA October 10, 2019 FINAL Review

Item #1 - Case # HDC-2019-00054 - Proposal to continue alteration of cornice

Property located at: 339 N 8th Street Property Owner: Thomas Gilman

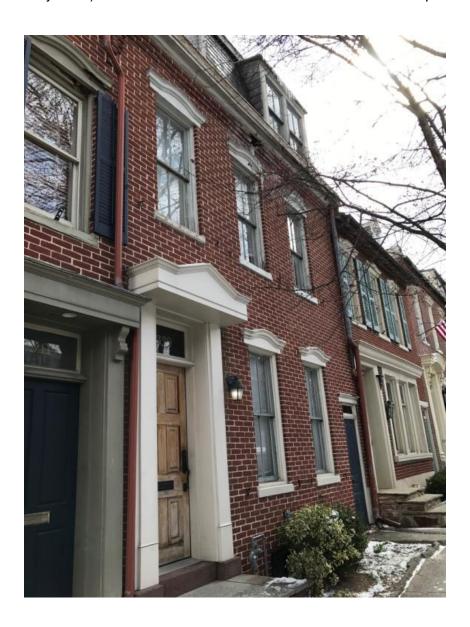
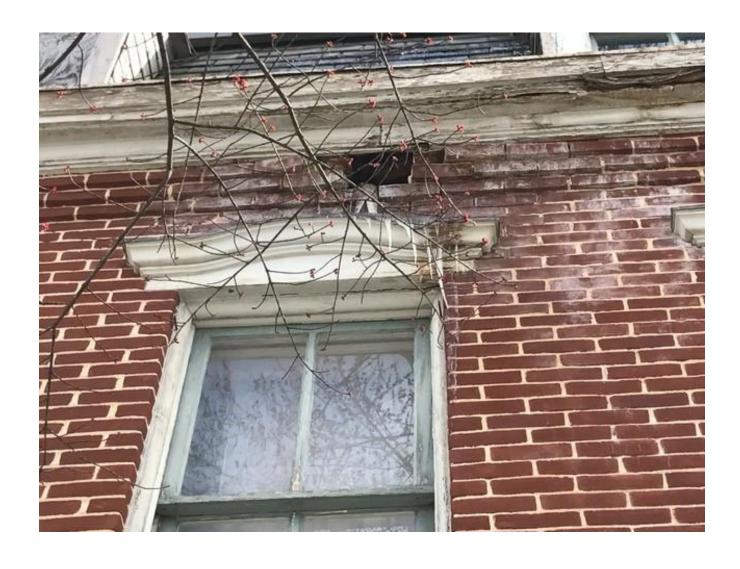
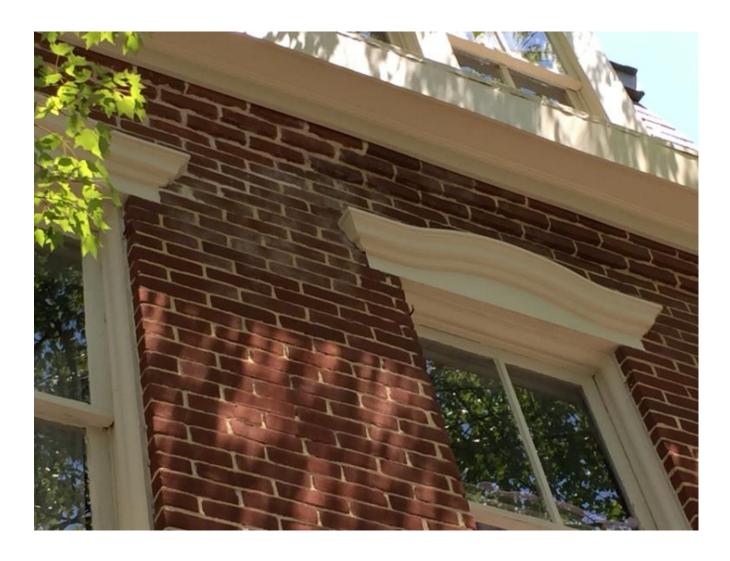
Building description, period, style defining features: This structure is a 3 bay, 3 story, attached red brick dwelling with Mansard roof, simple shed-roofed dormers, built-in gutter system with wood fascia and soffit (most likely altered in a façade renovation in1997), corbeled brick cornice, 2 over 2 double-hung windows with arched headers, and entry with altered door surround (also likely 1997). The house dates from c. 1876 and is Second Empire in style.

Evaluation, effect on historic district, recommendations: From older photographs provided it appears that this building had been drastically altered a decade or more before 1885. A drawing provided showed plans for renovation that appear to have been carried out in 1997. The wood fascia and soffit dated that was replaced dated from that time. The replacement fascia and soffit proposed to be retained and approved differs from the non-original fascia and soffit in the size/scale of two items: the fascia is no longer stepped and larger (by 1") and the decorative molding below the soffit is smaller (1 ¾" instead of 3 ½"). Given the non-original condition of the replaced fascia and soffit the HARB may want to consider permitting the latest replacement to be retained or to require, possibly, the replacement of the molding below the soffit which is likely the most visible aspect of the cornice from the viewpoint of the pedestrian.

- 1. The proposal to continue alteration of cornice at 339 N 8th Street was represented by Tom Gilman.
- 2. The existing modification of the flat cornice will be modified by adding an appropriately scaled crown molding (about 4") at the top of the flat fascia.
- 3. Rot resistant species of wood or composite molding may be utilized.
- 4. The chosen molding must be reviewed by City staff or Historic Consultant for appropriate scale and detail.
- 5. The new molding must be installed by 30th May 2020. The proposal to recommend a COA was unanimously approved. (7-0; motion carried; Brobst, Fillman, Huber, Jackson, Olson, Roberts, Sell)
