**Historical Architectural Review Board
COA Final Review Sheet**

HDC-2023-00028

Address: 604 N. 6th Street

Proposal: Legalize cement repair at steps (violation correction)

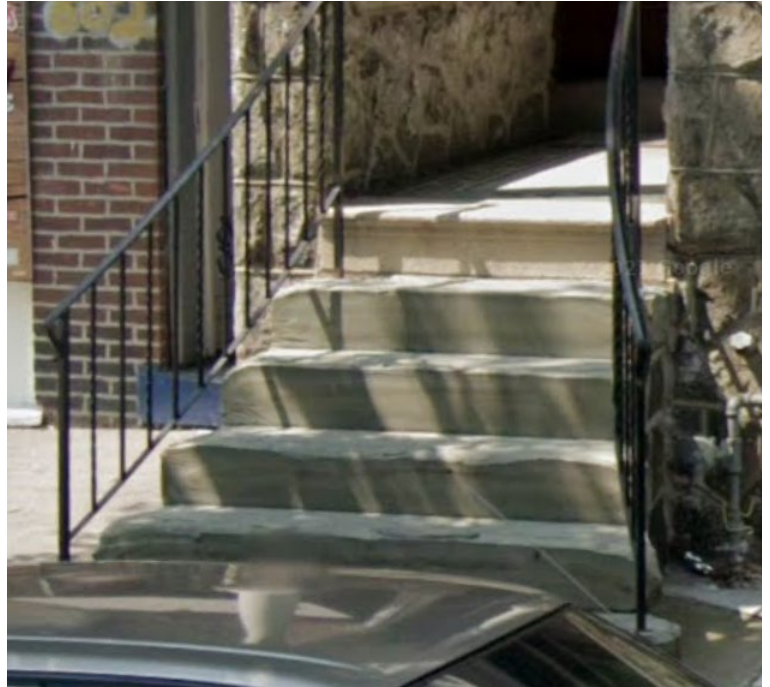
**Detail of the stone steps prior to the concrete repair, 2021.
(Google StreetView)**

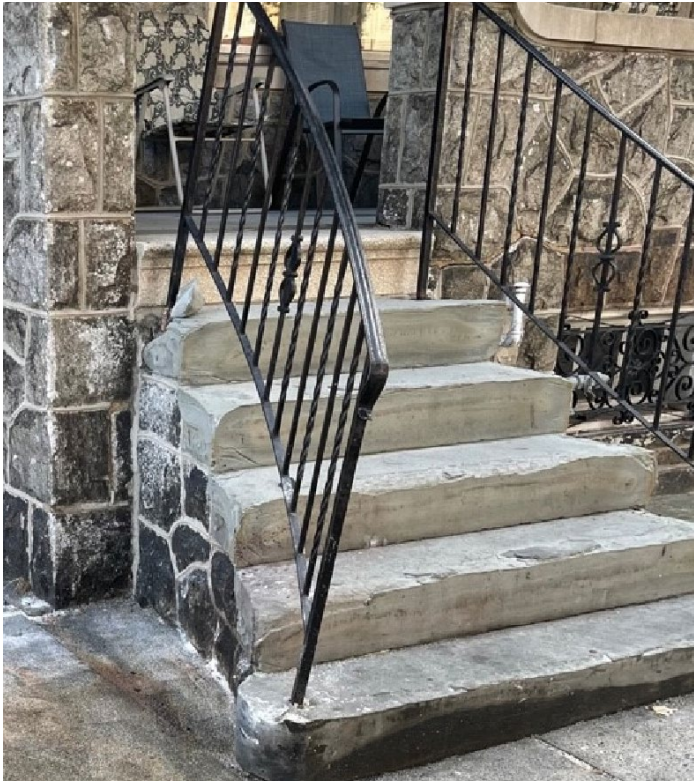
**Photo showing the damage sustained following an accident before the coating was applied.
(Applicant)**

The owner contends that the steps have sustained repeated damage from car accidents and noted that accidents occurred on September 11, 2021, and again on May 12, 2022. In both cases, the accidents resulted in significant damage to the steps and railings. The cementitious coating was applied as an emergency repair to the steps to address localized loss of stone and displacement of the railings.

The cementitious repair does not comply with the design guidelines. For the type of repair needed to address the damage at the steps, Guideline 3.3.3 advises undertaking either a Dutchman repair, which would be recommended for substantial loss where the railings attach to the steps, or a patch with a compatible compound. Staff suggests testing the feasibility of removing the cementitious coating from the steps to determine whether removal would result in additional damage. If removal is possible, staff recommends a combination of Dutchman repairs and a patching compound such as Jahn Mortar by Cathedral Stone.

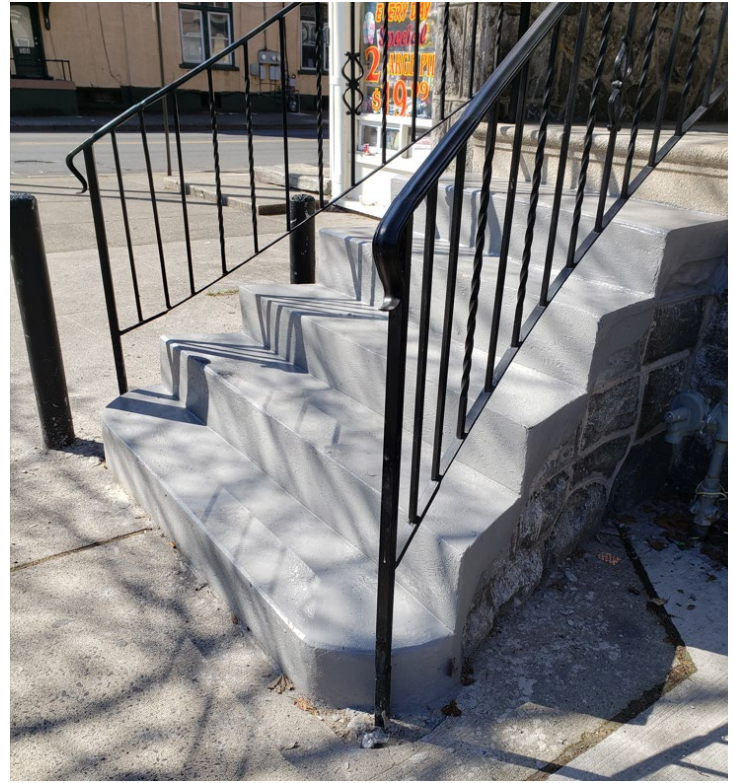
**Detail of the stone steps following the cement repair, 2023.
(HARB files)**

Denial of the legalization of the cementitious coating, provided removal does not result in further damage, pursuant to Chapter 3, Section 3.3 Masonry and Section 3.7 Porches & Steps. If the coating cannot be removed without causing damage, staff recommends approval of the coating, with the stipulation that an appropriate repair be made when the current coating fails; appropriate repairs include installation of Dutchman repairs in a matching stone and patching with a compatible patching compound.

The HARB agreed with the staff recommendation and discussed the feasibility of removing the cement coating from the limestone treads, questioning whether removal would cause damage to the steps. Mr. Vargas stated that a binder was used to adhere the cement to the steps, and the HARB expressed concern that removal would lead to significant damage. The HARB commented that the steps were painted with an inappropriate high gloss paint in a poorly matched color and requested that an appropriate flat paint be used to match the color and texture of the top riser of the steps.

Mr. Lichtenwalner moved to approve the application presented on 6/5/2023 for the legalization of the cement repair at the steps of 604 N. 6th Street, with the staff to review details, pursuant to Chapter 3, Section 3.7 Porches & Steps, with the condition that the steps be painted with an appropriate paint to match the upper riser. Mr. Encelewski seconded the motion, which carried with unanimous support.
