# Historical Architectural Review Board

## COA Final Review Sheet

**HDC-2023-00029**

**Proposal:** Replace vinyl fence with wood fence (violation correction)

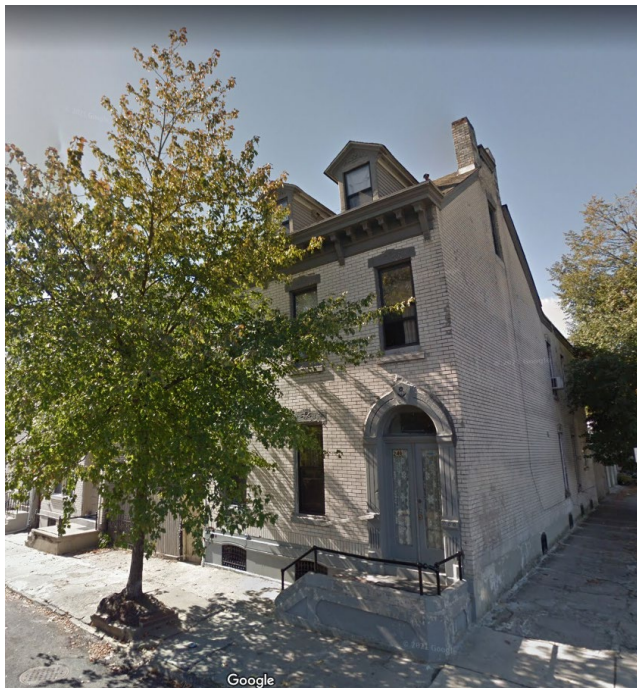
**Front and side façades of 246 N. 11<sup>th</sup> Street, 2019.  
(Google StreetView)**

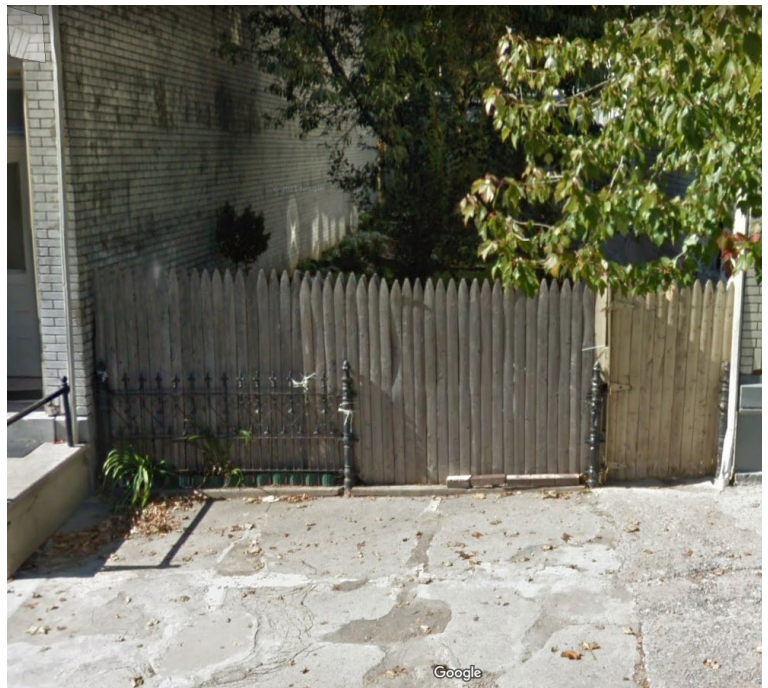
**Detail of wrought iron and wood fencing, 2014.  
(Google StreetView)**

The previously installed wood privacy fence had been in place behind the historic wrought iron fence for approximately ten years. The 2014 photo shows both fences, and staff notes that a large section of the wrought iron fencing was missing at that time. While the design guidelines advocate for in-kind replacement of historic fences, they also allow for wood shadow box or picket fences, provided primary or highly visible facades are not obscured. In this case, the fence encloses a side yard and does not significantly impact the building's facades. Staff finds the proposed wood privacy fence to be acceptable, provided it is painted, since much of the historic wrought iron fence has been missing for approximately ten years.

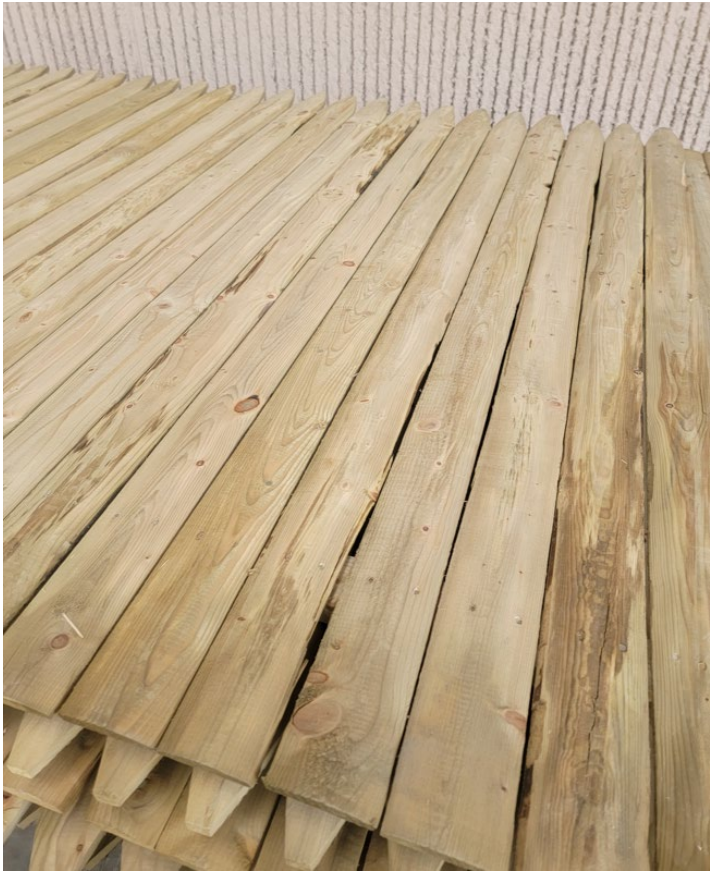
**Proposed wood fence to replace vinyl fence.  
(Applicant)**

The HARB recommended following the guidelines as closely as possible and suggested changing the vinyl fence to either a picket fence or shadow box fence. The HARB discussed the proposed wood stockade fence and agreed it would be acceptable with the pointed ends either placed in the ground or squared off at the top. The HARB agreed that the fence should be painted to meet the guidelines.

Approval, provided the fence is painted and with the staff to review details, pursuant to Chapter 3, Section 3.12 Fences & Streetscape Features.

Mr. Lichtenwalner moved to approve the application presented on 7/10/2023 for the installation of a wood fence at 246 N. 11<sup>th</sup> Street, with the staff to review details, provided the fence is painted and top is squared off, pursuant to Chapter 3, Section 3.12 Fences & Streetscape Features. Mr. Encelewski seconded the motion, which carried with unanimous support.

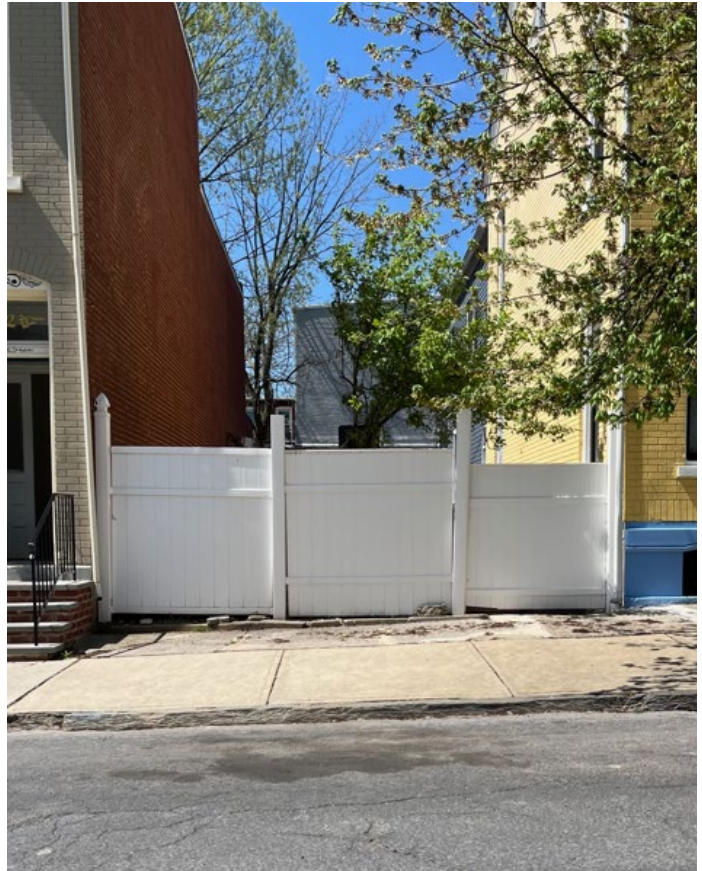
On May 12, 2023, staff issued a notice of violation for the installation of a vinyl fence where a historic wrought iron and wood privacy fence were previously located. In speaking with the property owner, staff learned that the historic wrought iron fence was stolen at some point in the past. To address the violation, the owner is proposing to remove the vinyl fence and install a 6-foot tall wood privacy fence.

**Vinyl fence installed without permits.  
(HARB files)**
