HDC-2022-000XX (Temporary HDC-2022-2023)

Address: 430.5 N. 10th Street

HARB Meeting Date: May 02, 2022

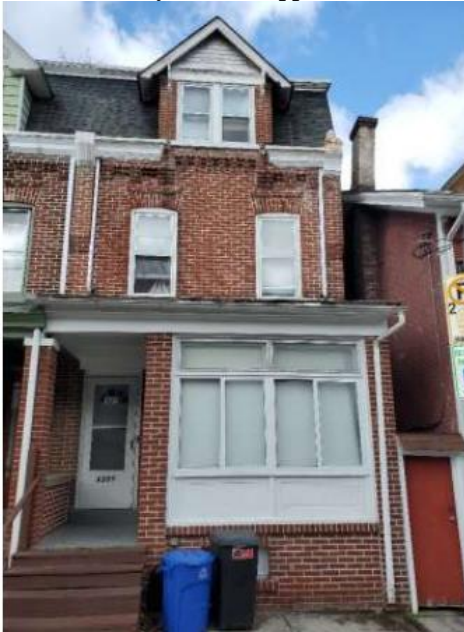
Primary Facade (Applicant)

Provided by Applicant: Replacement of eight (8) lead-based paint hazard deteriorated windows with new aluminum clad windows. (Two - 2nd floor front, two - 3rd floor front, one - 2nd floor side, one - 2nd floor rear, and two – 3rd floor rear).
Noted from Supplied Materials: The scope of work notes that new windows will be fit to existing openings and new screens will also be installed.

TA stated the current condition of the windows in the scope of work are presenting a potentially hazardous condition at the level of deterioration they exhibit.

Repair and reuse of wood windows, or in-kind replacement, are the most appropriate treatments. Aluminum-clad wood windows are an acceptable alternate material per Guideline 3.5.9. The proposed replacements are 1/1 double-hung, which match the existing configuration and operation, and will be fit to the existing opening. These factors are consistent with the Guidelines.
