Historical Architectural Review Board
COA Preliminary Review Sheet

HDC-2025-00008

Address: 1528 Linden Street

Proposal: Violation correction - Vertical platform lift installation with landing infill and railings.

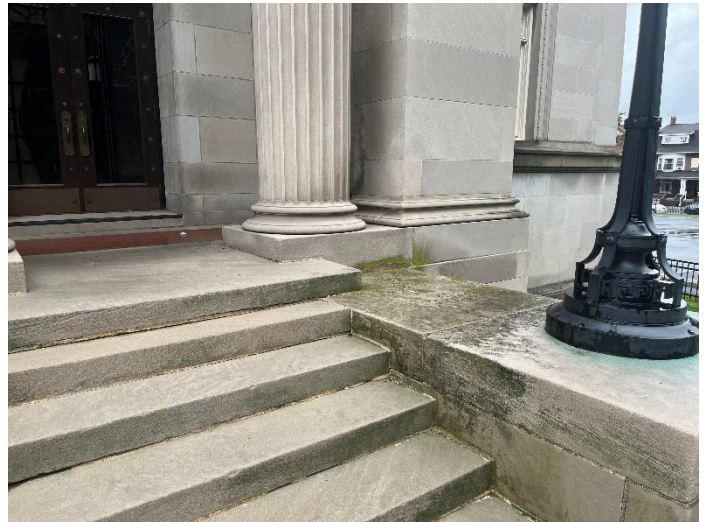
Original Top Landing Area (Applicant)

The Guidelines recommend considering provisions for reversibility so that modifications can be easily removed without damaging historic fabric in the future. It appears in the photos that concrete was built up over the existing stairs and tiled entryway. Any future removal of this concrete may compromise the integrity of the historic materials.
