Historical Architectural Review Board COA Preliminary Review Sheet

HDC-2025-00010 Address: 419 N 9th Street District: Old Allentown Historic District Owner: Archana Gujjari and Kiran Kumar Nalla Applicant: Owner Proposal: Window replacement at front and rear

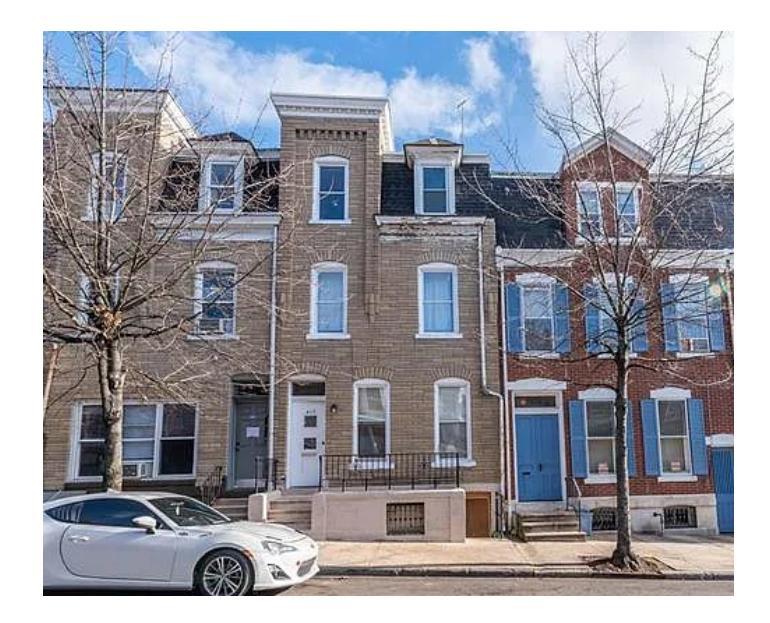
Project Description: Replace four windows facing 9th Street, and one rear window only visible from the side. Decrease the size of the first floor 9-lite window in the rear. The existing windows show significant signs of wear, including drafts, rotting wood, and difficulty in operation. Replacing them will improve energy efficiency, structural integrity, and overall safety while preserving the historical aesthetics of the property.
