**Historical Architectural Review Board  
COA Preliminary Review Sheet**

**HDC-2024-00028**

**Address: 825 W Gordon Street**

**Proposal: Replace front door**

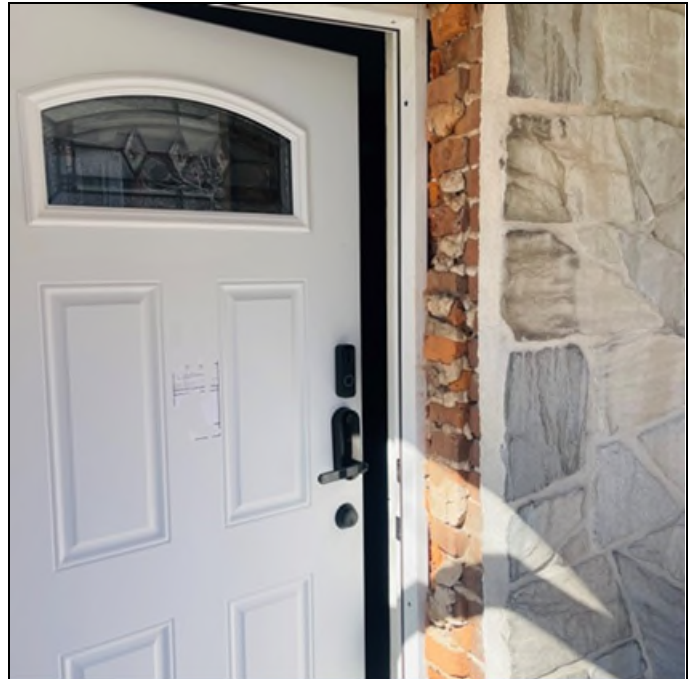
**Proposed Door Exterior (Applicant)**

**Observations & Comments:** If the door is beyond feasible repair, replacement with the proposed metal door is not historically appropriate. Ideally, the wood door with original, character defining detailing would be retained and repaired. This door contains an immense amount of character defining features, including the bottom panel detailing. From the photographs, it does not appear that the door material is in poor condition, so perhaps upgrades to the hardware and/or weatherization is more appropriate, instead of replacement.

**Staff Recommendation:** It is recommended to deny the application. The original door should be retained if at all possible.
