**Historical Architectural Review Board  
COA Preliminary Review Sheet**

**HDC-2025-00102**

**Address: 521 N 6<sup>th</sup> Street**

**Proposal: Remove and install new decorative paneling around second floor bay window (Violation Correction)**

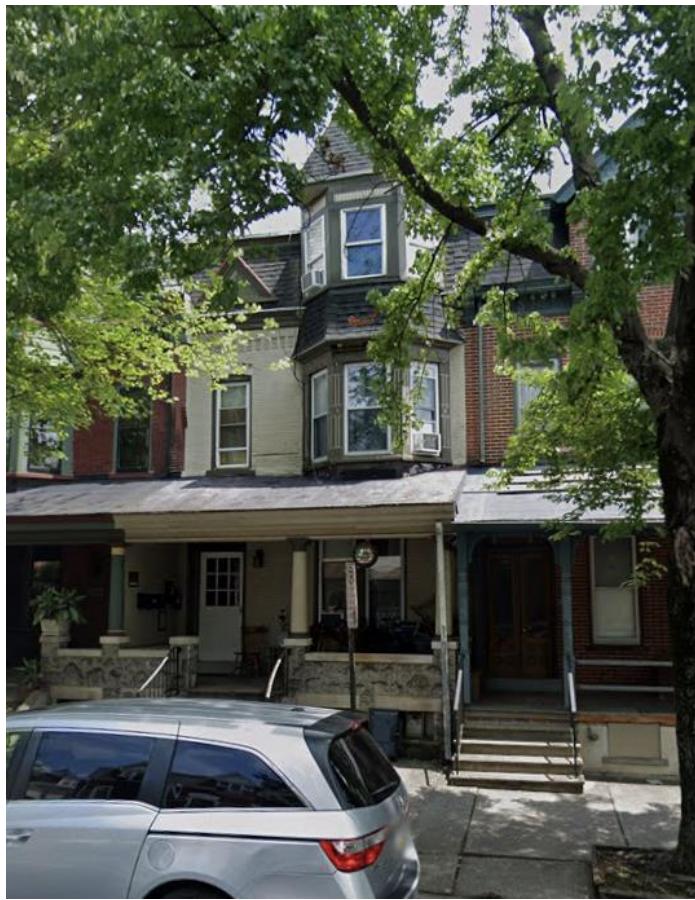
Front Elevation, July 2024 (Google Maps)

From application: The existing exterior window panels and surrounding wood components exhibit deterioration, including rot in multiple locations. In addition, sections of the soffit board are missing, leaving the assembly exposed and vulnerable to further damage.

The scope of work includes the careful removal of all deteriorated and damaged wood elements around the affected window areas and soffits. Any unsound material will be replaced with new pressure-treated lumber where structural integrity or moisture exposure is a concern.

On top of the pressure-treated substrate, new exterior trim boards will be custom carved and installed to match the existing architectural pattern and profile, ensuring visual continuity with the original design. All replacement components will be securely fastened, properly aligned, and prepared for exterior finishing.

- Wood trim replacement material would be cedar, cypress, or mahogany. Final material to be submitted to staff
