## APPENDIX 19

### *Park Pump Station Force Main Inspection Report*

Park Force Main Internal Inspection  
from ARVs 4, 5, and 6

December 22, 2021

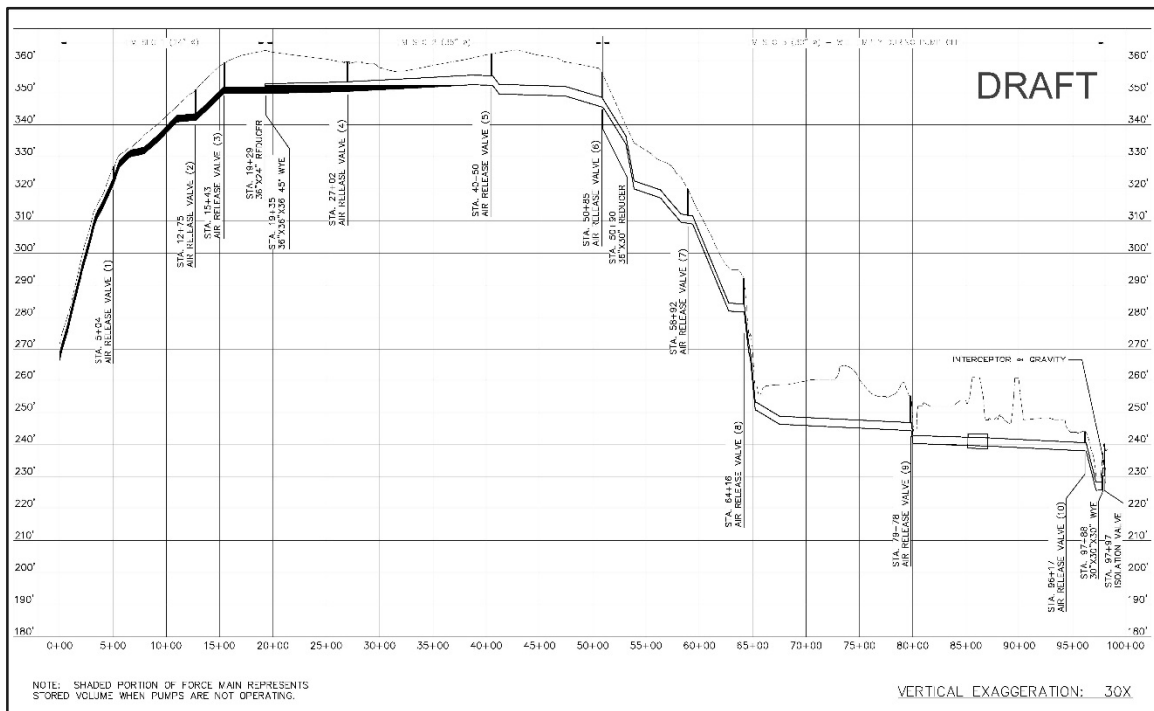
Figure 2: Park FM Consolidated Profile

Figure 2 shows the profile of the PFM. The 10 ARVs are located at 5+04, 12+75, 15+43, 27+02, 40+50, 50+85, 58+92, 64+16, 79+78, and 96+17. Reducers are located at 19+29 and 50+90. Access chambers are located at 70+16 and 91+04. The wye is located at 19+35.

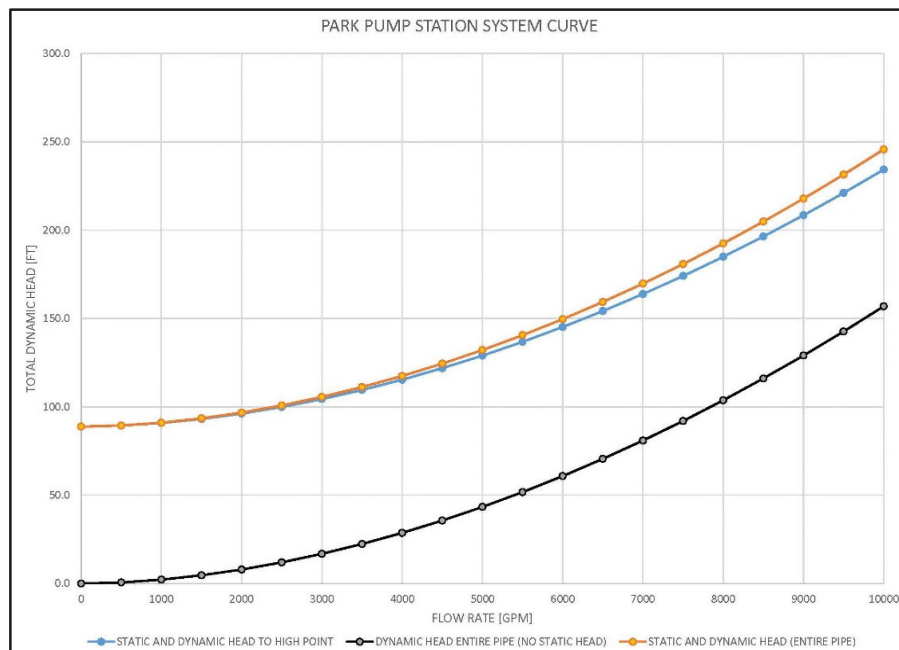
Figure 3: Park Pump Station System Curve

The PFM system curve, assuming no loss of diameter due to deposits, no increase in diameter due to liner loss, and no change in friction characteristics due to either, is shown in Figure 3.
