CITY OF ALLENTOWN

R63 – 2024

Certificate of Appropriateness for work in the Historic Districts:

**Historical Architectural Review Board
FINAL Review Sheet**

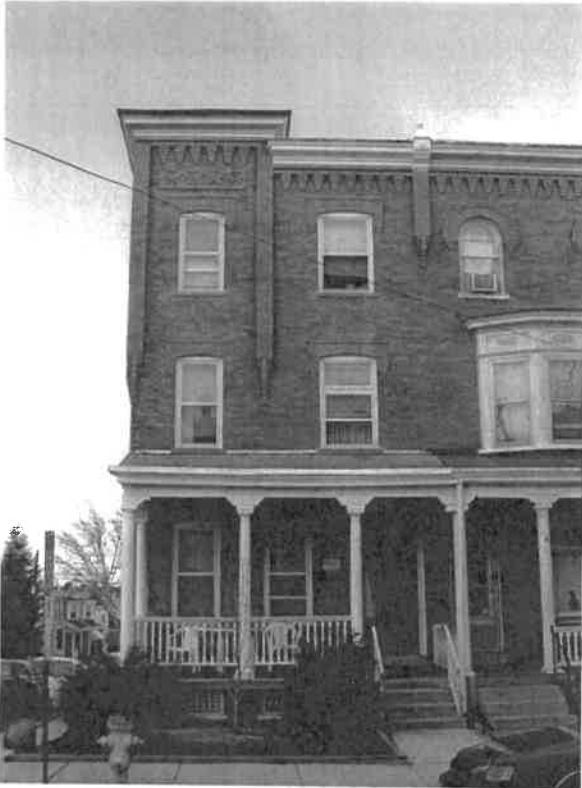
Porch Elevation (Directory)

Observations & Comments: This is a relatively straightforward in-kind repair and appears to match the existing configuration well. Although no existing photographs were provided and it is not clear if there was any additional detailing at the header (similar to what is present at the adjacent porch header).

Staff Recommendation: It is recommended to approve.

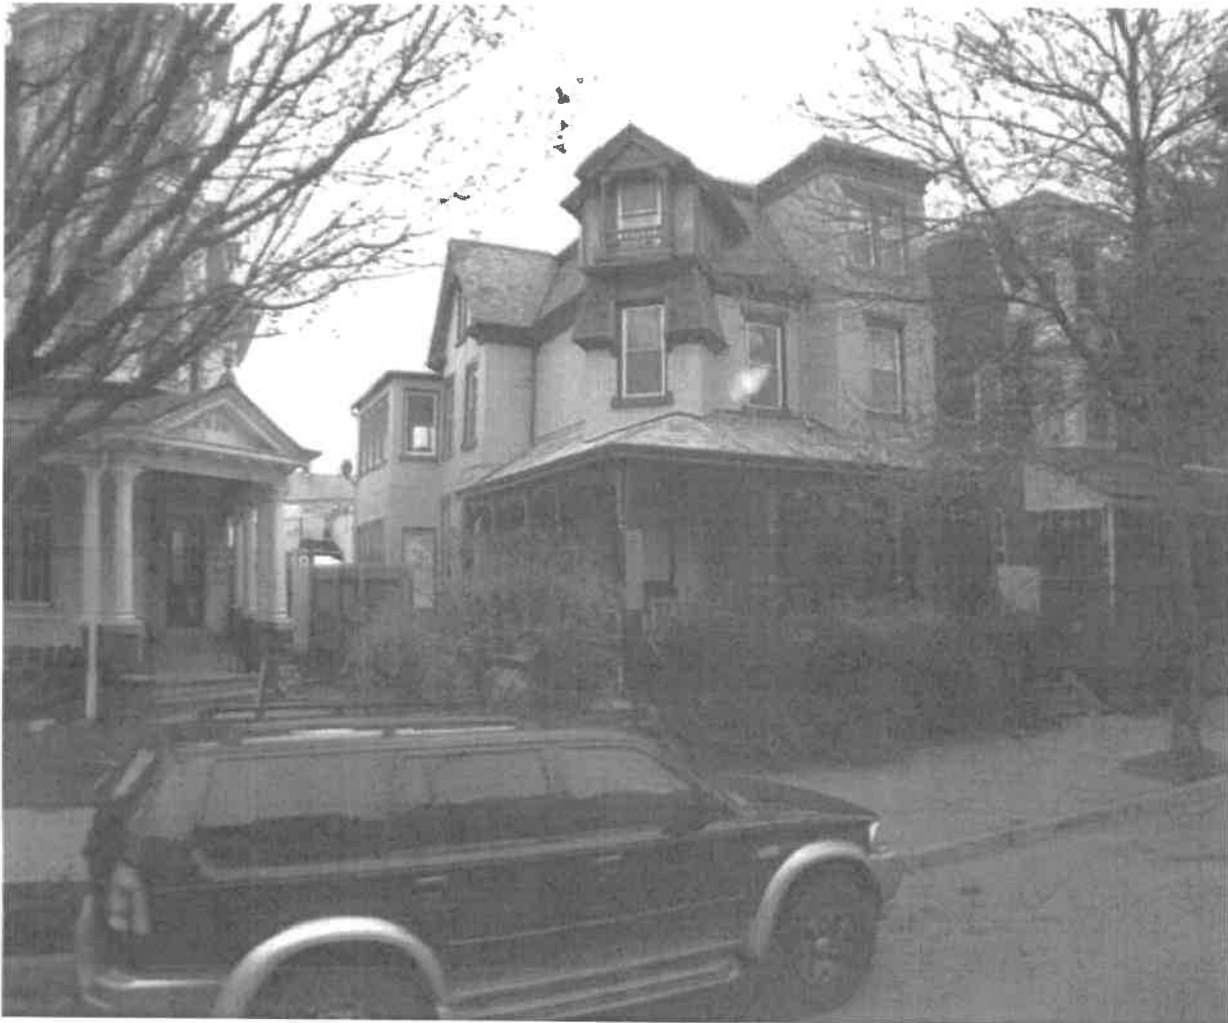
Previous Photograph Prior to Fire Damage (Applicant)

This application proposes to make various repairs due to fire damage, including: replacing windows with aluminum clad wood windows, repointing and cleaning/painting brick masonry, replacing damaged roof shingles with Owens Corning Berkshire shingle in the Canterbury Black color, paint all wood around windows with a color to match existing, repair the front porch, paint the metal handrail to match existing, replace all downspouts, and repairing box gutters to match existing.

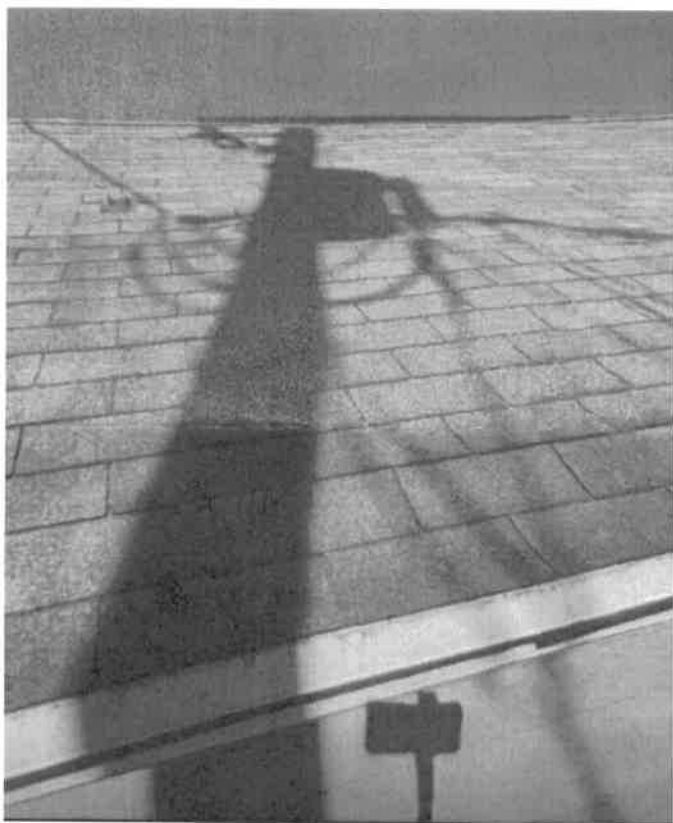
Existing Roof (Applicant)

This application proposes to replace the gable shingle roofing, as well as the flat roofing, this will include the removal of the existing roof surfaces, replacing damaged plywood, the installation of a drip edge, ice & water shield at the eaves, roof boots, and flashing around the chimney.
