**Historical Architectural Review Board
COA Final Review Sheet**

HDC-2023-00065

Address: 614 N. 5th Street

Proposal: Replace wood porch columns with fiberglass columns; infill opening

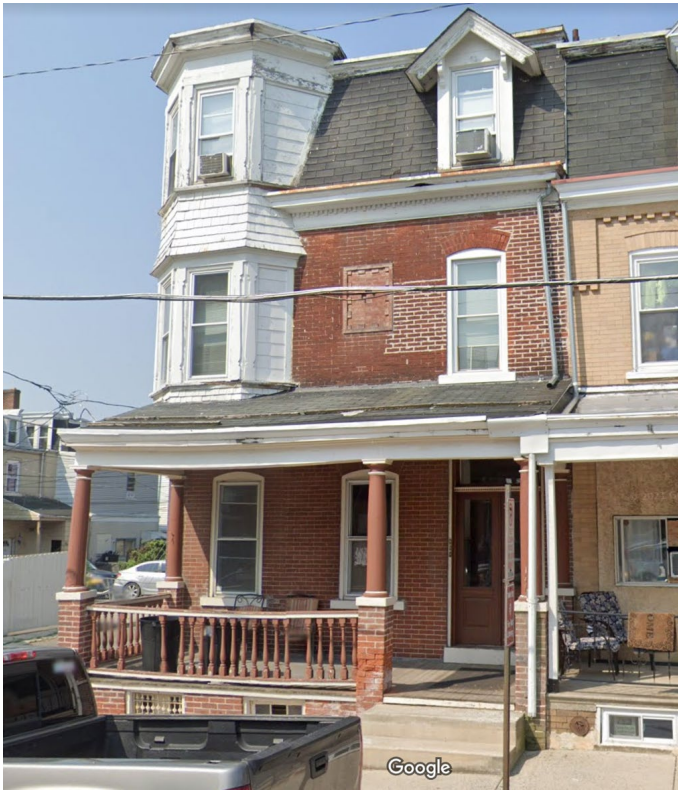
**Front façade of 614 N. 5th Street, 2021.
(Google StreetView)**

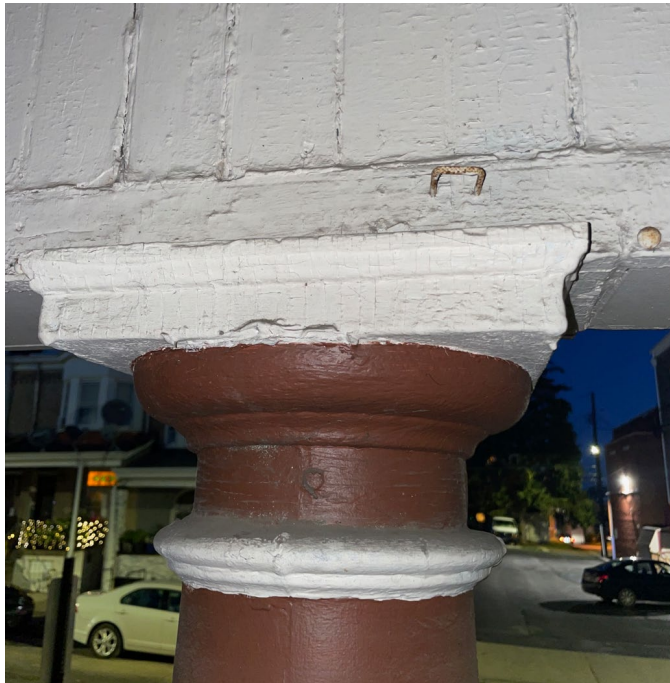
Previous porch configuration, 2019.
(Google StreetView)

Building Standards has inspected the property and determined that two porch columns are rotted and require replacement. The owner has provided staff with specs on matching columns in fiberglass (PermaCast) and wood. The owner noted that the wood columns are hollow, though loadbearing, and that he prefers the fiberglass columns. The proposed columns have a tapered shaft and matching components. While a material change, they would replicate the appearance of the historic. Staff finds that the columns do not comply with Guideline 3.7.4 because of the material change, but do comply with Guideline 3.7.8. Despite the material change, staff finds the proposed alternative to be compatible and acceptable.

Approval of the replacement of the wood porch columns with fiberglass columns, pursuant to Chapter 3, Section 3.7 Porches & Steps, but denial of the infilling of the window with brick veneer, pursuant to Chapter 3, Section 3.5 Windows.
