# Historical Architectural Review Board COA Preliminary Review Sheet

**HDC-2025-00086**

**Address: 126-128 N 15<sup>th</sup> Street**

**Proposal: Roof Replacement (Violation Correction)**

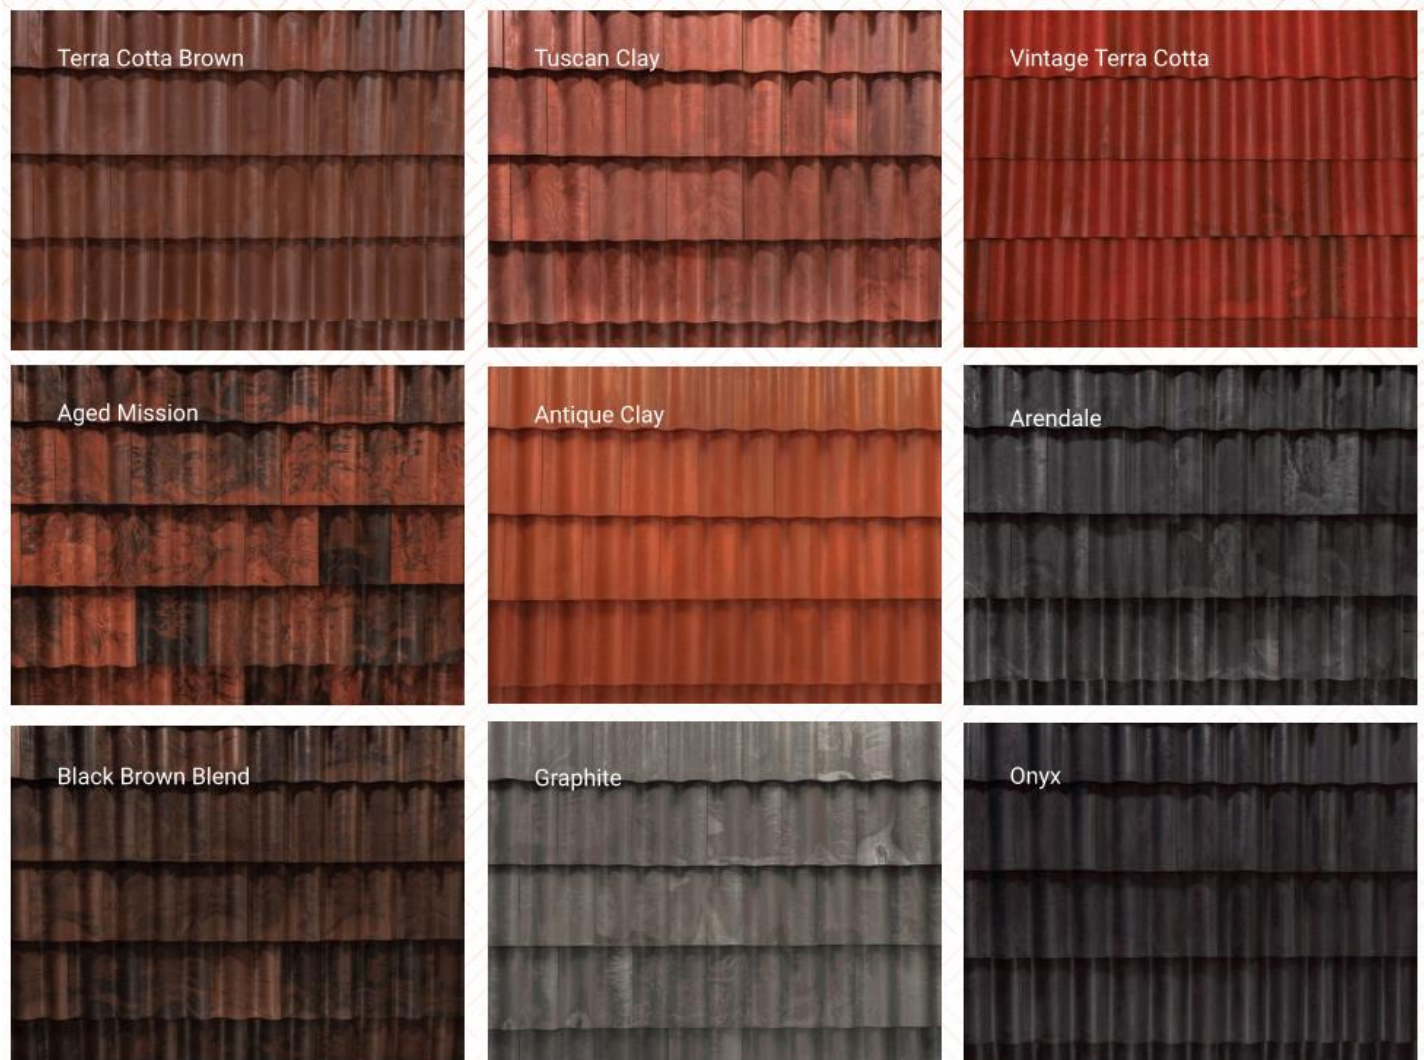
**Color Options (Applicant)**

**Observations & Comments:** The original roof of 126-128 N 15 Street was Spanish barrel terra cotta clay tile. It appears that the original roofing materials have been completely removed at the main roof areas, and replacement with a red shake style architectural asphalt shingle was begun until work was stopped. The applicant has submitted an alternate material for review: Brava's Spanish Barrel Tile, a synthetic material that matches the original clay tile. This product appears to be an appropriate alternate material, as color options, profile, and appearance are consistent with the original historic clay. No specific color was proposed by the applicant. From the color chart, Antique Clay appears to be the closest match to the original clay; the applicant may obtain samples and submit photos to Staff showing the sample and the remaining original tile for final color selection.
