**Historical Architectural Review Board  
COA Final Review Sheet**

**HDC-2023-00082**

**Address: 531 W. Allen Street**

**Proposal: Remove slate shingles; install asphalt shingles**

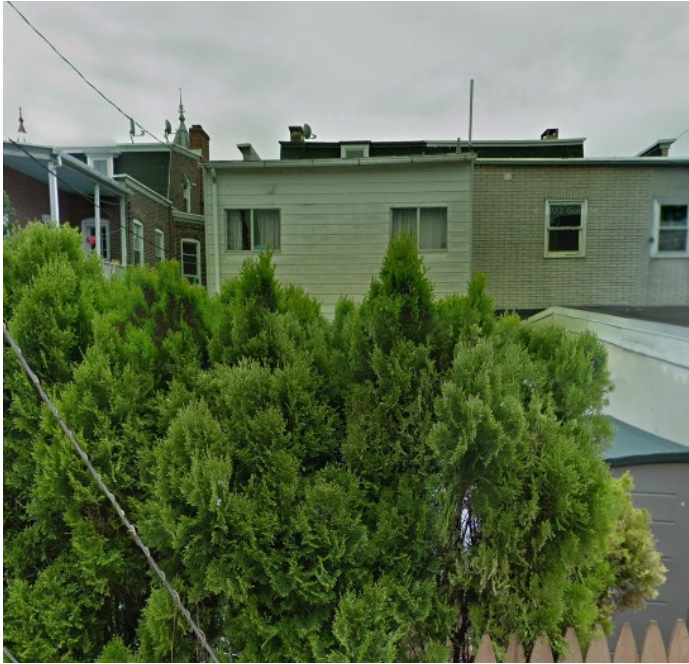
Rear view of 531 W. Allen Street, 2011.  
(Google StreetView)

The applicant contends that the existing slate roof is failing and in poor condition. Photographs show that there are displaced shingles throughout the roof. Staff notes that the roof currently contains slate shingles in rectangular and beveled shapes, though there is no discernible patterning. Based on the beveled slate shingles at 527 and 529 W. Allen Street, staff contends that the mansard at 531 W. Allen Street historically had beveled shingles and that rectangular shingles were installed to replace many of the failing original shingles; however, no documentation exists to confirm this assumption.

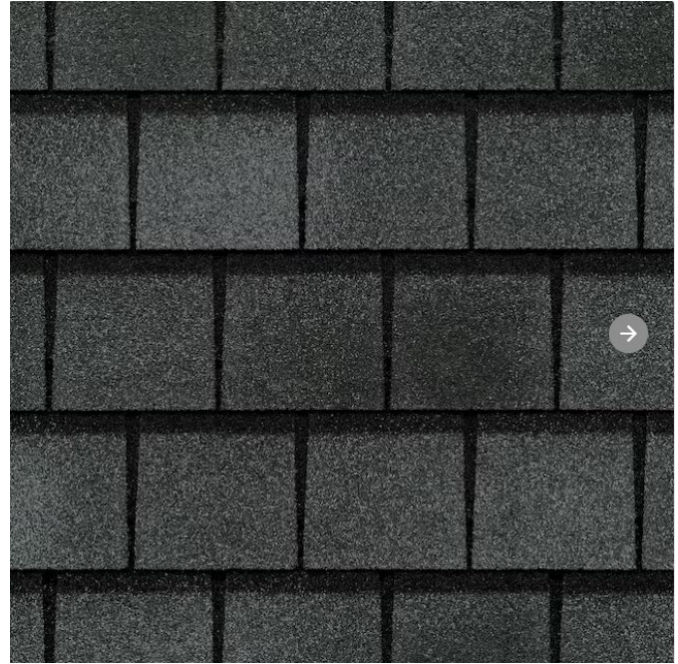
GAF Slateline in English gray.  
(www.lowes.com)

Mr. Huber agreed with staff that the historic shingles were likely beveled and many were replaced with rectangular shingles over time. He stated that most of the original shingles are missing, and that the proposed GAF Slateline shingles provide a close match to most of the existing slate shingles. The HARB agreed that the proposed shingles are appropriate.
