**HISTORIC ARCHITECTURAL REVIEW BOARD  
CITY OF ALLENTOWN, PENNSYLVANIA  
October 4, 2021  
FINAL REVIEW**

**Property Location:** 342-344 N. 9<sup>th</sup> St.

**Case:** HDC-2021-00022

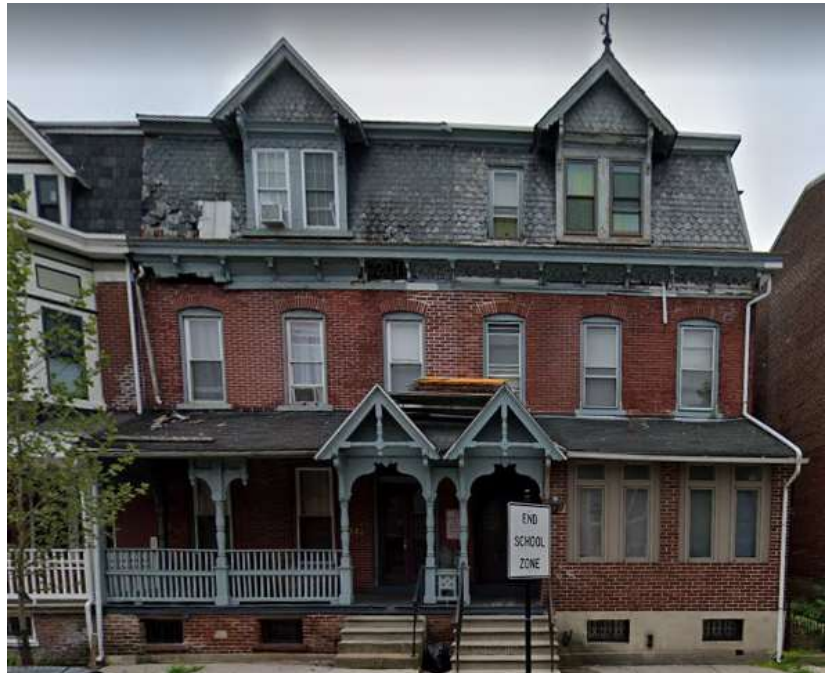
**344:** This 3-story brick end of the row house is a Queen Anne porch house with Eastlake influences. ca 1889, the mansard roof has scalloped slate. It displays a dormer that has a bracketed gable roof, scalloped slate in the peak of the gable and a finial atop the peak. There is also a small window to the left of the dormer. There is a bracketed projecting eave between the 2<sup>nd</sup> and 3<sup>rd</sup> floors that has a decoratively stenciled frieze. A dormer on the side of the house is also visible. There also appears to be a side porch with 2 stories above it.

The windows are 1/1 sash set into segmental brick arches. The window openings are topped with segmental brick arch lintels. The main entry is a single modern door with projecting moldings. The porch has been enclosed with brick and glass blocks. The concrete steps have a wrought iron railing with a peak roof over them. There are 2 basement window grilles visible
