# Historical Architectural Review Board

## COA Preliminary Review Sheet

**HDC-2025-00086**

**Proposal: Roof Replacement (Violation Correction)**

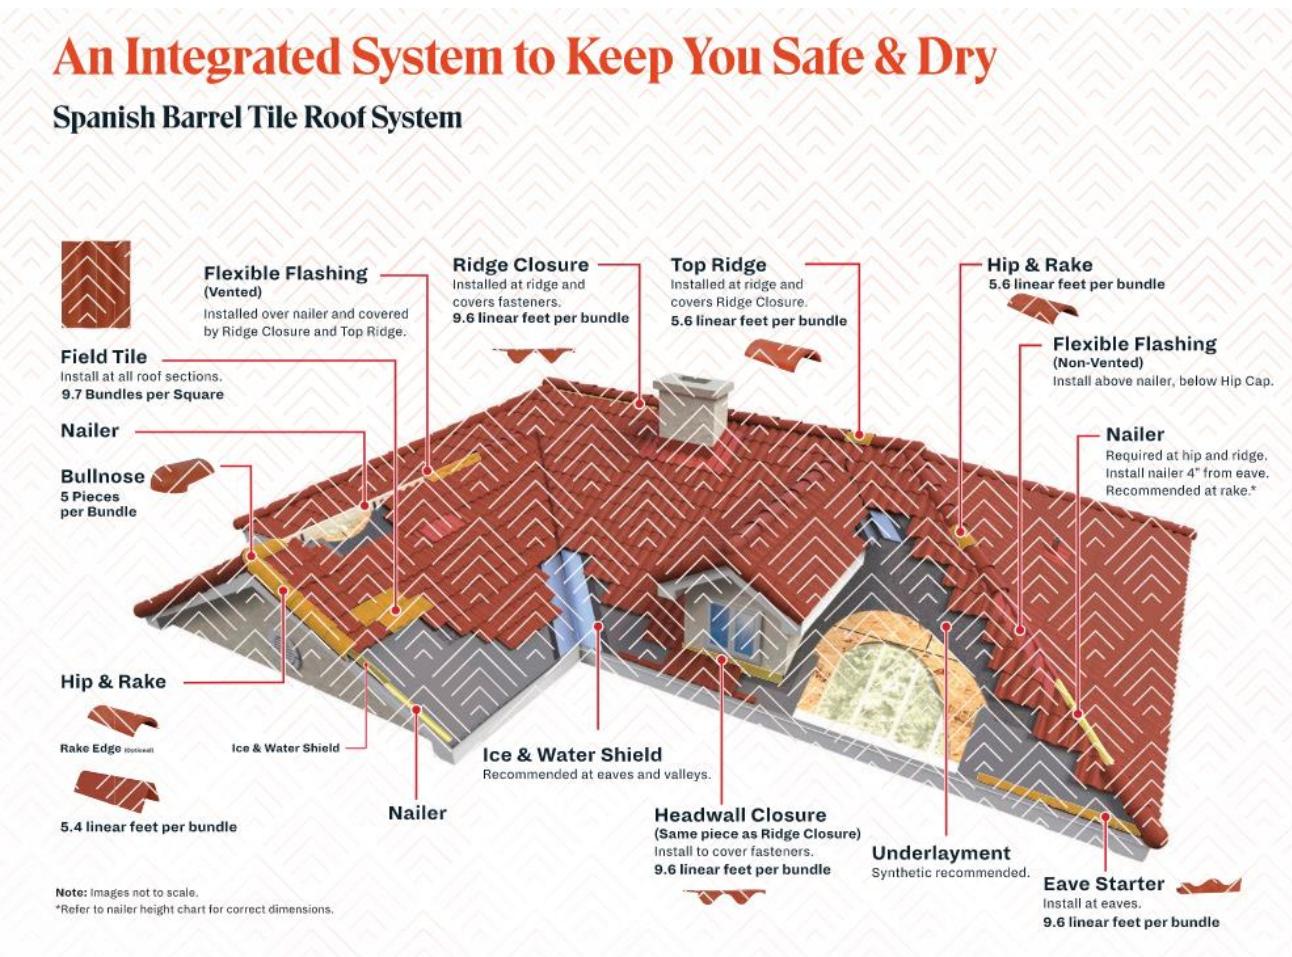
Proposed Material (Applicant)

## An Integrated System to Keep You Safe & Dry

### Spanish Barrel Tile Roof System

**Observations & Comments:** The original roof of 126-128 N 15 Street was Spanish barrel terra cotta clay tile. It appears that the original roofing materials have been completely removed at the main roof areas, and replacement with a red shake style architectural asphalt shingle was begun until work was stopped. The applicant has submitted an alternate material for review: Brava's Spanish Barrel Tile, a synthetic material that matches the original clay tile. This product appears to be an appropriate alternate material, as color options, profile, and appearance are consistent with the original historic clay. No specific color was proposed by the applicant. From the color chart, Antique Clay appears to be the closest match to the original clay; the applicant may obtain samples and submit photos to Staff showing the sample and the remaining original tile for final color selection.
