## CITY OF ALLENTOWN

**RESOLUTION**

**R82 – 2022**

**Certificates of Appropriateness for work in the following addresses in Historic Districts:**

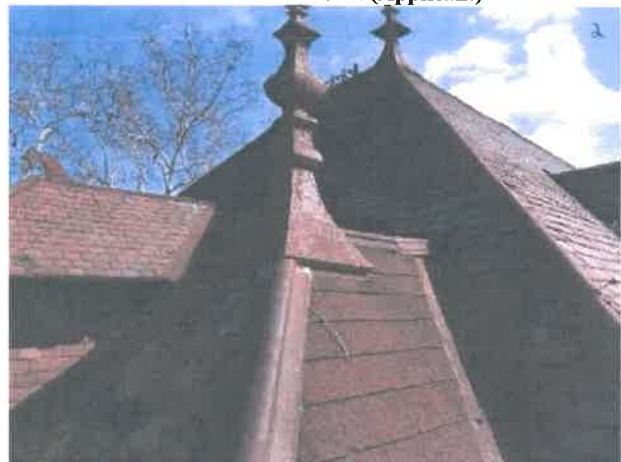
**Roof and Finial Detail (Applicant)**

New flashing is appropriate to keep the roof watertight. Proposed metal would be an in-kind replacement and therefore appropriate. The most appropriate treatment of the historic roof features (finials and rolled ridge caps) is restoration and reuse, or replaced in-kind, to be consistent with Guideline 3.1.5.

AJ asked the status of the finial replacement. Applicant noted the neighbor sourced replacement units which he will pursue.

GL asked applicant to clarify what replacement materials would be used at the metal gable hip and ridge flashings, DF replied they will be replaced in kind.

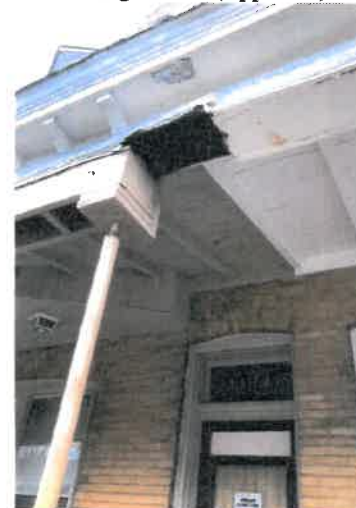
Existing Header (Applicant)

As Provided by Applicant: Removal of soffit to expose header. Replacement of structural header. Install new wood (HB+G) column. Build new soffit with pine lumber to match HARB criteria.

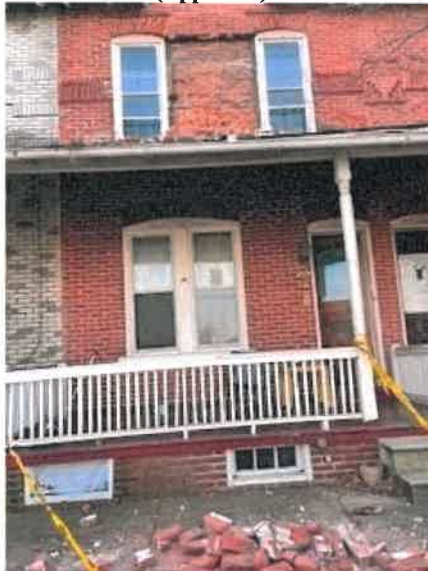
**Damaged Primary Facade  
(Applicant)**

As Provided by Applicant: Replace exterior brick facade that fell down during the winter. A temporary support of wood was placed after the brick initially fell, ok'ed by Building Standards and Safety. Replacement of exterior brick facade at front, 2<sup>nd</sup> story between 2 windows.

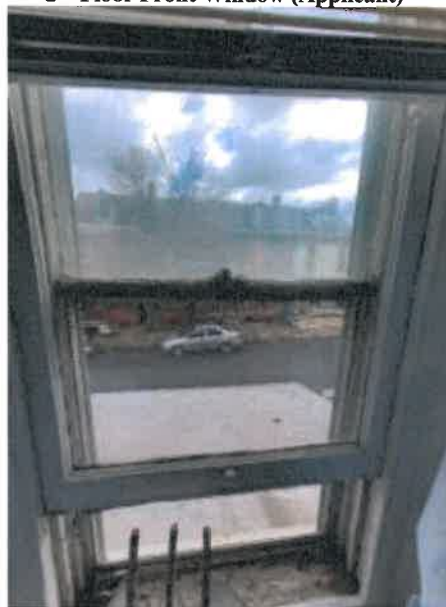
**2<sup>nd</sup> Floor Front Window (Applicant)**

Provided by Applicant: Replacement of eight (8) lead-based paint hazard deteriorated windows with new aluminum clad windows. (Two - 2<sup>nd</sup> floor front, two - 3<sup>rd</sup> floor front, one - 2<sup>nd</sup> floor side, one - 2<sup>nd</sup> floor rear, and two – 3<sup>rd</sup> floor rear).  
 Noted from Supplied Materials: The scope of work notes that new windows will be fit to existing openings and new screens will also be installed.

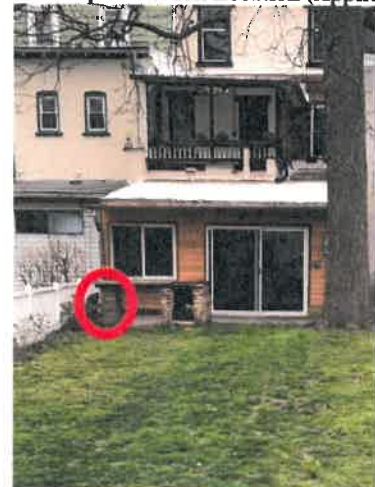
**Detail of Proposed Work Location (Applicant)**

Additional Information from Submitted Materials: Exterior refrigerant lines will penetrate the enclosed porch at the base of the wall near the unit, and at the second story will run along the base of the wall. Upper story lines will be covered from the point of origin to the outdoor unit.
