**FINAL REVIEW**  
**CITY OF ALLENTOWN, PENNSYLVANIA**  
**HARB**  
**June 12, 2019**

**Case # HDC-2019-00012**– Proposal to do façade improvement, restoration and rehabilitation

**Property located at:** 535 Park Street

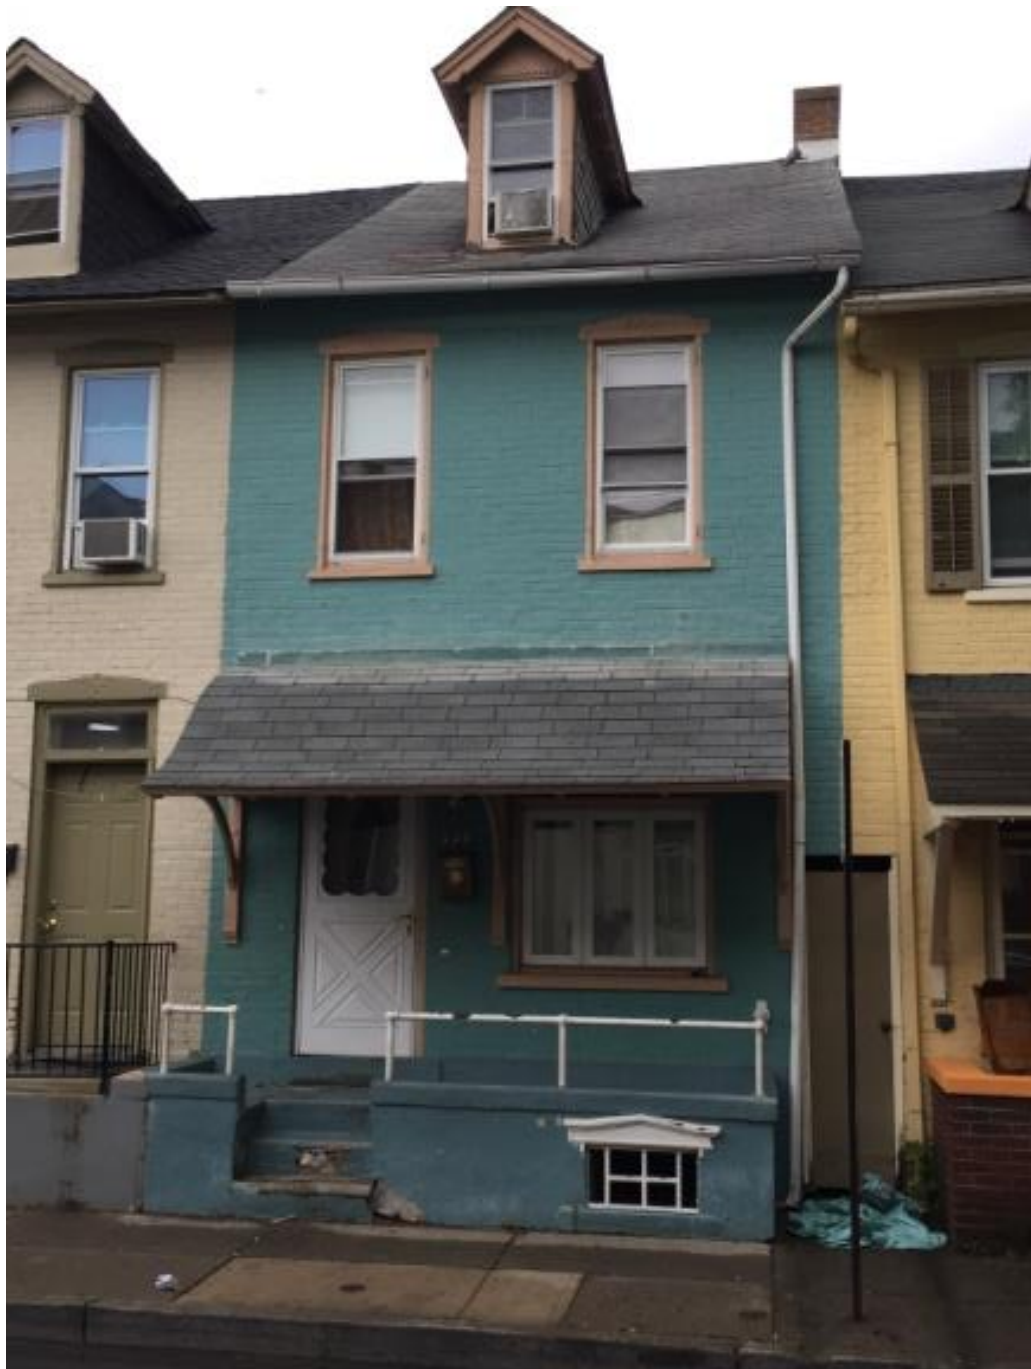
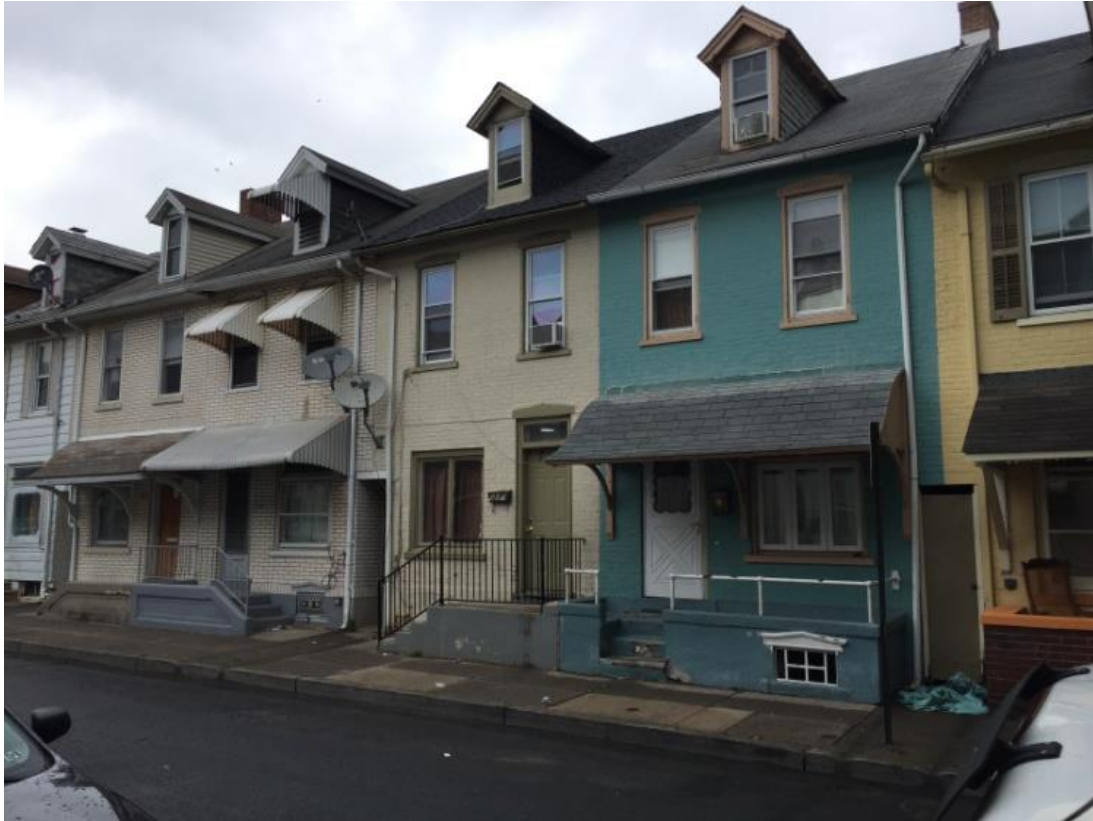
**Building description, period, style, defining features:** Build c.1875 the building is a brick rowhouse that is Federal in style with East Lake incised lintels. Added to the front of the building are a bell shaped Allentown porch roof and a concrete porch with pipe railing. Roofing is asphalt shingles. Walls are brick that has been painted. Windows are one over one on the second floor and in the dormer on the roof. First floor window is a modern casement type replacement. There is a modified basement grate and a shared flat (flush) grocers alley door. The front entrance has an inappropriate aluminum storm door.
