HDC-2022-00005

Address: 38 N 15th Street

Building Description:

Project Description:

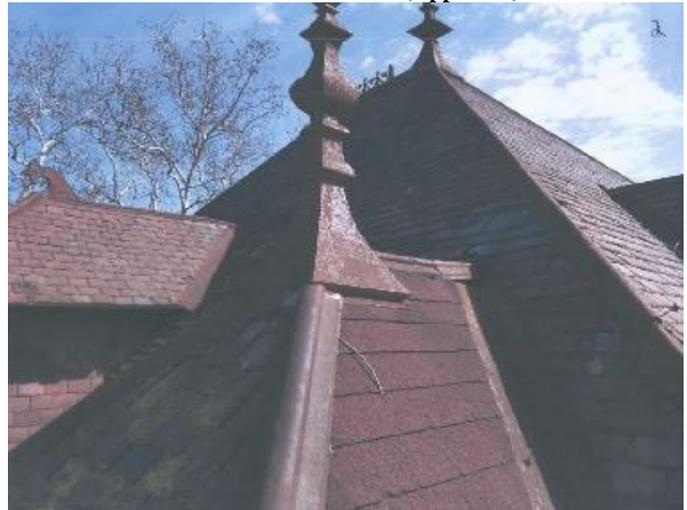
Roof and Finial Detail (Applicant)

New flashing is appropriate to keep the roof watertight. Proposed metal would be an in-kind replacement and therefore appropriate. The most appropriate treatment of the historic roof features (finials and rolled ridge caps) is restoration and reuse, or replaced in-kind, to be consistent with Guideline 3.1.5.

AJ asked the status of the finial replacement. Applicant noted the neighbor sourced replacement units which he will pursue.

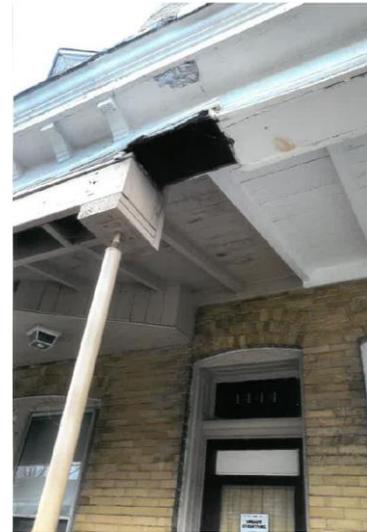
**Existing Header (Applicant)**

As Provided by Applicant: Removal of soffit to expose header. Replacement of structural header. Install new wood (HB+G) column. Build new soffit with pine lumber to match HARB criteria.

The header repair and new soffit is appropriate. The soffit and wood trim around the structural header should match the existing appearance. All wood elements should be painted to match the existing trim and to protect the wood material. The proposed use of a new wood column to replace the missing original material is appropriate. The proposed tapered wood column with new capital and base to match existing historic elements is appropriate in material, size, shape, and

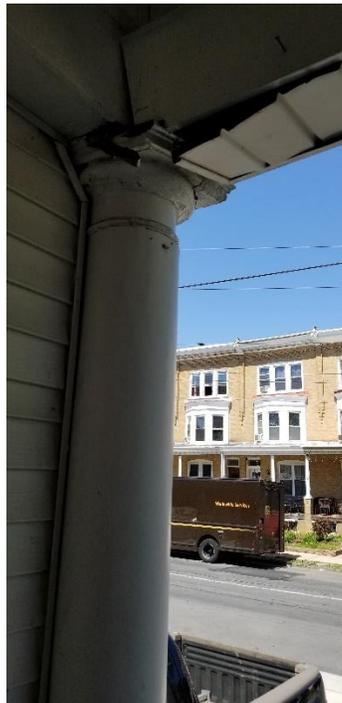
**Porch Column and Header
(Applicant)**

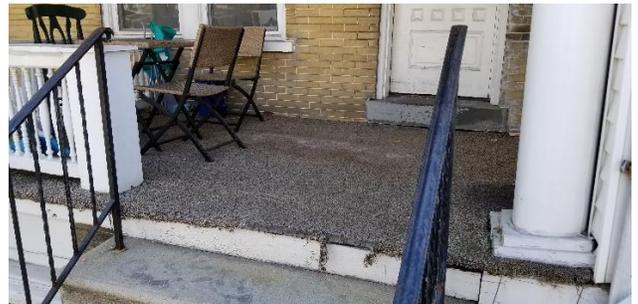
Porch Floor Decking (Applicant)

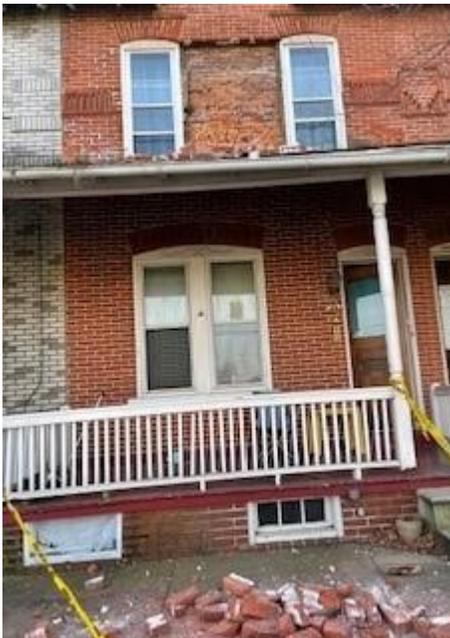
**Damaged Primary Facade
(Applicant)**

As Provided by Applicant: Replace exterior brick facade that fell down during the winter. A temporary support of wood was placed after the brick initially fell, ok'ed by Building Standards and Safety. Replacement of exterior brick facade at front, 2nd story between 2 windows.

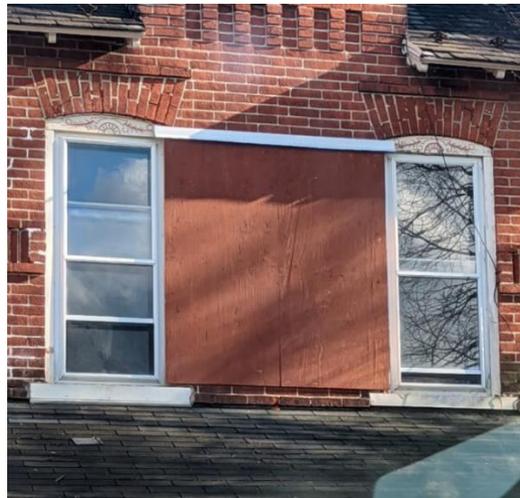
**Current Condition with Temporary Protection
(Staff)**

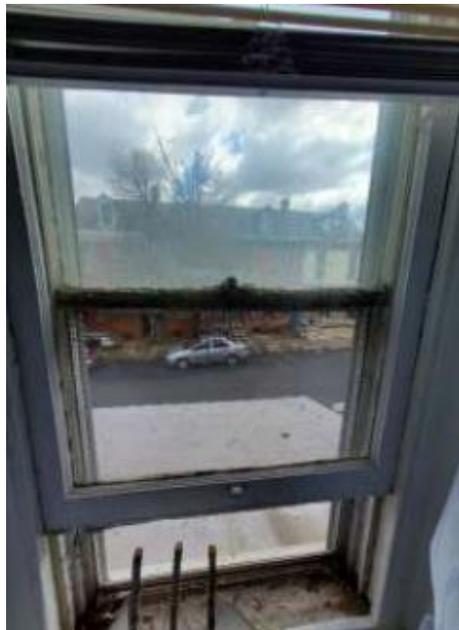
2nd Floor Front Window (Applicant)

Provided by Applicant: Replacement of eight (8) lead-based paint hazard deteriorated windows with new aluminum clad windows. (Two - 2nd floor front, two - 3rd floor front, one - 2nd floor side, one - 2nd floor rear, and two - 3rd floor rear).
Noted from Supplied Materials: The scope of work notes that new windows will be fit to existing openings and new screens will also be installed.

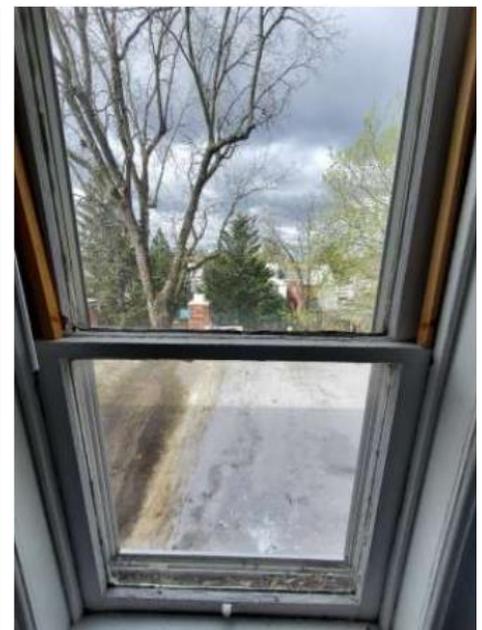
2nd Floor Rear Window (Applicant)

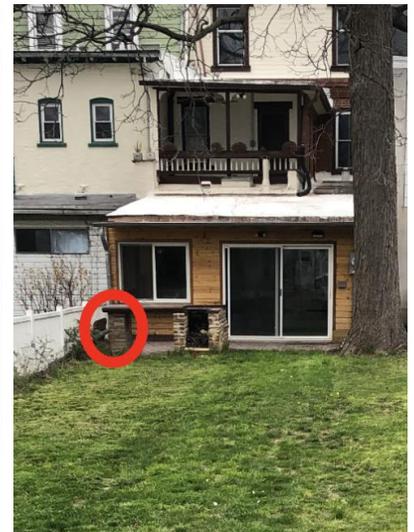
Detail of Proposed Work Location (Applicant)

Additional Information from Submitted Materials: Exterior refrigerant lines will penetrate the enclosed porch at the base of the wall near the unit, and at the second story will run along the porch wall base of. Upper story lines will be covered from the point of origin to the outdoor unit.
