**FINAL REVIEW**  
**CITY OF ALLENTOWN, PENNSYLVANIA**  
**HARB**  
**June 12, 2019**

**Case # HDC-2019-00014** – Proposal to do façade improvement, restoration and rehabilitation

**Property located at:** 220 N 10th Street

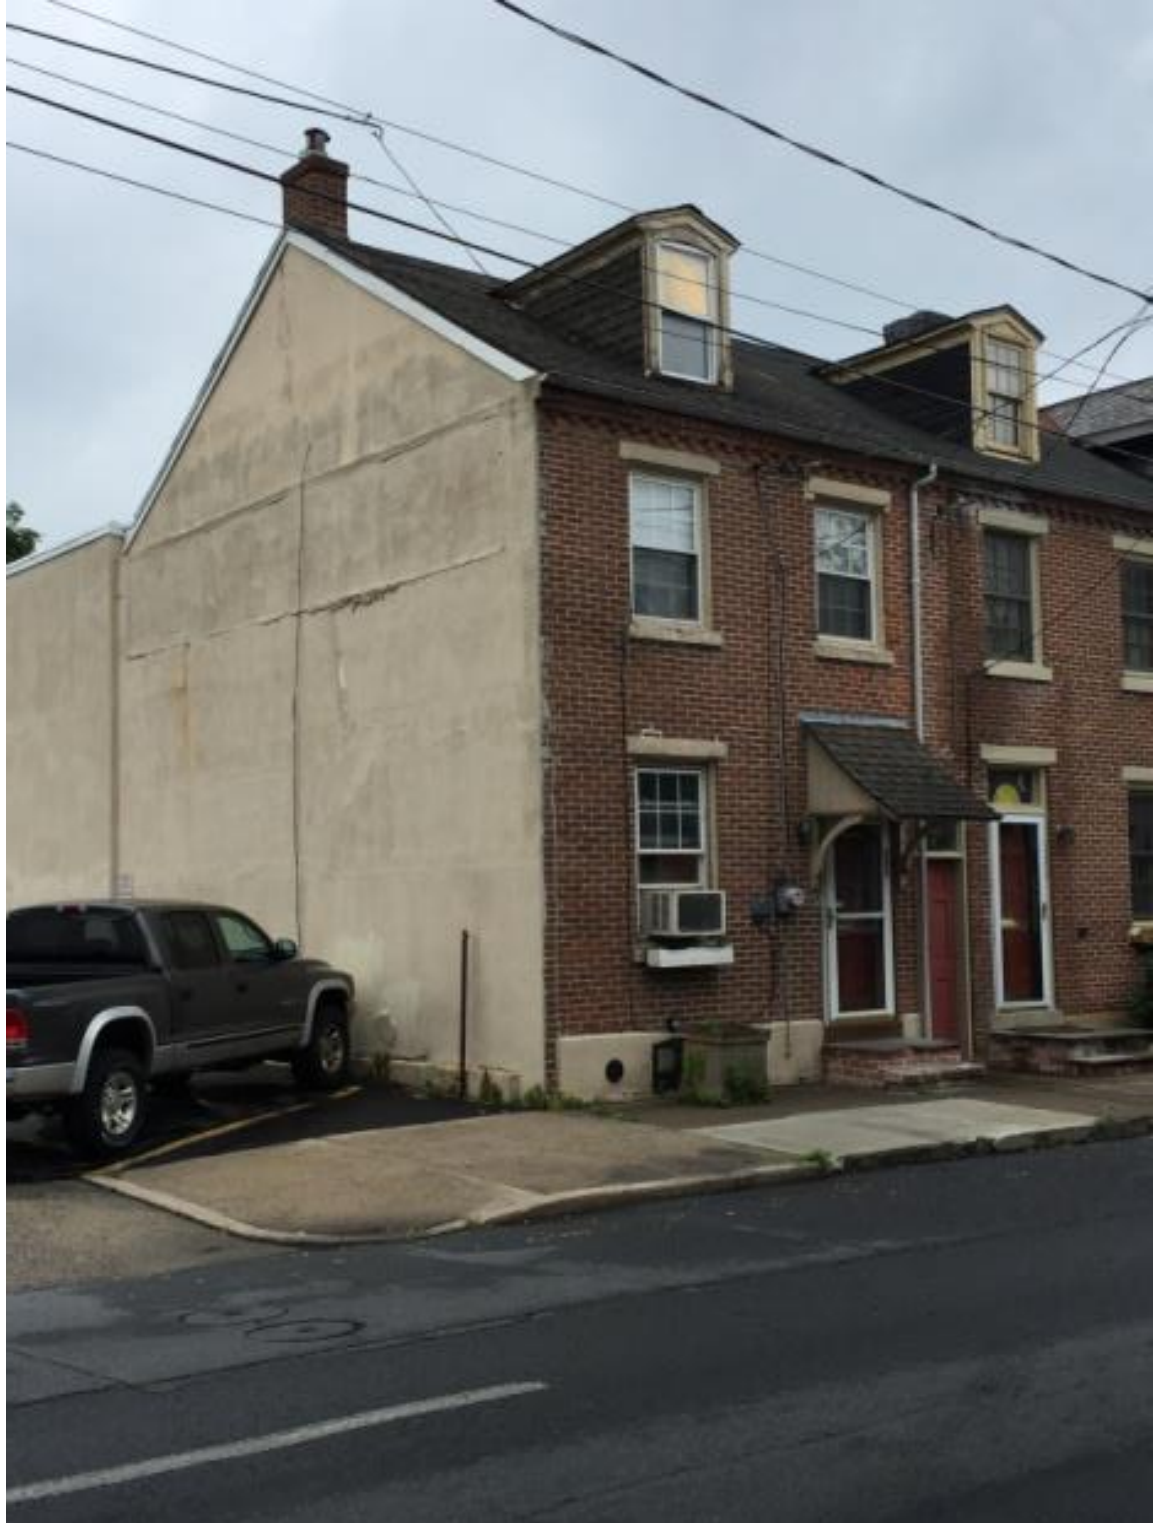
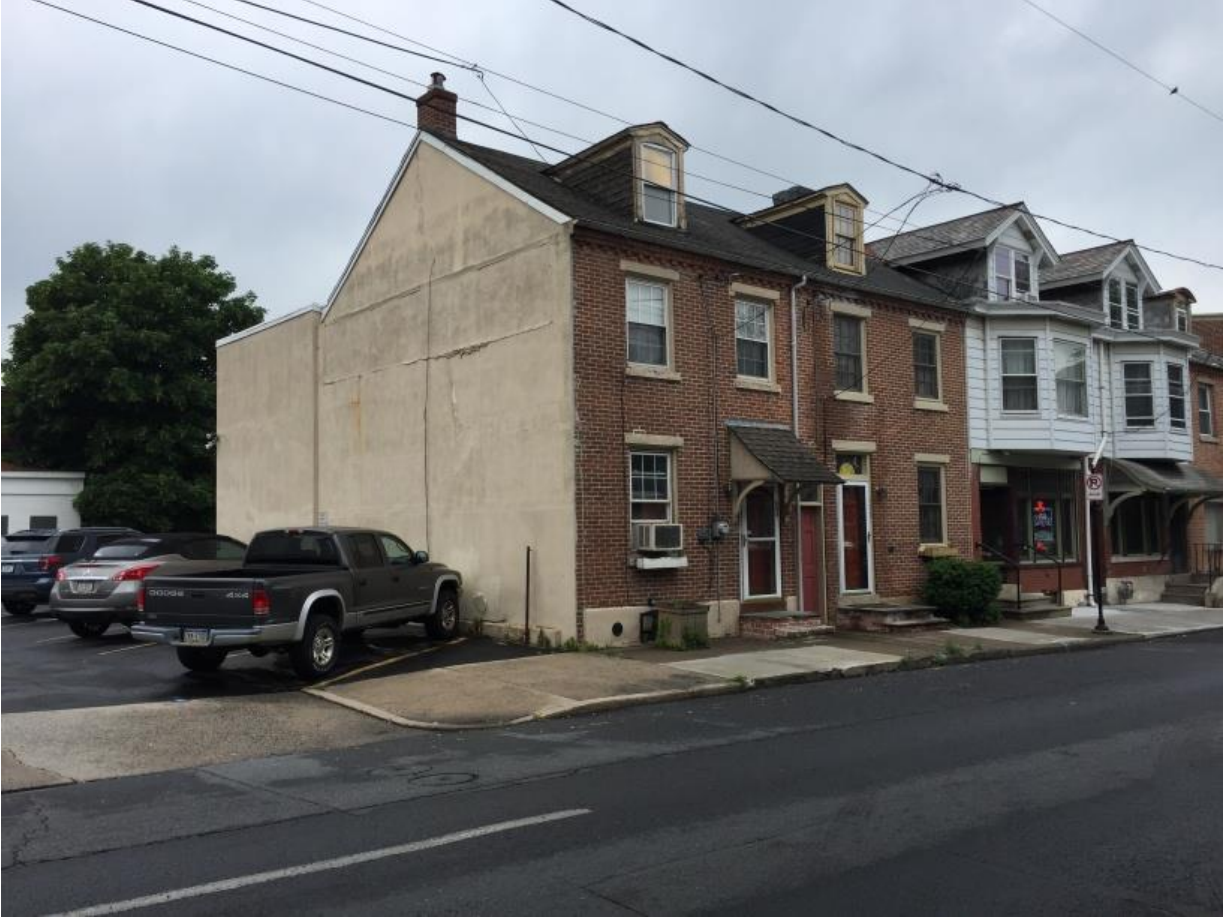
**Building description, period, style, defining features:** This 2½-story brick end-of-row house, ca 1865, is Federal in style with some Victorian modifications and details. The asphalt shingle gable roof displays a single dormer sided with asphalt shingles, a gable roof with brick cornice with dentils, and 6/6 vinyl windows with flat wood lintels. The main entry is a single glazed door with transom and a concave Allentown hood that stands alone, with closed ends and decorative wood brackets. There is a shared grocer's alley with a paneled door.
