# Historical Architectural Review Board COA Preliminary Review Sheet

**HDC-2025-00017**

**Address:** 627 Liberty Street

**Proposal:** Window replacement, front door replacement, installation of rear dormer, parking pad, and fence.

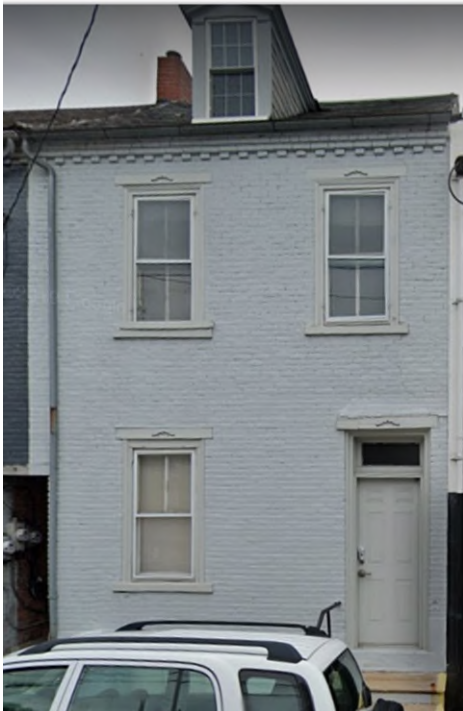
Existing Front Elevation (Applicant)

**Building Description:** 627 Liberty is a two story brick row home built in 1880, featuring a symmetrical façade, 2/2 windows with flat lintels and trim, and a transom over the doorway. There is a dentilated cornice and gable roof with a single pedimented central dormer.

- **Four Front Window Replacement:** While aluminum clad wood is an appropriate material for replacement windows, it would be helpful to review evidence that the current windows require replacement and cannot be repaired. From available imagery it appears that the windows may be original and are in a two-over-two

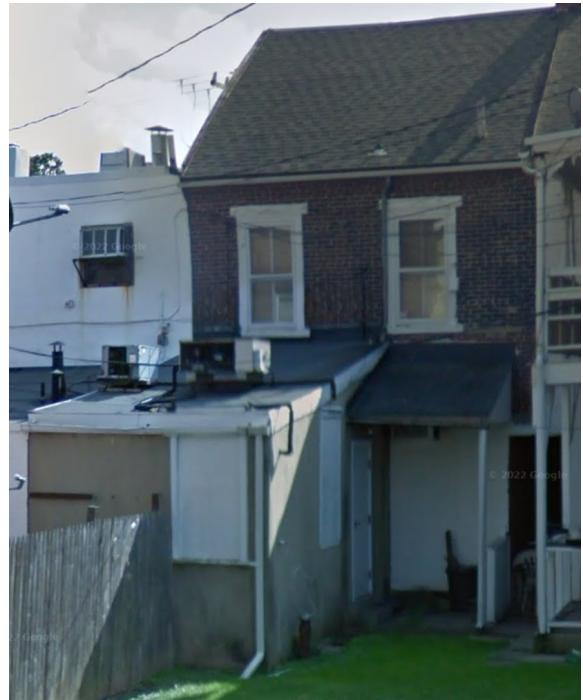
Rear of Property (Google Maps, October 2014)

- **Rear Windows:** Remove rear second floor bathroom window and infill with brick, due to interior modifications. Replace other rear second floor window in a new configuration due to interior modifications, reducing the height of the window opening.

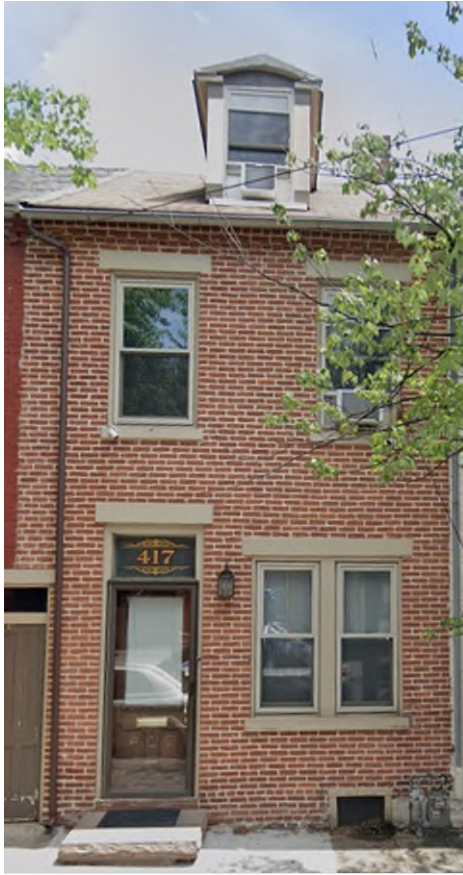
Example front entry door and storm (Applicant)

- **Front Door:** Replacement of the previously replaced front door with a salvaged ½ to ¾ lite historic wood door, with no change to the configuration of the entrance, and the addition of a full view bronze storm door (see example photo)

- **Front Door:** Replacement of the previously replaced front door with a salvaged  $\frac{1}{2}$  to  $\frac{3}{4}$  lite historic wood door, with no change to the configuration of the entrance, and the addition of a full view bronze storm door is appropriate per the guidelines.

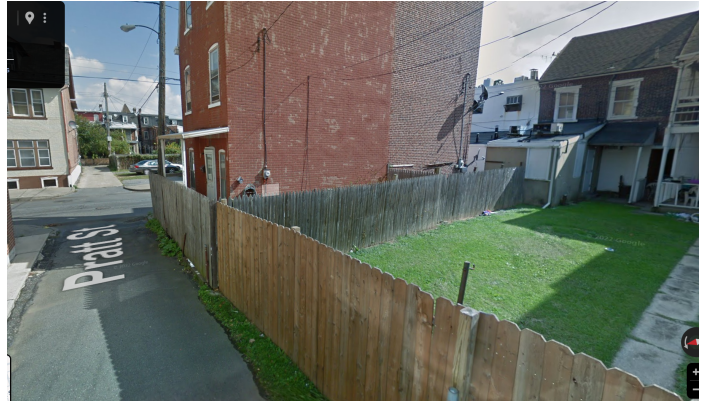
Rear of Property, Fence (Google Maps, October 2014)

- **New Wood Fence and Parking Pad:** Proposed rear parking pad with a new wood stockade fence.

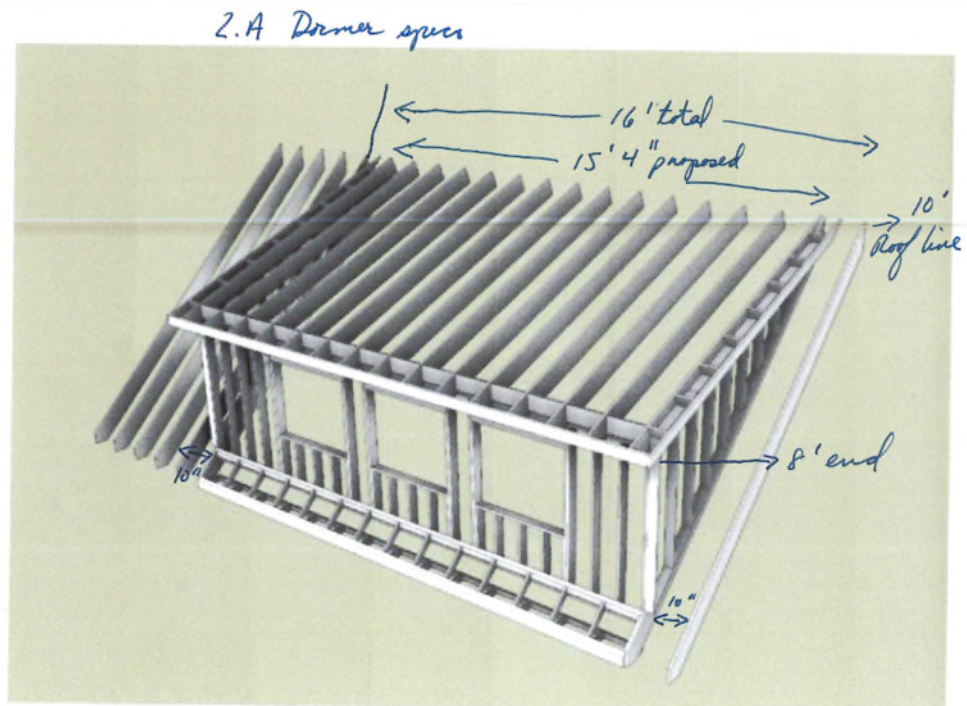
Proposed rear shed dormer (Applicant)

- **New Rear Dormer:** Install a new rear dormer; a shed dormer to extend the full length of the roofline, held 10" from either side, and clad in cement board siding or cedar shake. 2 to 4 aluminum clad wood 1/1 windows are proposed for the dormer. Due to the location of stairs at the interior, a narrower dormer is infeasible. Half round galvanized gutters and downspouts are proposed.

The dormer will be further designed by a design professional, but Mr. Lunes wanted to confirm that the intent and approach to the design is appropriate before proceeding. A staircase in the middle of the room in the attic is a constraint on the configuration of the dormer, but the proposed rear dormer would provide more functionality to the layout of the building. Mr. Lunes noted that the windows on the dormer would be 1/1 aluminum clad wood, which Mr. Huber noted that that would be appropriate, and that replacement windows on the rest of the building should be 2/2 aluminum clad wood to match the original in configuration. Applicant to provide more information on condition of windows proposed to be replaced.

Mr. Lunes clarified that the existing front roof slope is asphalt and the existing dormer is slate, and both are to be retained. The current rear roof slope is asphalt shingle. Mr. Lunes offered to use cedar shake, fiber cement, or wood clapboard for the sides of the proposed rear dormer. Mr. Huber suggested that fiber cement would be the most appropriate, since the other materials do not appear to have been used on the building historically. Mr. Huber also noted that GAF Slateline or 3-tab shingles would be appropriate for the dormer roof. The HARB discussed the overall size of the proposed dormer; while it is wider than typical dormers, its location on a rear façade and limited visibility from major rights-of-way does not create a negative impact on the streetscape.

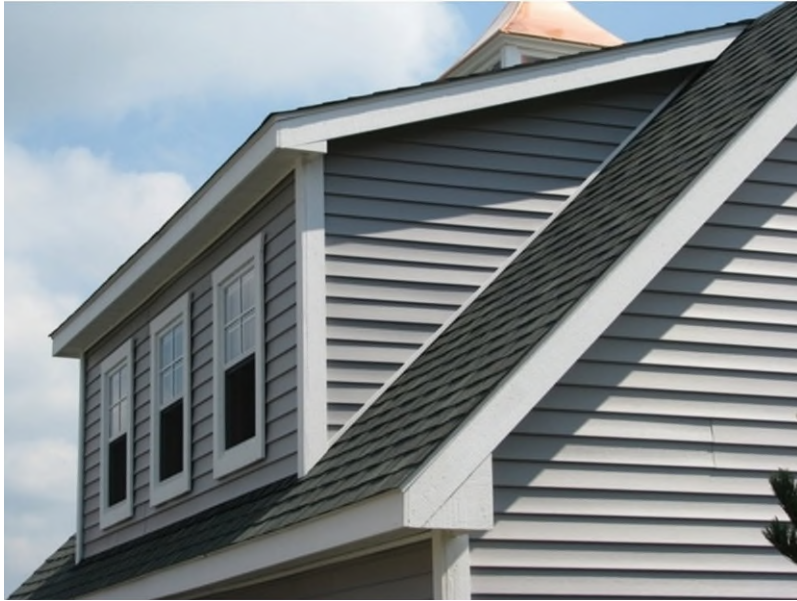
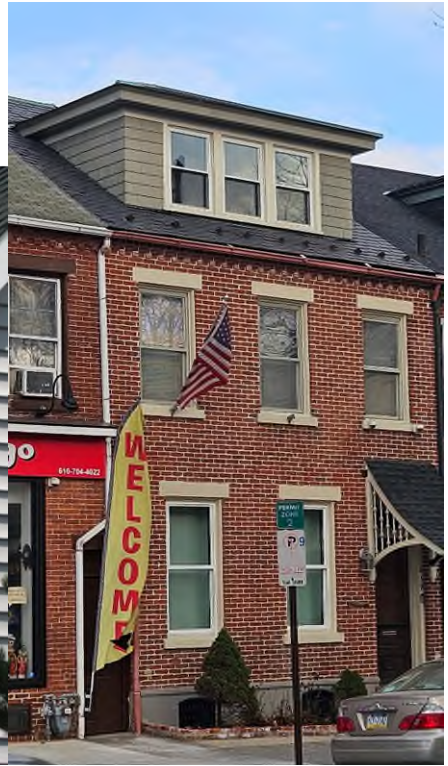
Example of similar intended shed dormers (Applicant)

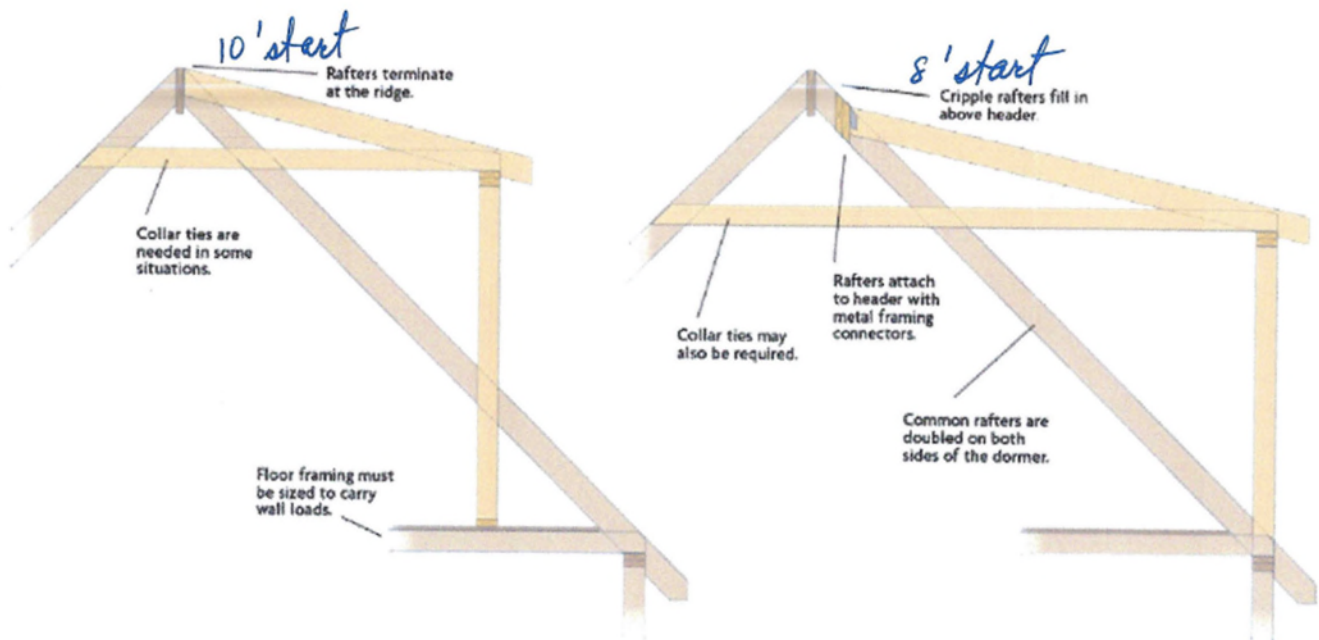
*2. A Framing for roof heights  
and starting points*

Example dormer framing heights (Applicant)

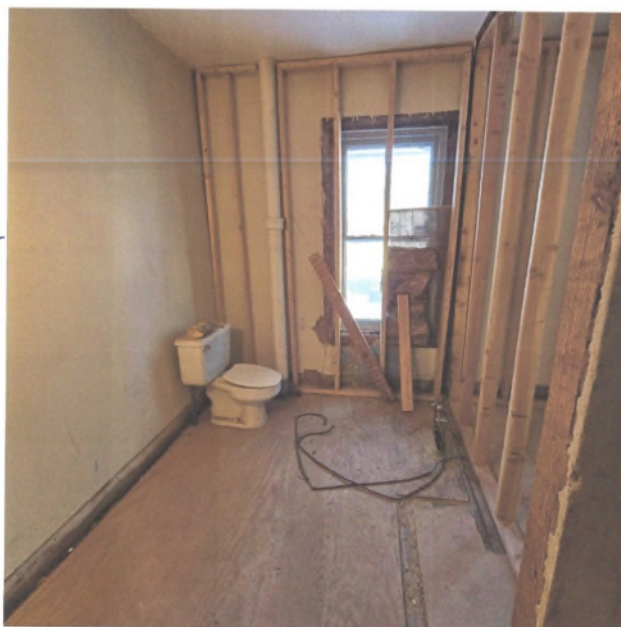
2.C  
Existing  
Bathroom

**Existing bathroom configuration (Applicant)**

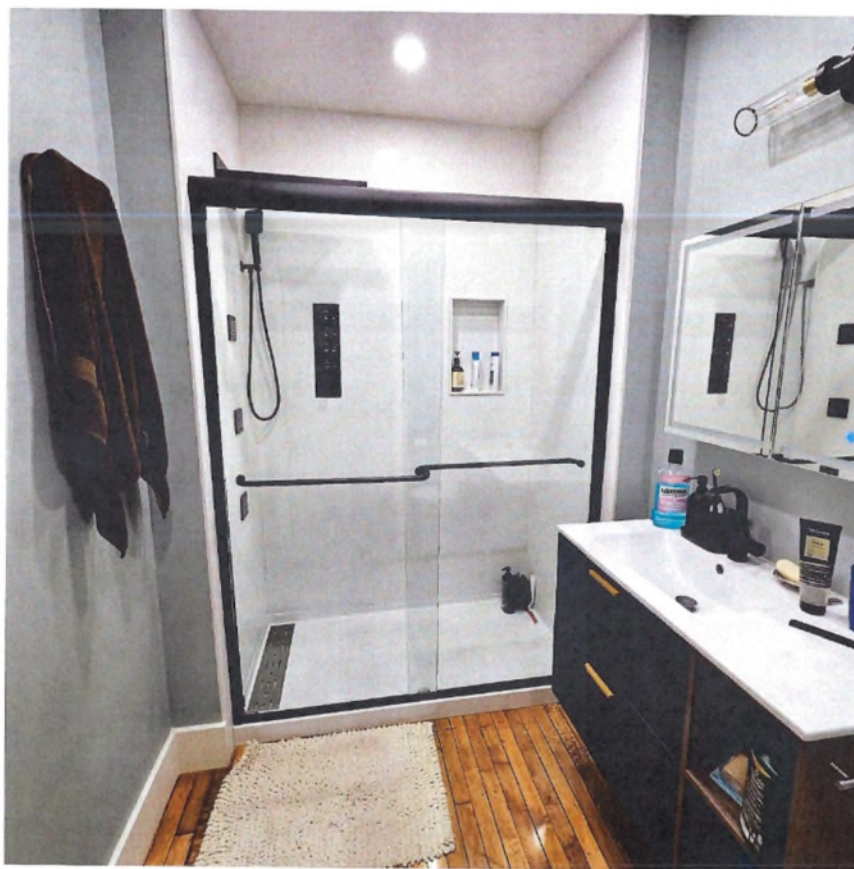
2.C  
Proposed  
(shower)

**Proposed bathroom configuration, with infill window (Applicant)**

**Discussion:** Mr. Lunes noted that the two rear window openings that he had proposed to be removed/reconfigured will remain, and he will adjust the interior layout to accommodate their locations. He noted that all of the windows will need to be replaced, and that he photographed their condition. The window in the front dormer was previously replaced. The fence at the rear would match the existing wood fence, which Mr. Huber said is appropriate.

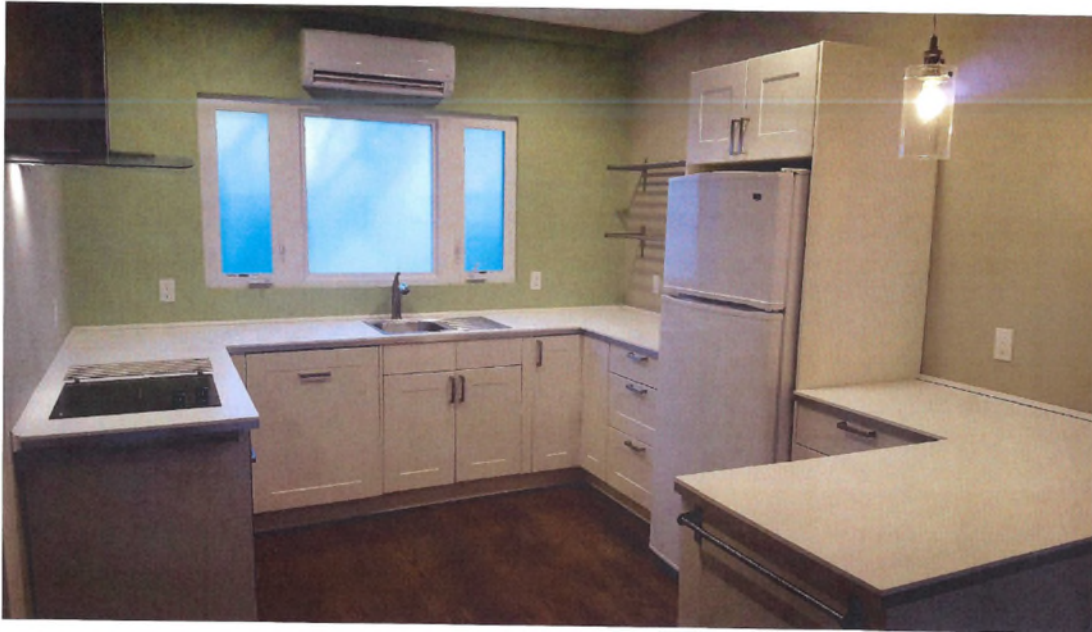
*2.C Kitchen Window Example*

Example kitchen window configuration (Applicant)
