CITY OF ALLENTOWN HISTORIC ARCHITECTURAL REVIEW BOARD FINAL REVIEW SHEET December 11, 2018

Case #HDC-2018-00036- Proposal to renovate the façade

Property located at: 409 N 10th Street Agenda #2 Historic District: Old Allentown Case # HDC-2018-00039 Meeting date: December 3, 2018 Property Owner: Richard Sodke Owners Address: 2377 Dewey Ave, Northampton, PA 18067 Applicant: Heidi Westerman Address: 435 Hamilton St, Allentown, PA 18101

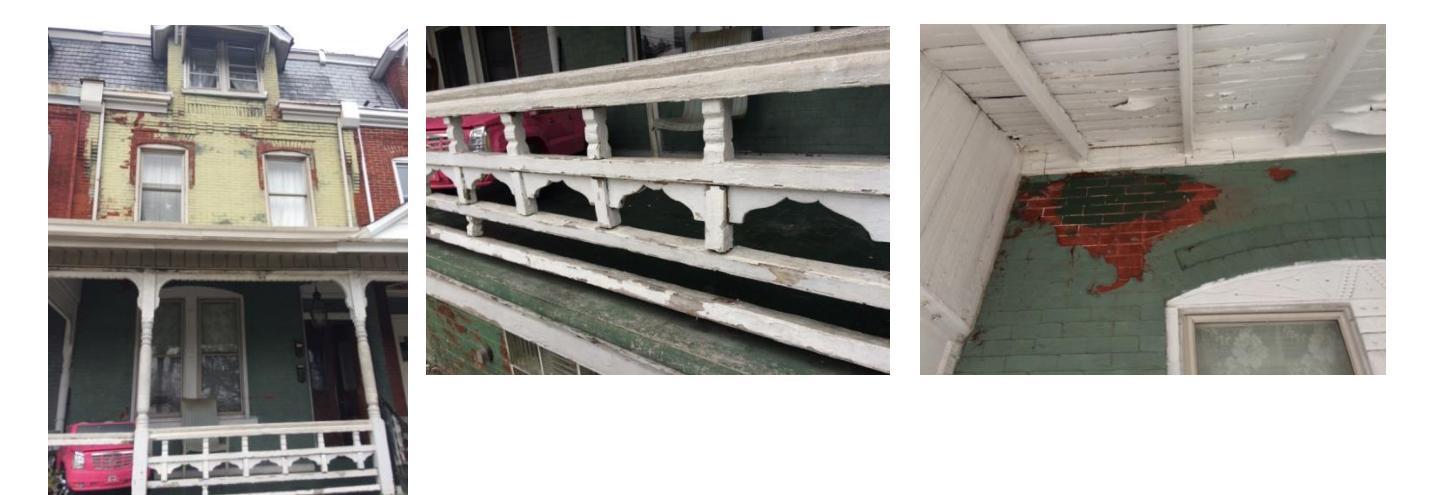
Building description, period, style, defining features: This structure is a 2 bay, 3 story painted brick row home with Mansard roof, gabled wall dormer with paired doubled hung windows, corbelled and decorative brick at the cornice and window heads, 1 over 1 double hung windows, and decorative and incised wood porch with original turned posts and unique porch railing. The house dates from c. 1893 and is Queen Anne in style. The house has a high level of historic integrity and is located in a row of homes showing integrity.

Evaluation, effect on historic district, recommendations: The proposed alterations are mostly historically appropriate with some modifications and clarifications:

- Any paint removal and repointing of masonry work should follow Preservation Brief # 1 Cleaning and Water-Repellent Treatments for Historic Masonry Buildings, and Preservation Brief #2 Repointing Mortar Joints in Historic Masonry Buildings. Cleaners should be gentle and proper disposal of removed paint and cleaner must be performed. Repointing should be done by a professional utilizing appropriately soft, lime-based mortar formulated as prescribed in the Brief.

- 2. Reconstruction of a new railing in wood is appropriate if milled to match. The design is not that complicated, and replication should be feasible.

- 3. It is recommended to simply scrap and paint the porch ceiling instead of covering with bead board, which is not the historic appearance.
- 4. Replacement in-kind of fascia is appropriate but it is not clear which fascia is intended. Removal of the aluminum capping on the porch entablature and soffit is recommended.

- 5. Not sure what is meant by "stabilizing paint". Trim should be scraped, sanded, and painted.
- 6. Porch floor should be scraped, sanded, and painted with appropriate flooring paint, not masonry paint.

- 7. Removal of existing wood windows should only occur if windows are beyond repair. If maintaining the storm windows, repair of existing windows, fitted with weather stripping, might be more cost effective and would be energy efficient in combination with the storms. If windows are beyond repair, new wood windows, or aluminum-clad wood windows would need to be installed vinyl is not approvable for front facades. Ideally existing vinyl windows would eventually be replaced with wood or aluminum-clad wood windows.
