CITY OF ALLENTOWN

R84 – 2019

Certificates of Appropriateness for work in the Historic Districts: 339 N 8th St.

Item #1 - Case # HDC-2019-00054 - Proposal to continue alteration of cornice

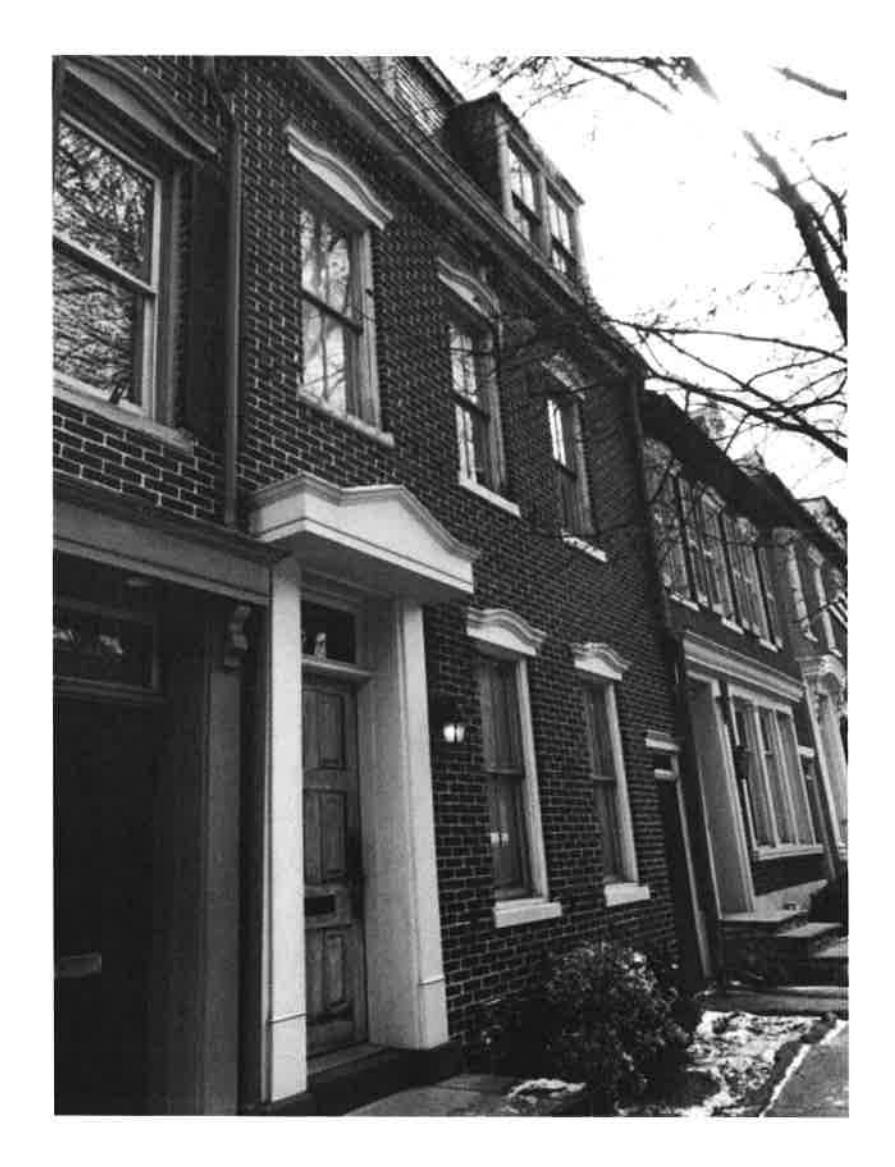
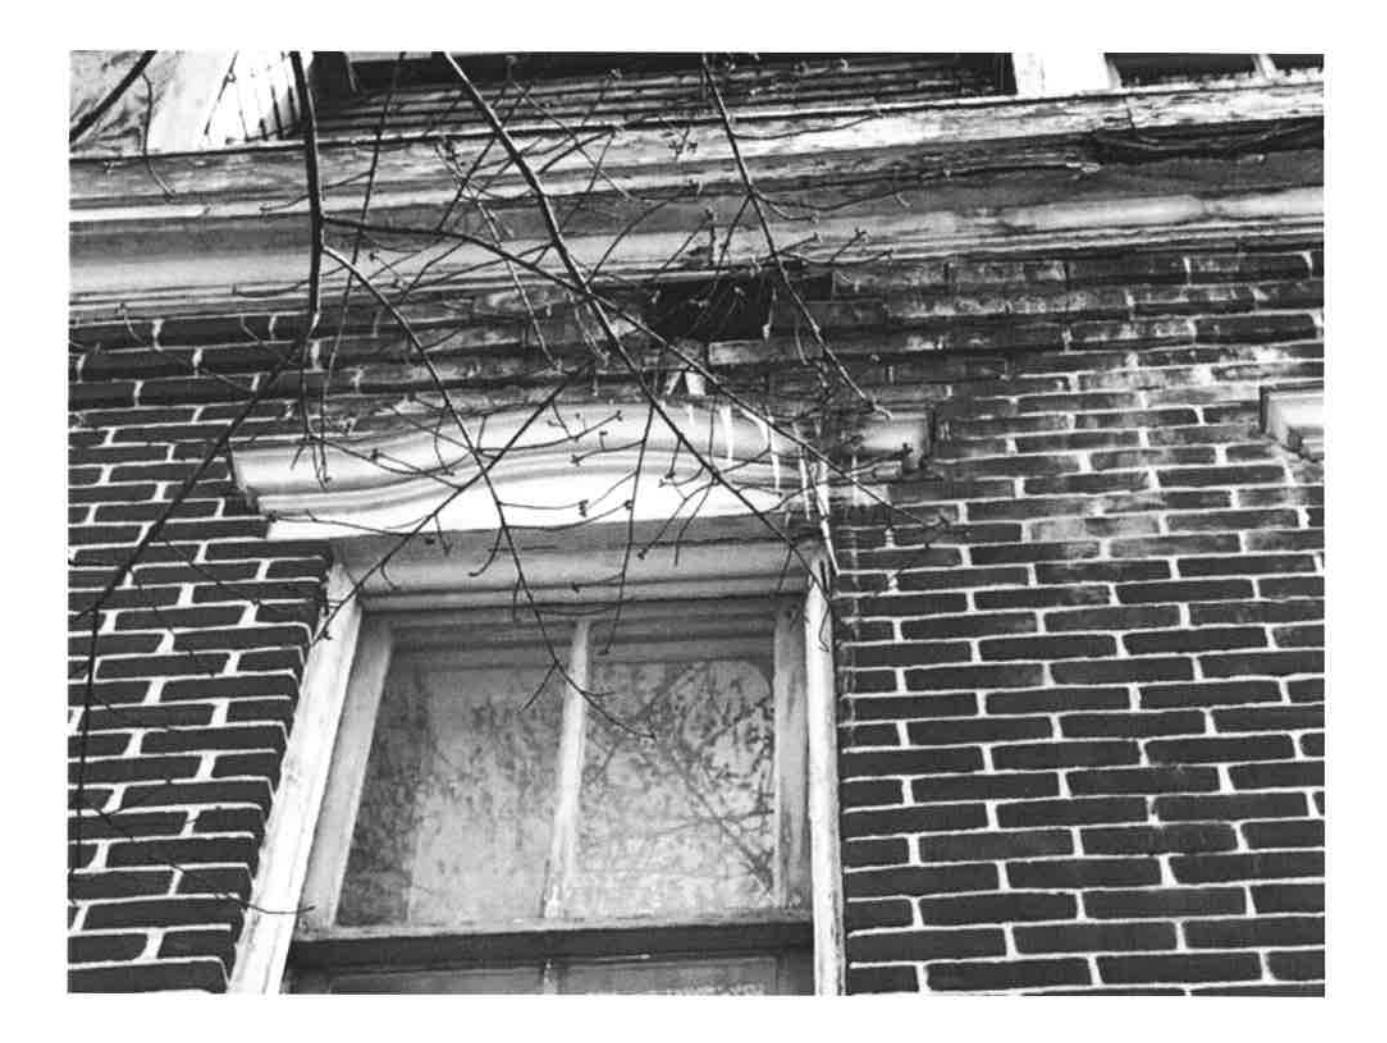
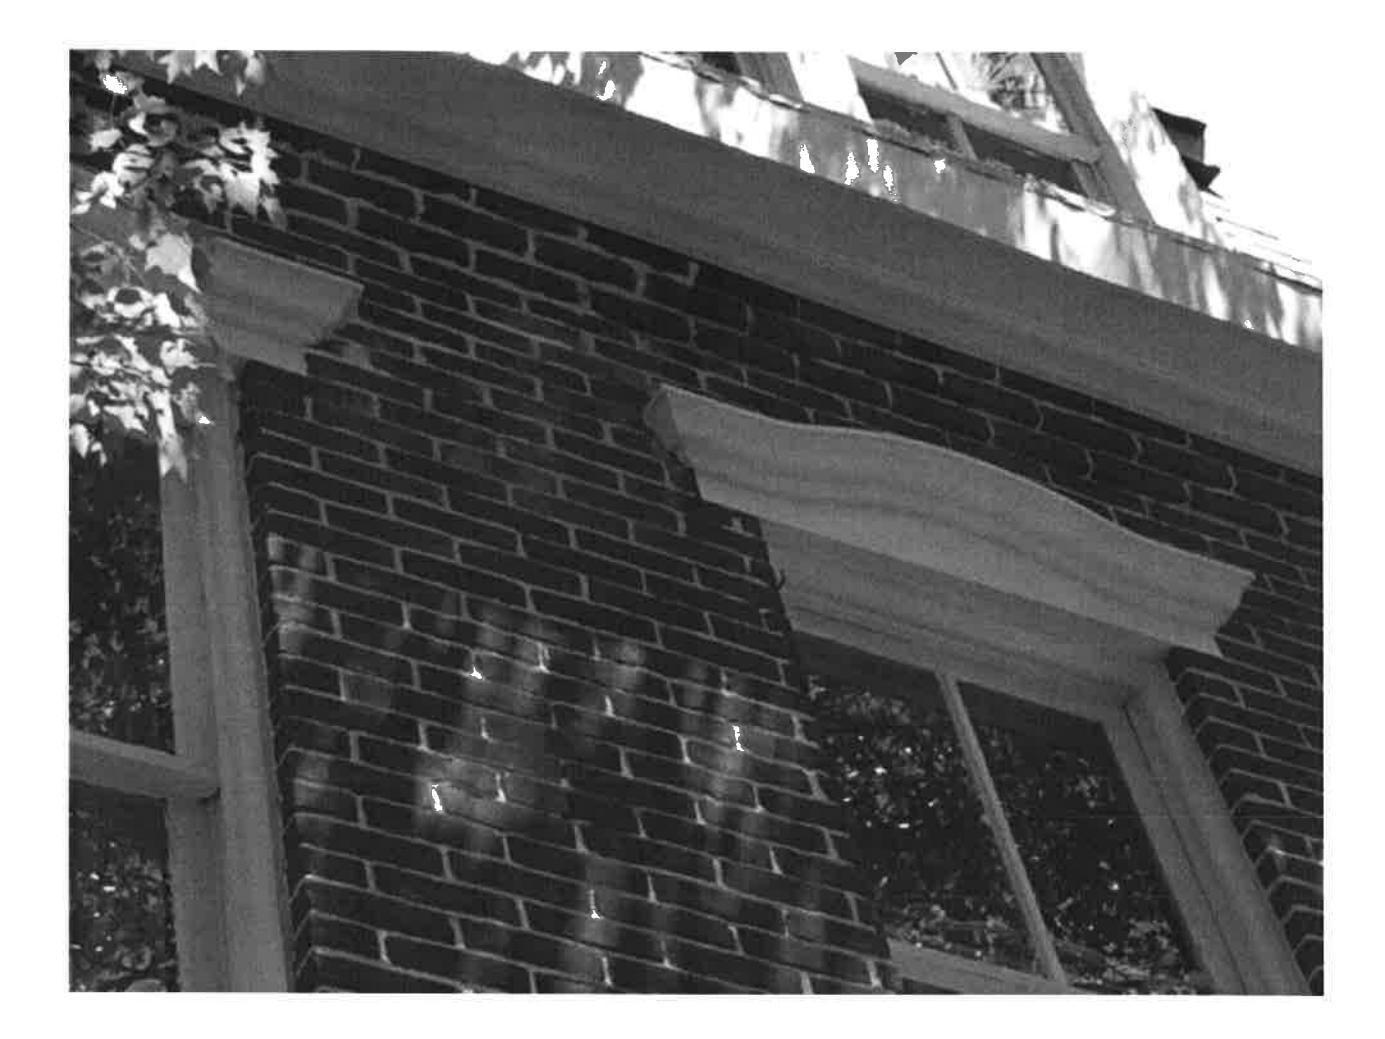
Building description, period, style defining features: This structure is a 3 bay, 3 story, attached red brick dwelling with Mansard roof, simple shed-roofed dormers, built-in gutter system with wood fascia and soffit (most likely altered in a façade renovation in1997), corbeled brick cornice, 2 over 2 double-hung windows with arched headers, and entry with altered door surround (also likely 1997). The house dates from c. 1876 and is Second Empire in style.

Proposed alterations: It is proposed to continue alteration of cornice.

Evaluation, effect on historic district, recommendations: From older photographs provided it appears that this building had been drastically altered a decade or more before 1885. A drawing provided showed plans for renovation that appear to have been carried out in 1997. The wood fascia and soffit dated that was replaced dated from that time. The replacement fascia and soffit proposed to be retained and approved differs from the non-original fascia and soffit in the size/scale of two items: the fascia is no longer stepped and larger (by 1") and the decorative molding below the soffit is smaller (1 $\frac{3}{4}$ " instead of 3 $\frac{1}{2}$ "). Given the non-original condition of the replaced fascia and soffit the HARB may want to consider permitting the latest replacement to be retained or to require, possibly, the replacement of the molding below the soffit which is likely the most visible aspect of the cornice from the viewpoint of the pedestrian.

The loss of the corbels under the front door pediment should be discussed. Although not original to the building, they were part of the 1997 renovation and added character to the ungainly cantilevered pediment over the door. Their reinstallation would lend visible support to the pediment.

- 1. The proposal to continue alteration of cornice at 339 N 8th Street was represented by Tom Gilman.
- 2. The existing modification of the flat cornice will be modified by adding an appropriately scaled crown molding (about 4") at the top of the flat fascia.
- 3. Rot resistant species of wood or composite molding may be utilized.
- 4. The chosen molding must be reviewed by City staff or Historic Consultant for appropriate scale and detail.
- 5. The new molding must be installed by 30th May 2020.
